Accident Report  
*ANL Progress*  
Person Overboard at Port of  
Lyttelton on 4 July 2004

## ANL PROGRESS

At 0105 hours on Saturday 3 July 2004, a stevedore from Lyttelton Stevedoring Services fell into the harbour from the container vessel *ANL Progress*, when he lost his balance while holding a three high lashing bar. The stevedore was rescued from the water and treated for hypothermia.

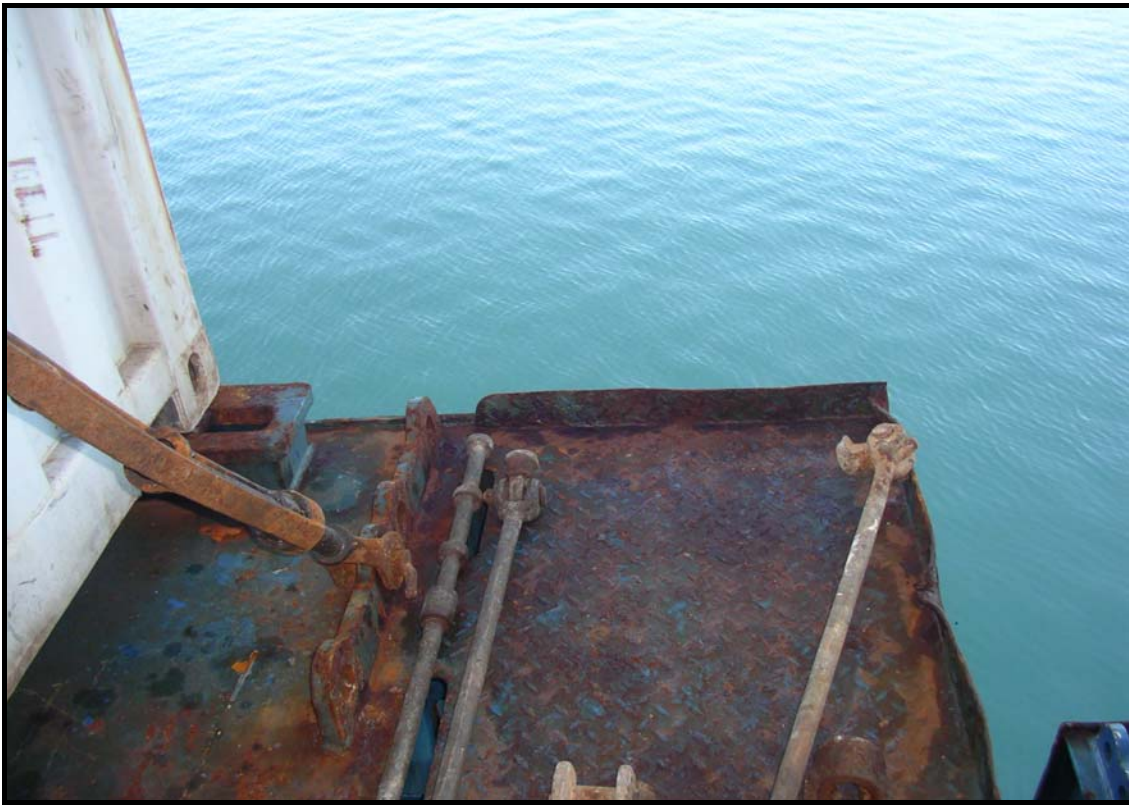
- 1.5 At approximately 0105 hours, Stevedore 1 undid the lashings on the outboard container. To do this he was standing on the lashing platform on the outboard side of the ship (See *Appendix 1 – Photos 1 & 2*). He undid the one and two high lashing bars and placed them on the deck. He then undid the first three high lashing bar (the lashing bar that is attached from the base of the first container to the base of the third container), (See *Appendix 1 - Photos 3 & 4*) and put it on the deck. He had just taken off the last three high lashing bar and was holding it upright when he lost his balance due to the vessel's movement (caused by the easterly swell coming up the harbour).

- 3.1 The weight and length of the three high lashing bar.
- 3.2 The restricted space in which the stevedore had to work.
- 3.3 Stevedore 1 was handling the bar alone.
- 3.4 The easterly swell conditions caused the vessel to range alongside the berth.
- 3.5 The lashing platform did not have a guardrail.
- 3.6 Stevedore 1 was not equipped with a fall arrest system.

Photo 1 – Lashing Platform From Which Stevedore 1 Fell

- 5.7 It is recommended that all stevedoring companies require the use of fall protection on platforms over three metres.
- 5.8 It is recommended that the Maritime Operations Division of the Maritime Safety Authority in conjunction with Occupational Safety and Health look further in to the issue of lashing safety onboard container vessels with special reference to the feasibility of fall protection.

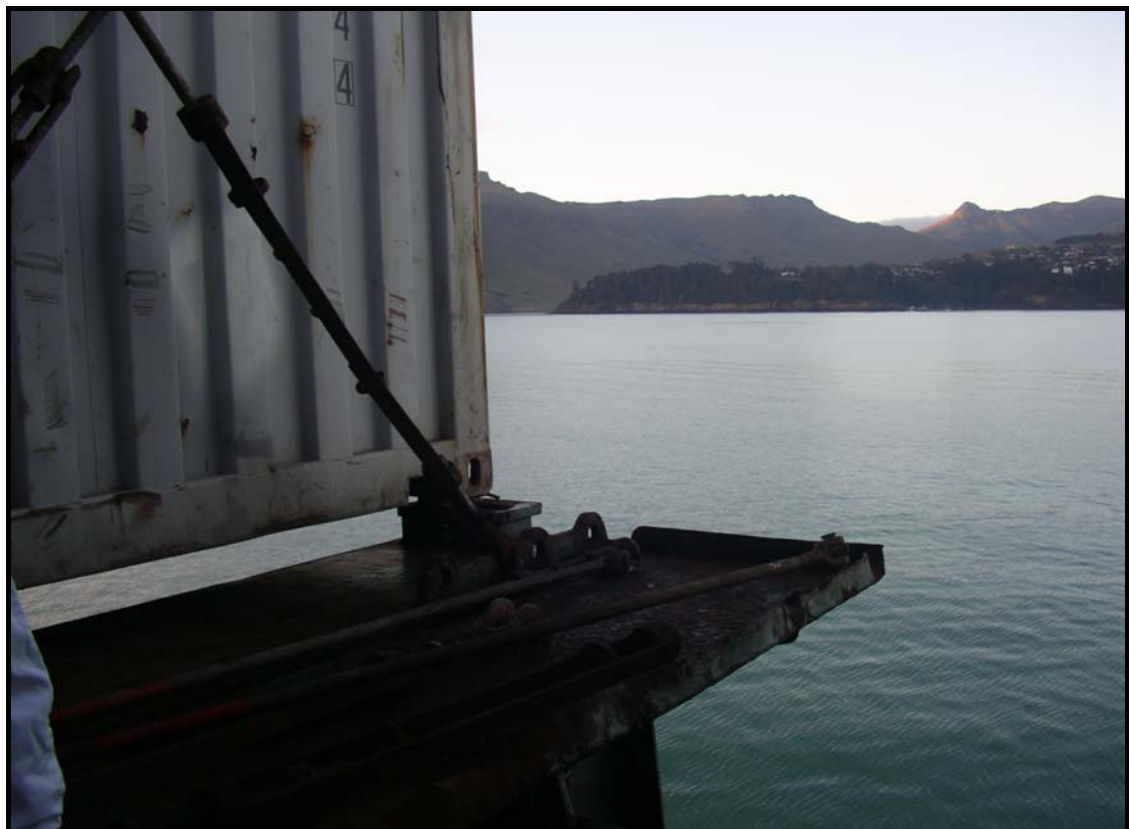
Photo 2 – Lashing Platform From Which Stevedore 1 Fell

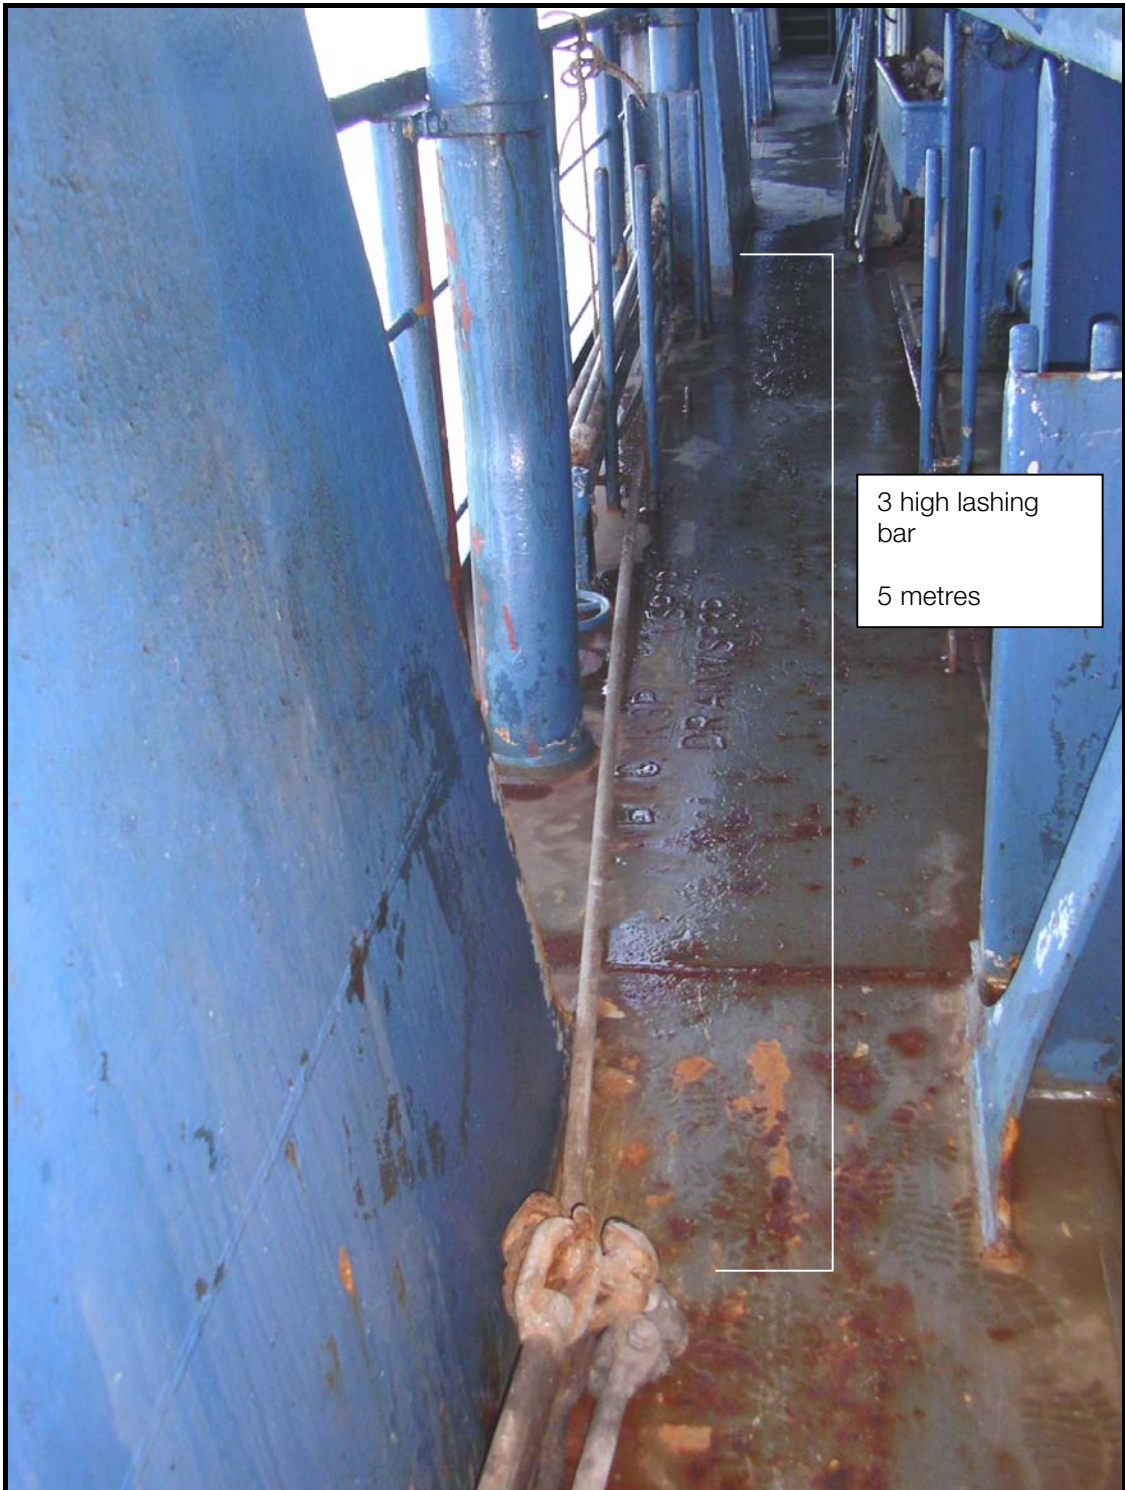
Photo 3

2.4.1 The three high lashing bars measure up to five metres in length and weigh up to a maximum of 24kgs.

3 high lashing  
bar  
5 metres
