Accident Report

Grounding

Amaltal Columbia

AMALTAL COLUMBIA – GROUNDING

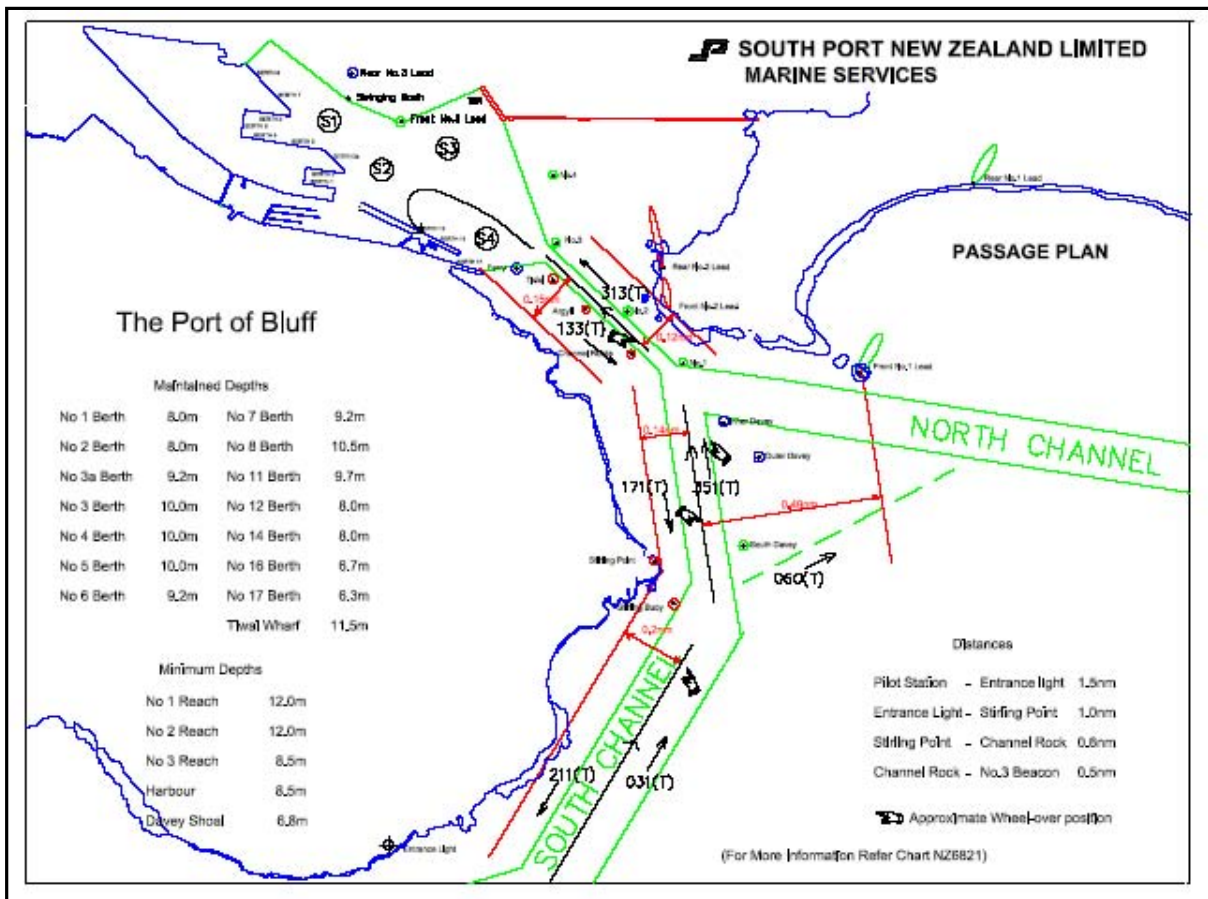
Figure 1
South Port Passage Diagram

The Pilot briefing consisted of running through the arrival checklist with the Skipper and Mate and showing them the Passage Diagram (See Figure 1). The actual Passage Plan for the vessel was also shown to the Skipper and Mate. This envisaged the vessel would be berthing port side to berth No.12. However, this had to be changed by the Pilot when he was told they needed to berth starboard side to this berth (See Figure 1a). The bridge team looked at both the electronic and paper charts but there was no specific discussion regarding the charted depths in the approaches to No. 12 berth, notwithstanding the Pilot had been aware that the depths shown were incorrect since **Stolt Kikyo** had touched bottom in July 2004.

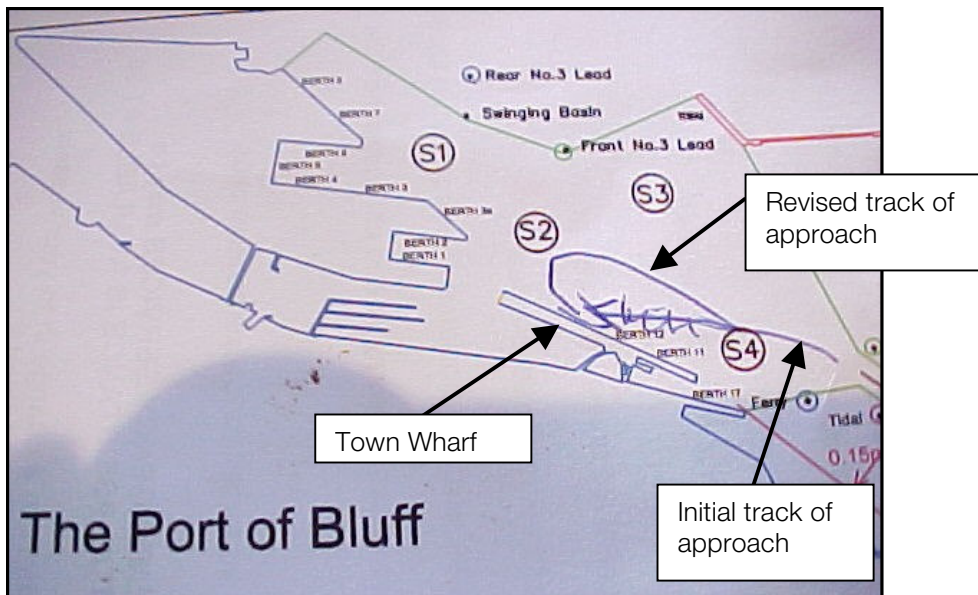
Figure 1a
Photograph of the actual Passage Plan that was presented to the Skipper of *Amaltal Columbia*. The initial track drawn by the Pilot was deleted after the he was told the vessel would be berthing starboard side to. A new approach course in the form of a loop, as shown above, was then drawn by the Pilot.

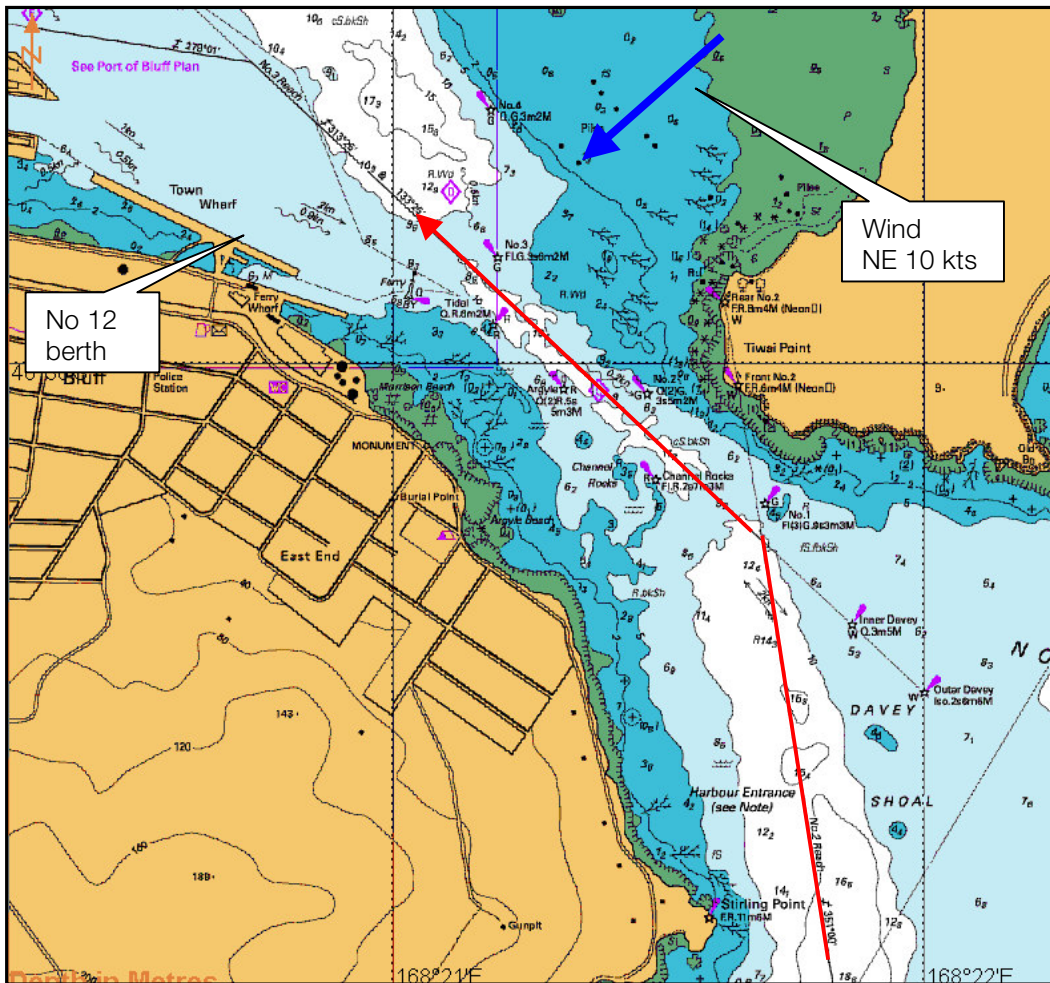
Figure 2
Chart extract from Land Information New Zealand Chart (LINZ) NZ 6821

The ship's electronic chart plotter was switched on and this showed the depth contours on the approach to berth No. 12. These were the same as those recorded on the paper chart for the Port of Bluff, NZ 6821, which, in the approaches to berth No. 12, showed an overall maintained depth of 8.5 metres and a maintained depth of 8 metres alongside this berth (See *Figure 4 – Extract of Chart NZ 6821*).

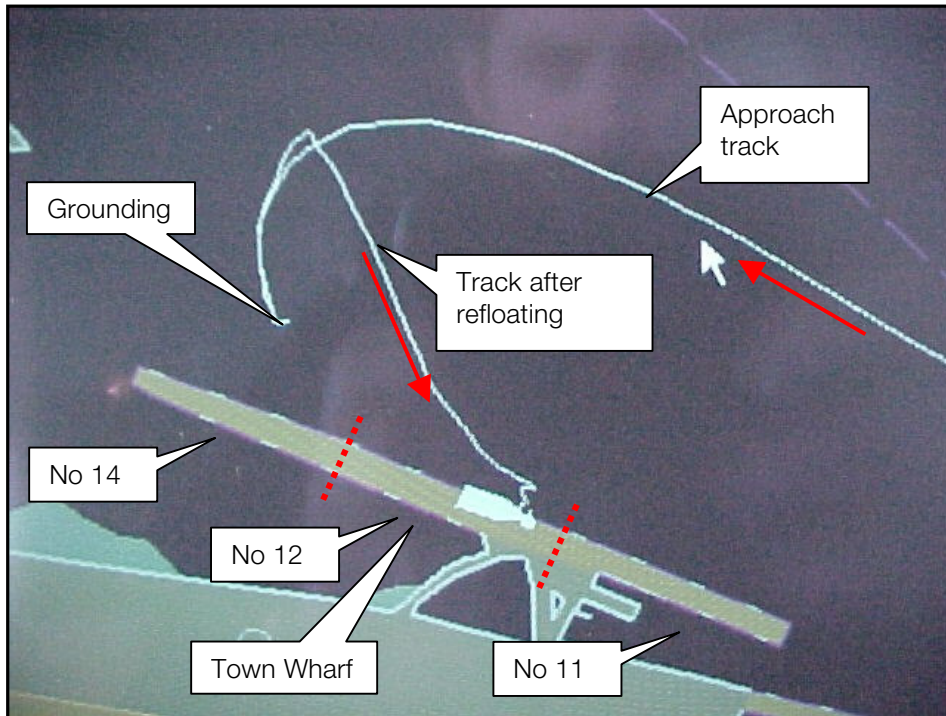
Figure 3

At about 0815 hours, when **Amaltal Columbia** was about 75% through her turn it became obvious to the bridge team that the forward momentum and swinging of the vessel had stopped and she was aground (See Figure 3).

Digital photograph taken of Chart Plotter Display after the grounding shows the vessel's actual tracks both before and following the grounding.

The Pilot disputes the position of grounding shown on Figures 3 and 4. It is his contention that based on the South Port sounding plan of June 2005 the vessel could not have grounded in this position. It is his opinion that the position of the grounding was further to the west and closer to the boundary of the shoal ground area.

The photograph of the chart plotter display on board **Amaltal Columbia** (See Figures 3 & 6) shows the vessel was approaching the westerly extremity of No. 12 berth at the time the turn to port was initiated. At that stage however, she was in excess of 2 cables off the Town Wharf and hence clear of the area where the sounding of 7 metres is shown off the Town Wharf (See Figure 5 above). However, having regard to the likely advance and transfer of **Amaltal Columbia** during her turn, the Pilot should have known the vessel would inevitably enter the area where the surveyed depth of water was recorded as being 7 metres.

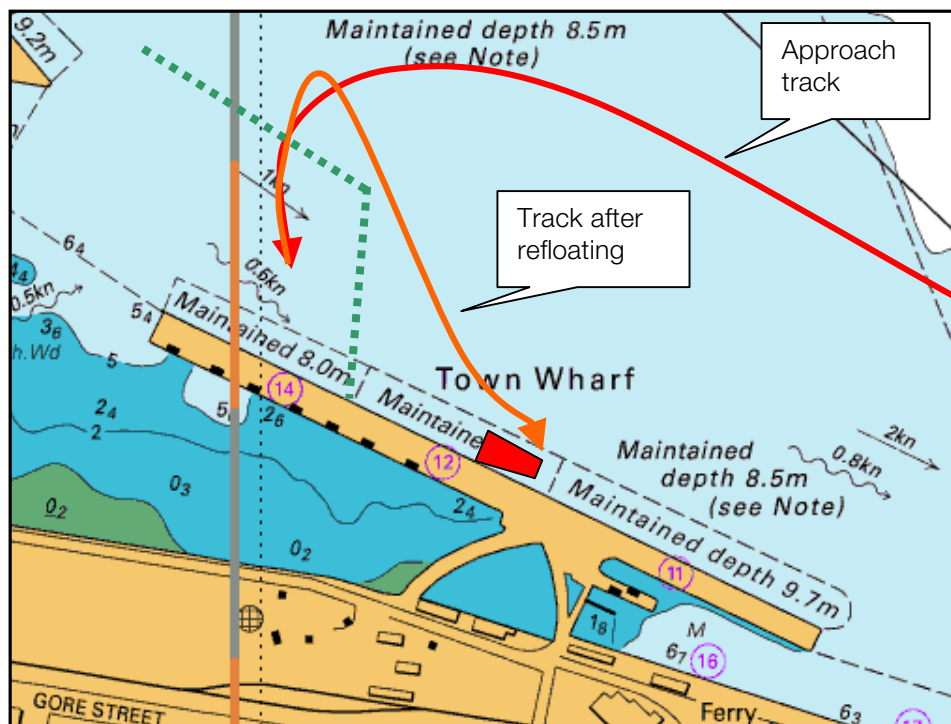
Figure 4

According to the Skipper, the vessel was about 150 metres off the Town Wharf, and approaching a point perpendicular to the boundary between Nos. 12 and 14 berths (See Figures 3 & 4), when the Pilot made the comment that "we should turn about now as it gets shallow up this end". The Pilot contends that this was done well before this juncture. The Skipper checked the echo sounder at this stage and found there was about 1 metre of water under the keel. However, he was not too concerned as the First Mate had just taken action to come round to port in accordance with the Pilot's advice.

The tracks from the vessel's Chart Plotter have been transposed on to LINZ chart NZ 6821.

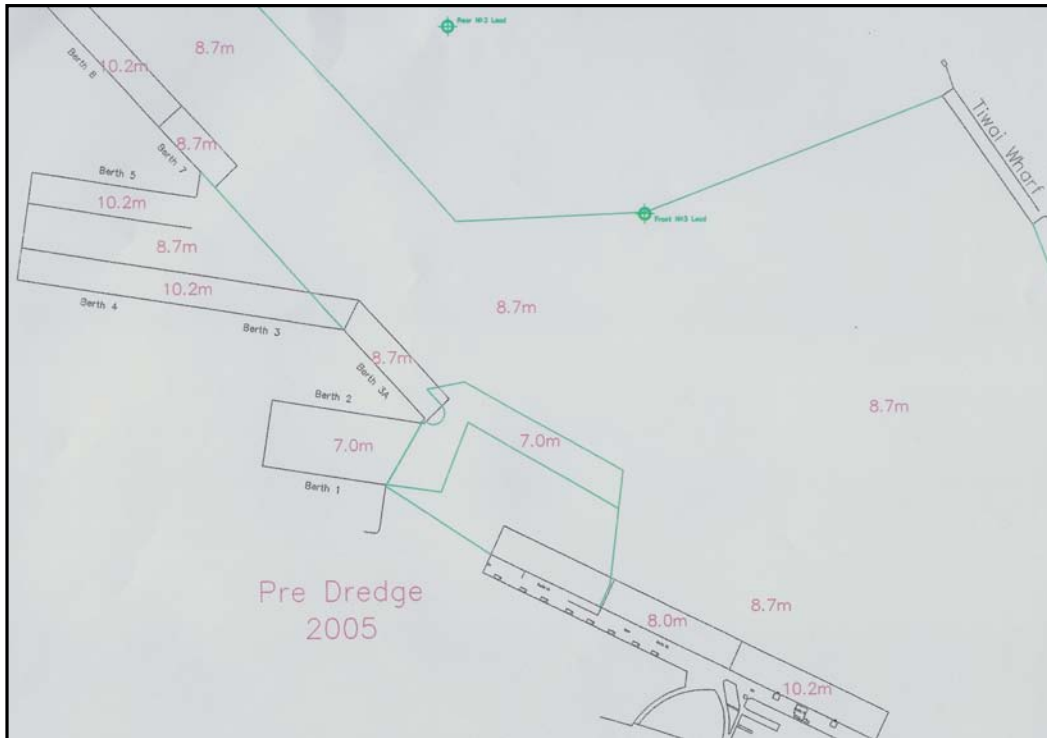
Figure 5
Pre Dredge Sounding Chart 2005 - Based on data from the December 2003 sounding survey

In August 2004, the correct sounding information, on which the soundings shown on *Figure 5* of the report are based, was sent to LINZ. Unfortunately, due to internal upheavals, this data was not followed up by LINZ and a revised Notice to Mariners was not issued. This omission only came to light after this accident occurred.

"South Port requires that any vessel with a draft greater than 7 metres arriving or departing from berth No.12 shall manoeuvre in such a manner that she does **not proceed west of berth No.12** (Maritime New Zealand emphasis) until she is at least 0.9 cables from the Town Wharf" (See Figure 5). The grounding position occurred about 90 metres or approximately 0.5 cables off the Town Wharf.

The known parameters of the shoal ground area and the soundings as shown on Figure 5 should have been drawn specifically to the attention of the Master and Mate at the time of the Master/Pilot briefing so that they had a shared mental model of the approaches to berth No.12 and the point at which the vessel needed to turn off the berth, having regard to the prevailing conditions, the maximum draft of the vessel and her turning circle data.

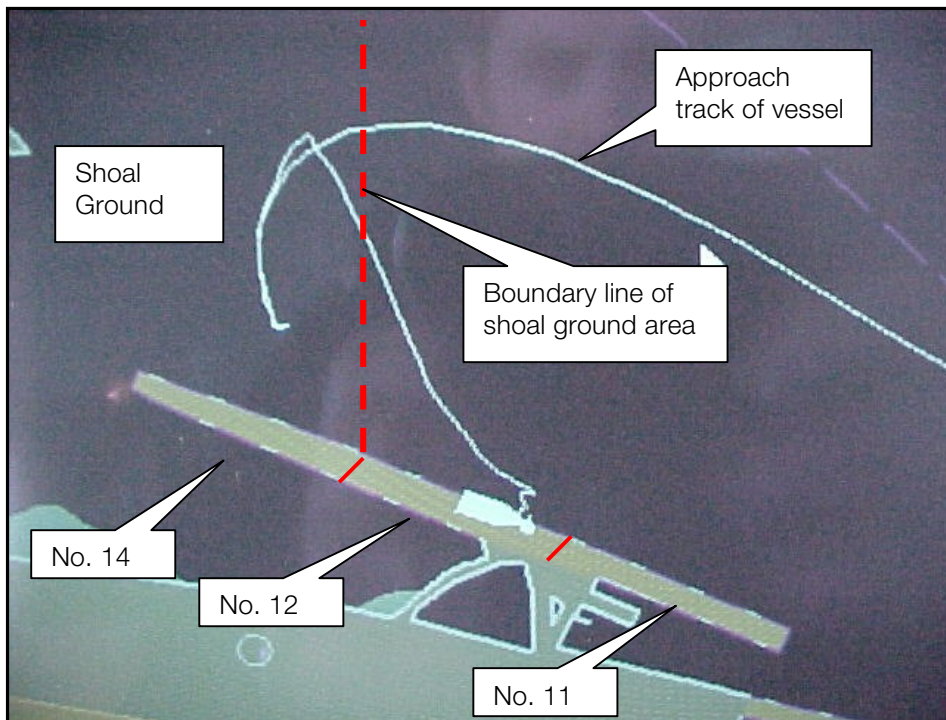
Figure 6
 The red line indicates the area west of berth No. 12 that is to be avoided by vessels' with a draft of greater than 7 metres until they are at least 0.9 cables from the Town Wharf.

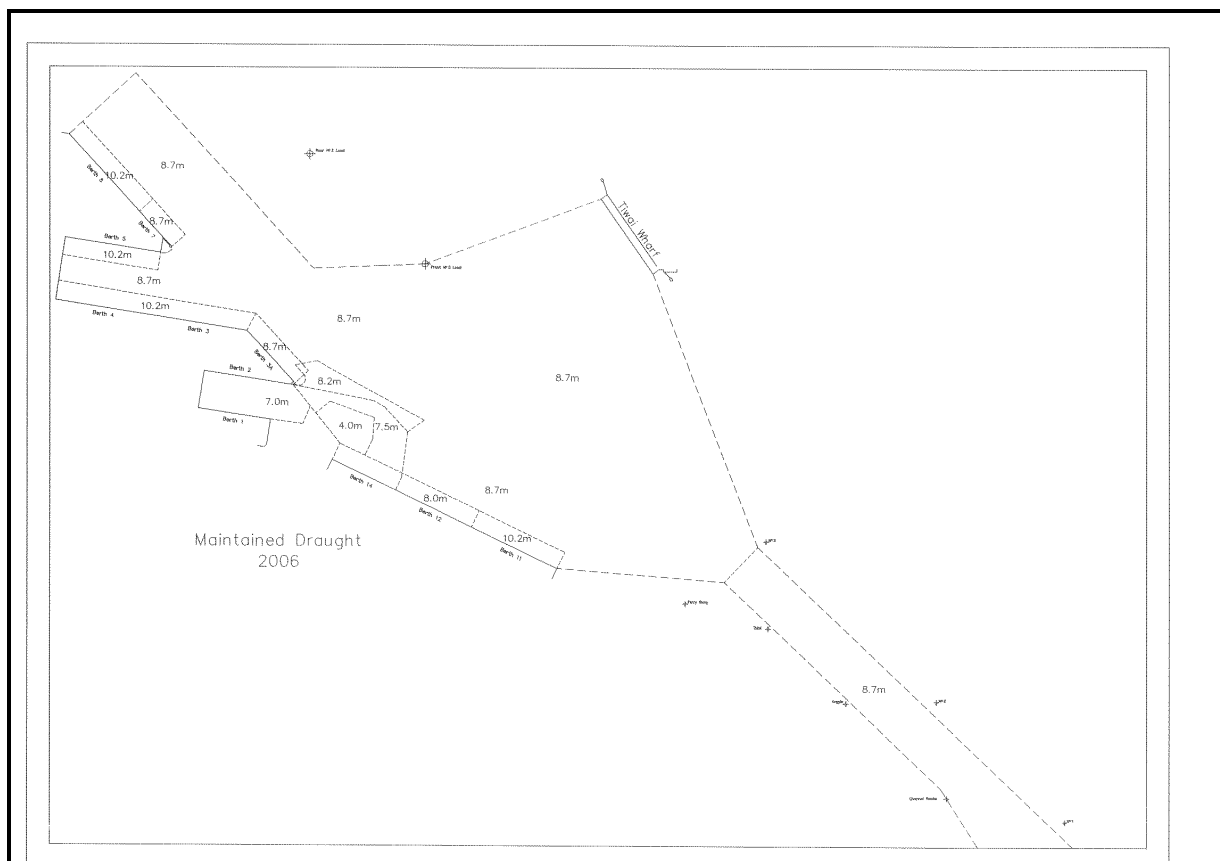
Figure 7

Since this accident, extensive dredging of Bluff Harbour has occurred resulting in depths of 8.7 metres above chart datum in the approaches to the Town Wharf berths (See *Figure 7*).

The Swinging basin situated in the area to the north of the Front No.3 lead beacon is dredged by external contractors on a 12 to 15 year cycle. Dredging was carried out between mid November and mid December 2005 (See Figure 7).

The above chart shows the maintained depths after dredging.
