Accident Report
Amaltal Enterprise
Serious Harm Injury
East Coast of New Zealand on
10 February 2005
Class A

REPORT NO.: 96 367

VESSEL NAME: *AMALTAL ENTERPRISE*

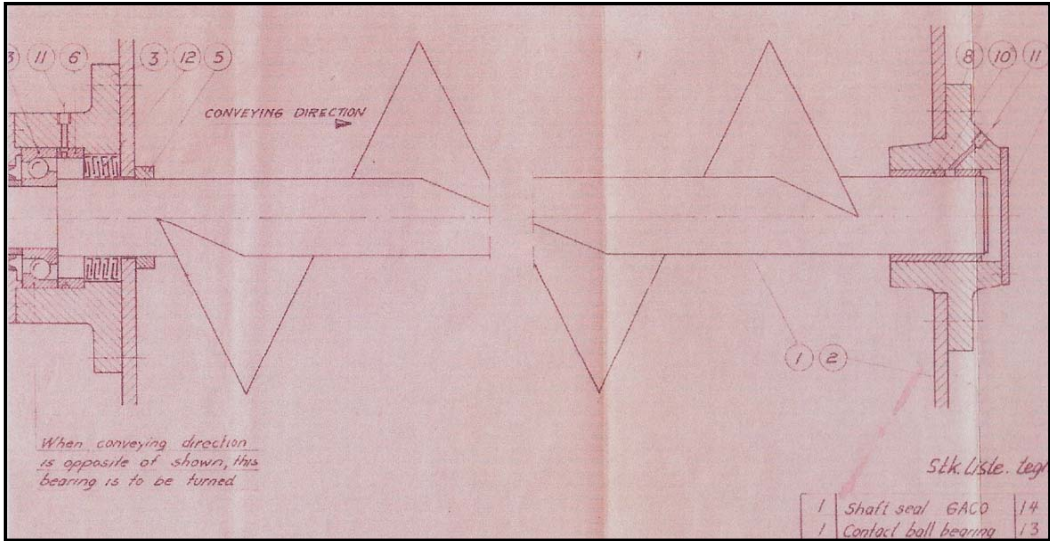
Diagram 2 – Drawing of Drain Screw

They found that the fish meal in the cooker had blocked the drain screw. Crewmember 2 deduced that the blockage had occurred after the drain screw had stopped rotating. The drain screw and other machinery in the factory deck and meal plant are driven by an hydraulic pump. Crewmember 2 believed this pump had stopped temporarily at some stage, thereby allowing a build up of fish meal in the cooker that, in turn, caused the blockage. The investigation was unable to determine the cause of this stoppage.

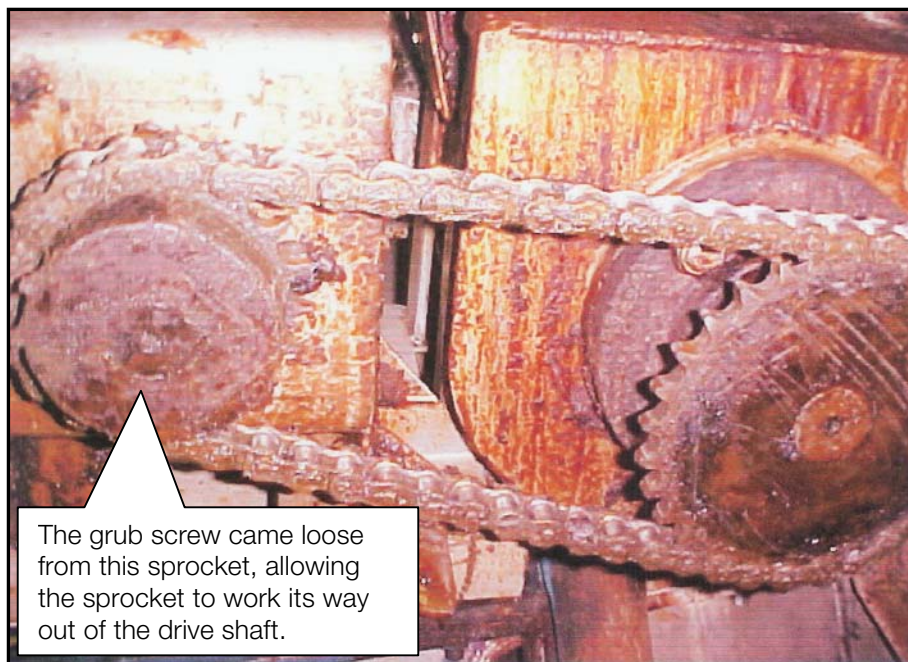
Photograph 2

At about 0930 hours, Crewmember 1 went to find the Chief Engineer as he was having problems with the drain screw drive (See *Photograph 2*). On returning to the meal plant the Chief Engineer and Crewmember 1 shutdown and isolated the cooker and the drain screw. They found that a drive sprocket had come loose and the drive key had dropped out (See *Diagram 4*).

Drain Screw drive – the drive is hydraulically driven through a set of sprockets

The Chief Engineer reinstated the drive and guard and then started the cooker and drain screw. He spent the next fifteen minutes monitoring the cooker. Once the Chief Engineer and Crewmember 1 were happy with how the plant was running, the Chief Engineer returned to his normal duties.

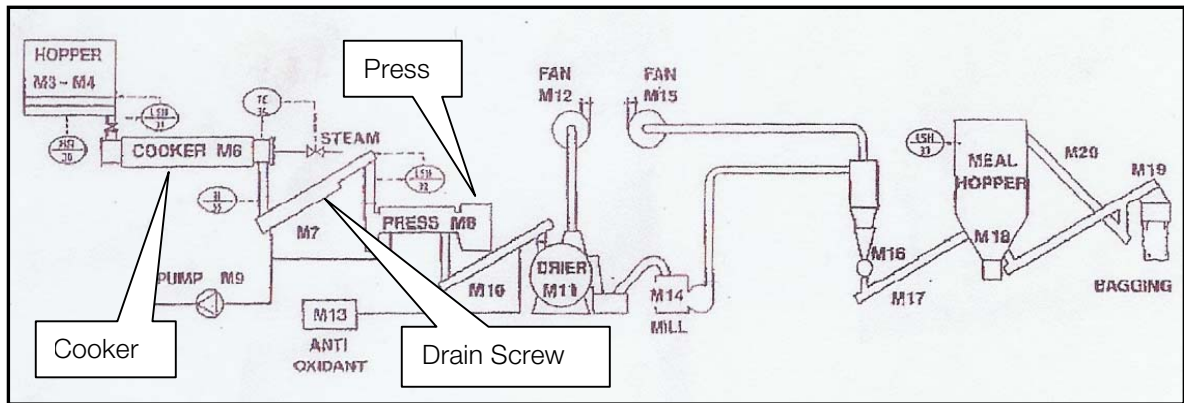
Diagram 5 – Stord Bartz Fish meal Plant

At about 1045 hours, Crewmember 1 noticed that no fish meal was being processed through the cooker to the press (See *Diagram 5*). He tried to open the end cooker hatch cover (See *Photograph 3*) but heard the sound of steam escaping and decided therefore to close the cover again.

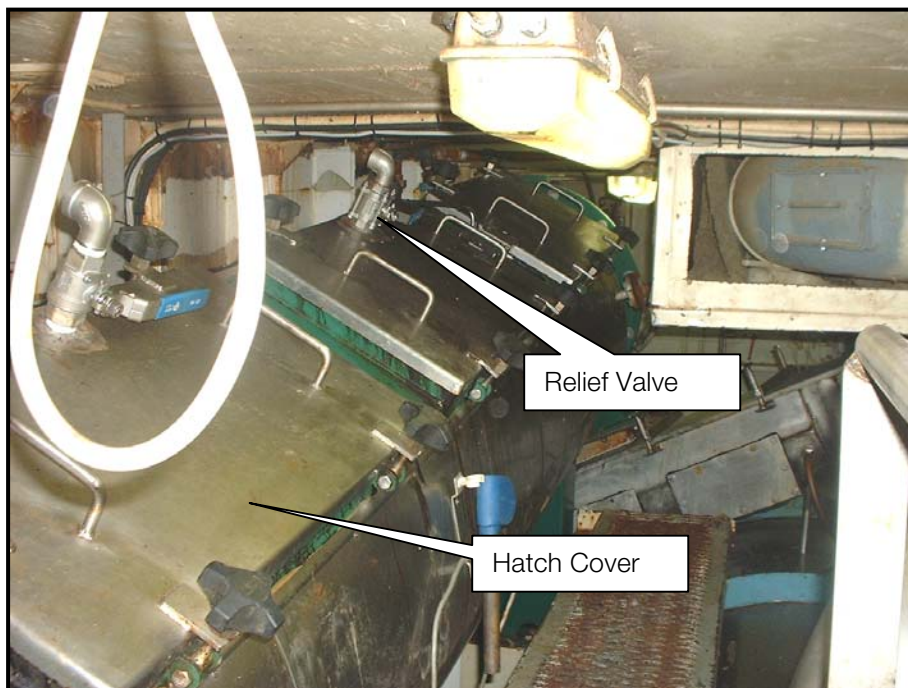
Photograph 3 – Cooker & Hatch Covers

Both crewmembers checked that the supply of steam and power to the cooker had been isolated. Crewmember 2 asked Crewmember 1 if he had opened the inspection hatch at the top of the cooker. Due to language difficulties, the response of Crewmember 1 was not very clear but Crewmember 2 believed Crewmember 1 had released any build up of steam within the cooker after opening the hatch cover.

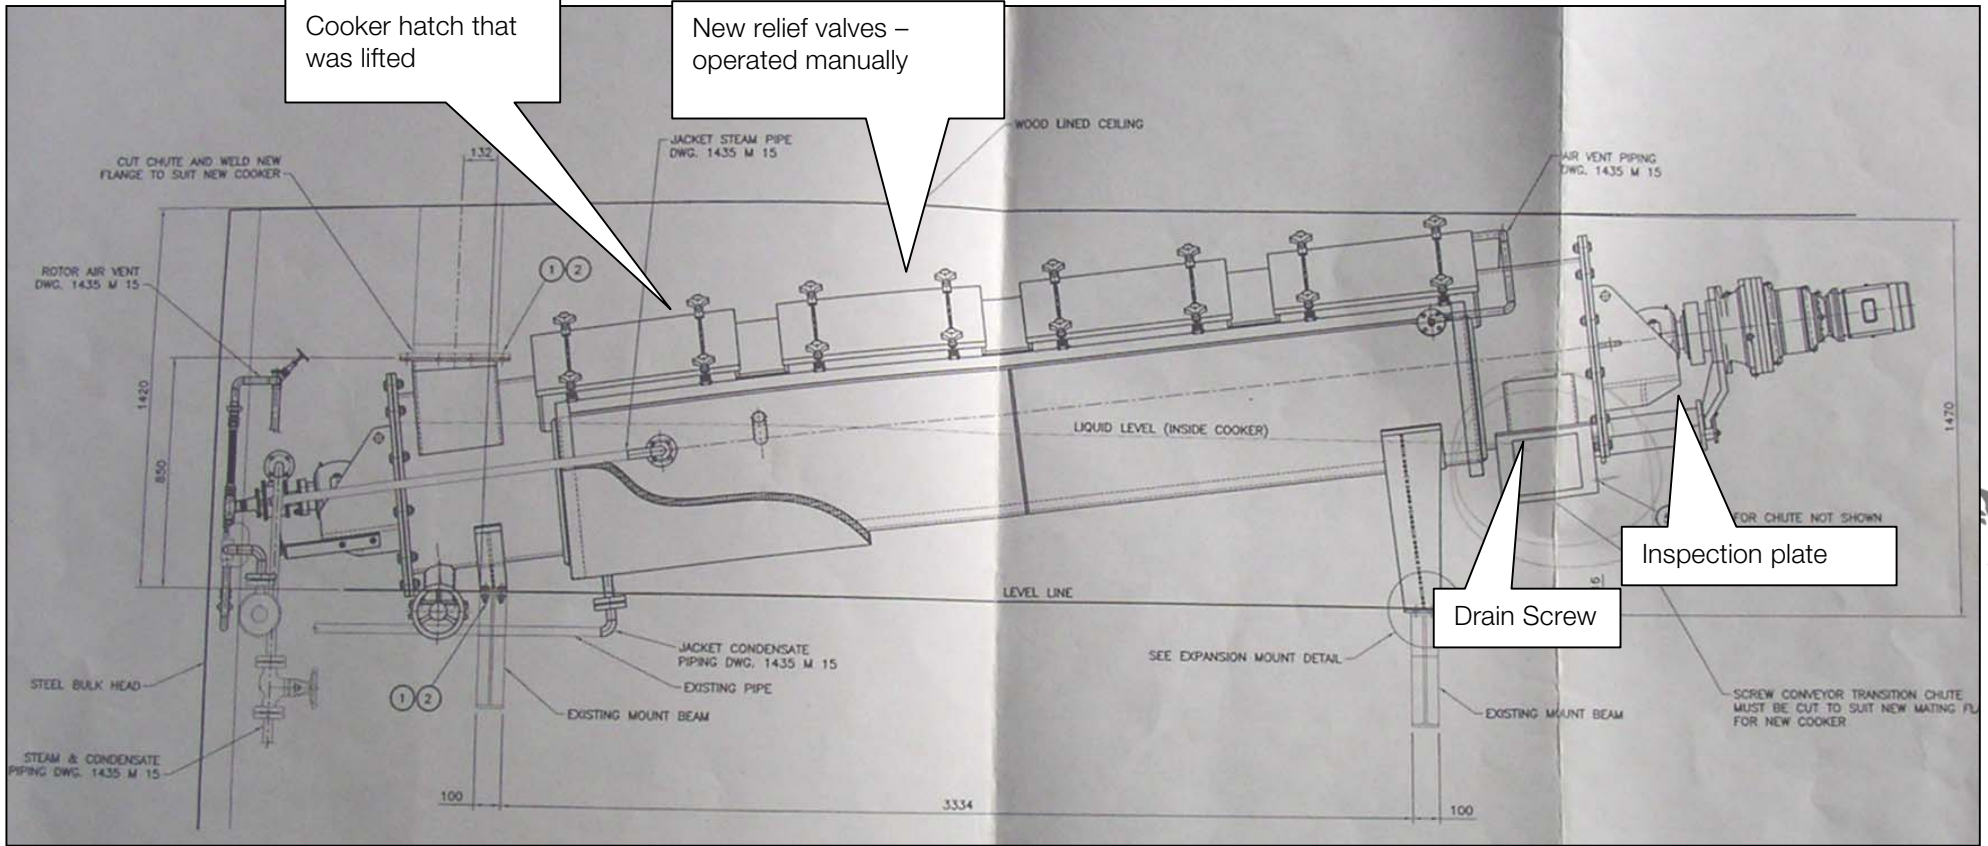
Diagram 3 – Fish Meal Plant Cooker

Crewmember 2 opened the side inspection plate (See *Diagram 3*) of the cooker and started to dig out the blockage of fish product, using a screwdriver.

After clearing the blockage, a quantity of steam that had built up within the cooker, suddenly vented from the drain screw opening. The steam struck Crewmember 2, who was unable to get clear in time, causing severe burns to his body.

The steam that was trapped within the body of the cooker was caused as a result of condensation from the fish product during the cooking process.

Since the accident, two one-inch relief valves have been installed in way of the hatch covers to the cooker (See *Photograph 3*). These are located above the drain screw, where the pressure or steam tends to collect due to the raised angle of the cooker at this point (see *Diagram 3*). Hoses are attached to the relief valves to direct steam away from the crew. Meal men have been instructed to make sure the relief valves are opened manually, to ensure the release of any steam, before removing the inspection plates to the cooker.

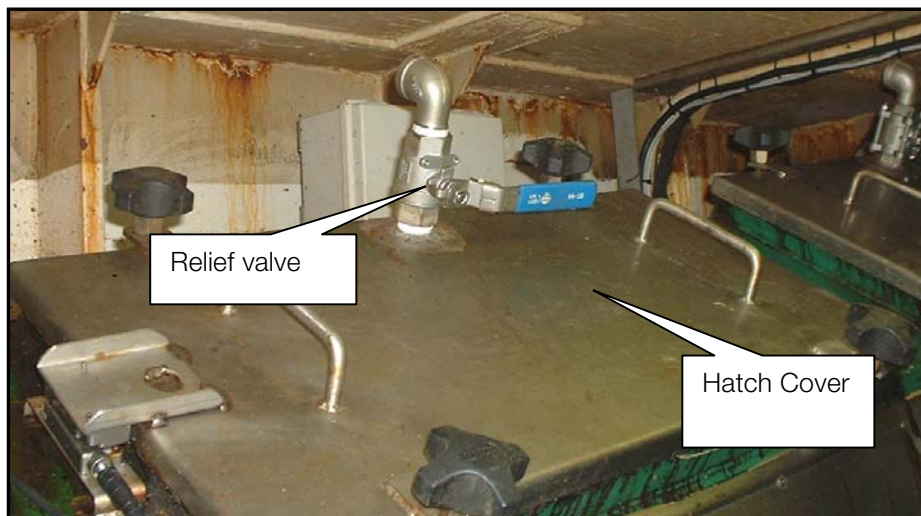
Photograph 3 – Cooker & Relief Valve

The cooker had not been identified as a hazard. There were no documented procedures for the safe operation of the cooker and no relief valves, to allow the release of any build of steam, had been fitted.
