Accident Report

Aquilo

Person Overboard/Fatality

REPORT NO.: 04 1155

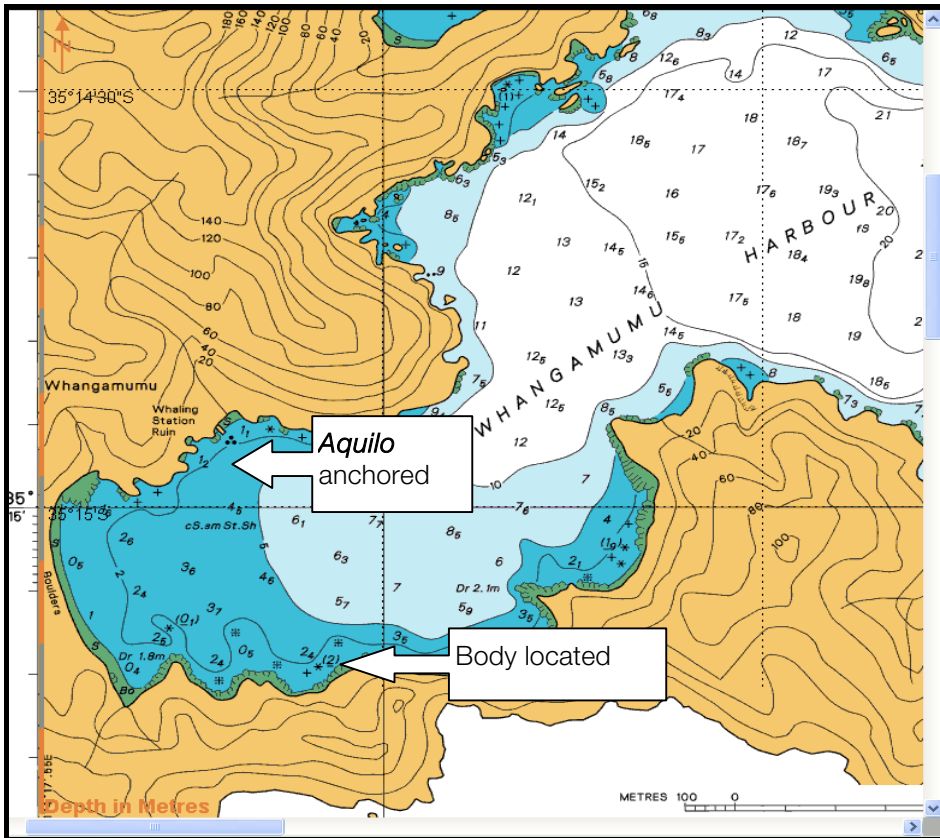
Figure 1

At about 1700 hours **Aquilo** moved further into the bay and anchored in the area with about 10 other vessels, including the yachts **Redeeder** and **Entourage** (See Figure 1). There was a light northwest wind.

At about 0730 hours they located the body of the Skipper's father on the rocks at about the high water level to the south of where **Aquilo** was anchored (See Figure 1). He was dressed in underpants and a singlet, which was his normal sleep attire and had minor cuts and grazes from being washed onto the rocks. He showed no signs of life.
