Accident Report
Arahura
Mechanical Failure in Tory
Channel on 14 December 2004
Class B

REPORT NO.: 04 3626

ARAHURA – MECHANICAL FAILURE

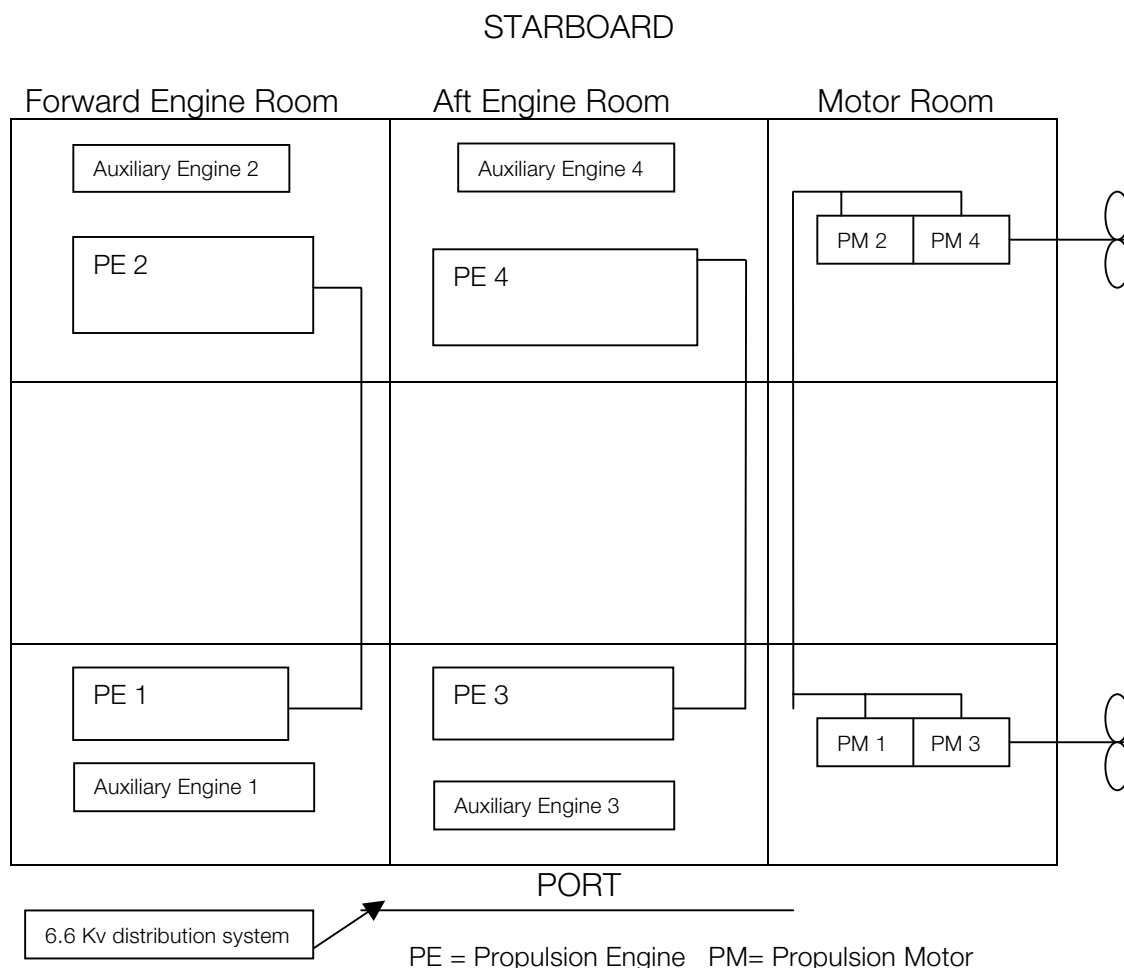
Figure 2 – Machinery Layout onboard *Arahura*

Whilst *Arahura* was transiting Tory Channel (Figure 1), a shore based Electrical Contractor was tracing/eliminating earth faults in the vessel's main engine room. These faults had been the cause of previous spurious alarms on the CSI alarm and monitoring system. The function of the system was to monitor the sensor outputs from the four diesel driven alternators (PE's – Figure 2). The PE's provided electrical power to four electric propulsion motors (PM's – Figure 2).

The Contractor mistakenly removed two wires from the CSI alarm system that were monitoring unit PE 4. This caused PE's 1 and 3 to shut down.

The above action caused a loss of electrical power to the starboard propulsion motor, which then stopped. *Arahura* still had power to the port propulsion motor (PM1).

- PE's 1 and 3 shut down after the wires were removed from PE 4. As the Contractor had ascertained that earth faults existed in the RPM sensors, it is probable that the removal of these wires caused an electrical spike. This then caused the voltage to rise high enough to trigger an over speed shut down of the three operating propulsion engines. This was the conclusion reached by the contractor.

1. Interislander responded to the incident by putting out a fleet memorandum; prohibiting work on any system, when the vessel was on passage in enclosed waters, which affected or could affect the propulsion of the ship, no matter how remote. This included any alarms and control systems relating to the propulsion of the vessel.
2. It is recommended that the above procedure be documented in the company's safety procedure manual and drawn to the attention of all engineering staff.
3. It is further recommended that Interislander give consideration to reducing the period between maintenance layovers to allow senior engineering officers to progress planned maintenance.
