Accident Report

Grounding

Ariel II

16 August 2006

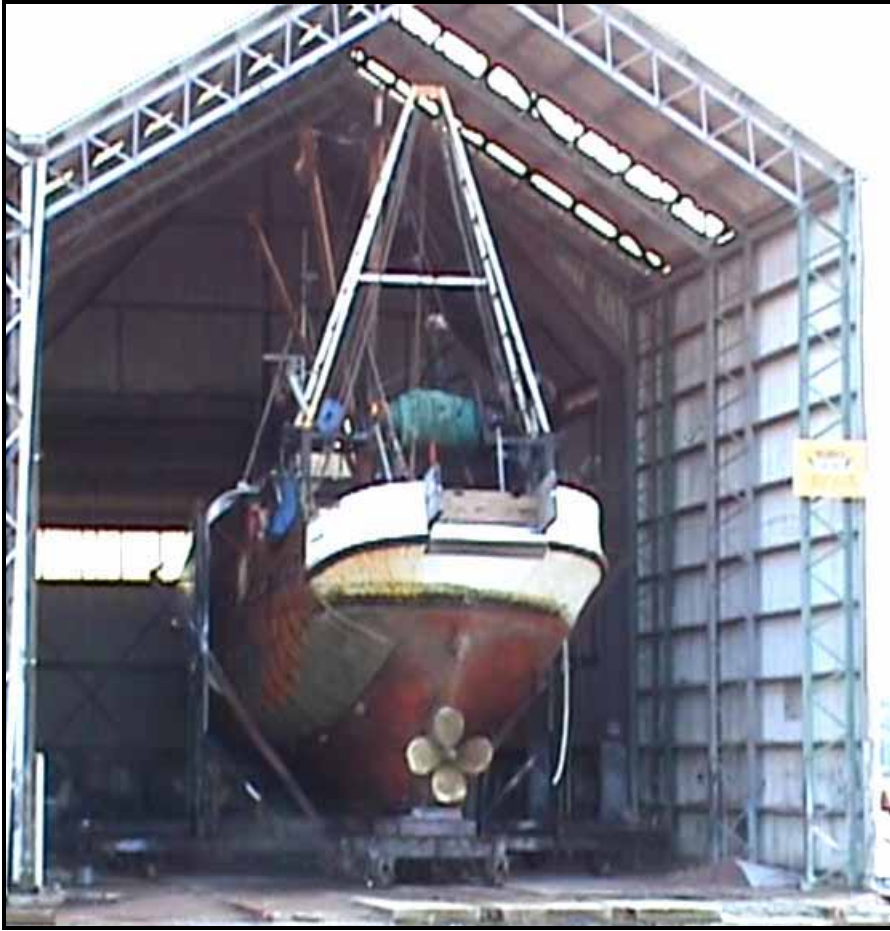
Photograph 1
Ariel II on slip in Bluff shortly after the grounding.

The vessel is to be repaired in Bluff.

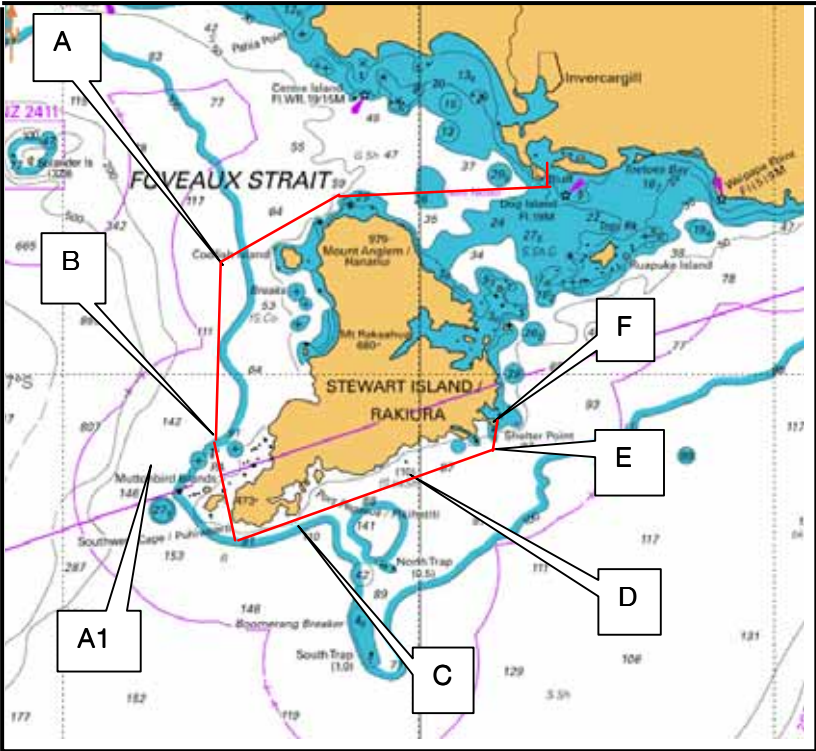
Figure 1

The vessel arrived at *Position A* (See Figure 1) at approximately 0600 hours, Tuesday 15 August, and commenced trawling. The Skipper towed south at a speed of about 3 knots. They continued fishing for the next 24 hours. The vessels' southernmost position was at *Position A1* (See Figure 1) at approximately midnight. At this time the Skipper shot away and towed north for about 6 hours.

Approximately 10 minutes later they were thrown off their feet as the vessel grounded in *Position F* (See Figure 1). The vessel was thrown bodily over to starboard with the bow pointing in a broadly westerly direction. The main engine stalled and the Skipper made his way to the wheelhouse where he made a Mayday call on the local Bluff Fisherman's Radio VHF channel. He checked the engine room and observed water coming in. He instructed one crewmember to launch the ship's dinghy that was lashed down on the fore deck. After this was completed, the Skipper and one crewmember boarded the dinghy. This capsized shortly afterwards. The dinghy sank leaving both men in the water clinging to the side of the vessel.

The Skipper spent about 10 minutes in the wheelhouse at *Position E* (See *Figure 1*). He states that at this position he made a course adjustment to pass through clear water between Shelter Point and Wreck Reef (See *Figure 4*). He then left the wheelhouse to help on deck for a further 10 minutes. Given a vessel speed of 9 knots and a multiplier of 10 minutes the distance travelled would have been 1.5 nautical miles.

The course selected by the Skipper after *Position E* (See *Figure 1*) should have taken the vessel clear of all obstructions in the area.

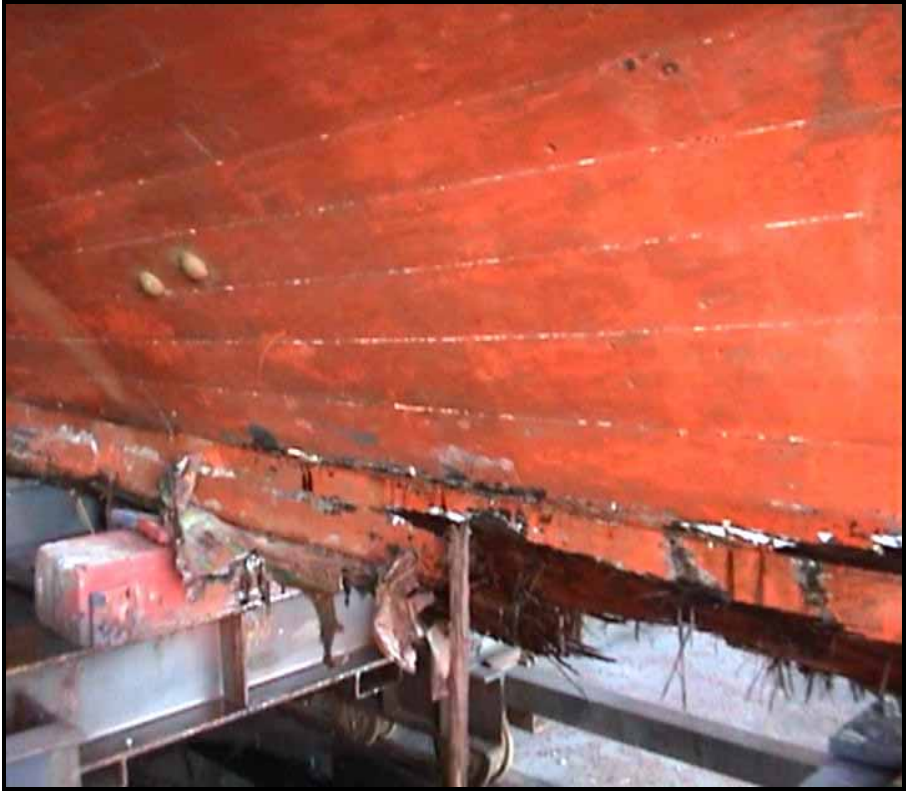
Photograph 3
Keel. The entire length of the keel has impact damage.

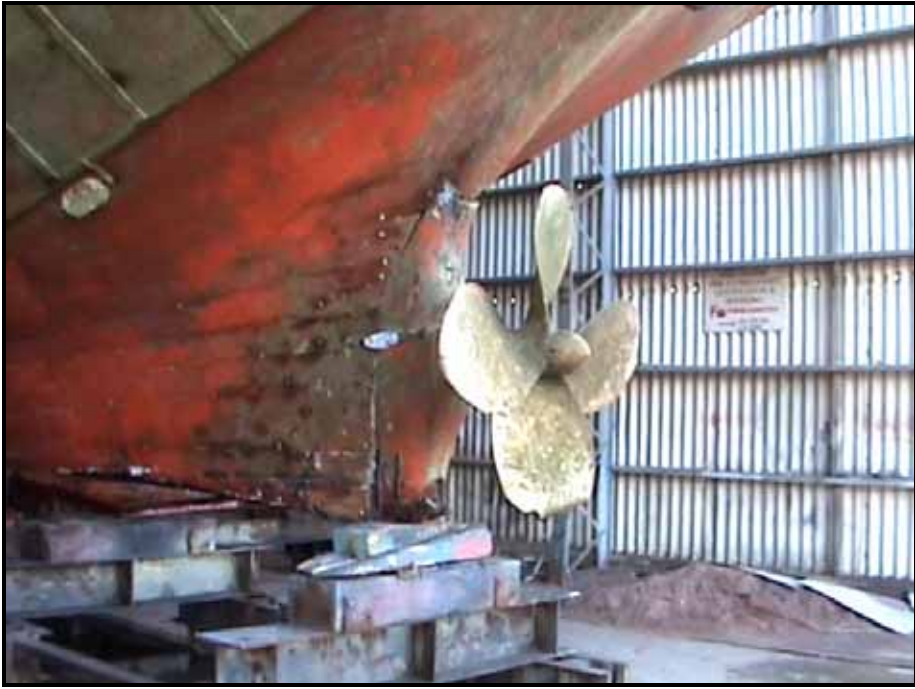
Photograph 4
Skag. The skag is completely missing from where it was scarfed into the keel. The holding bolts have been torn out.

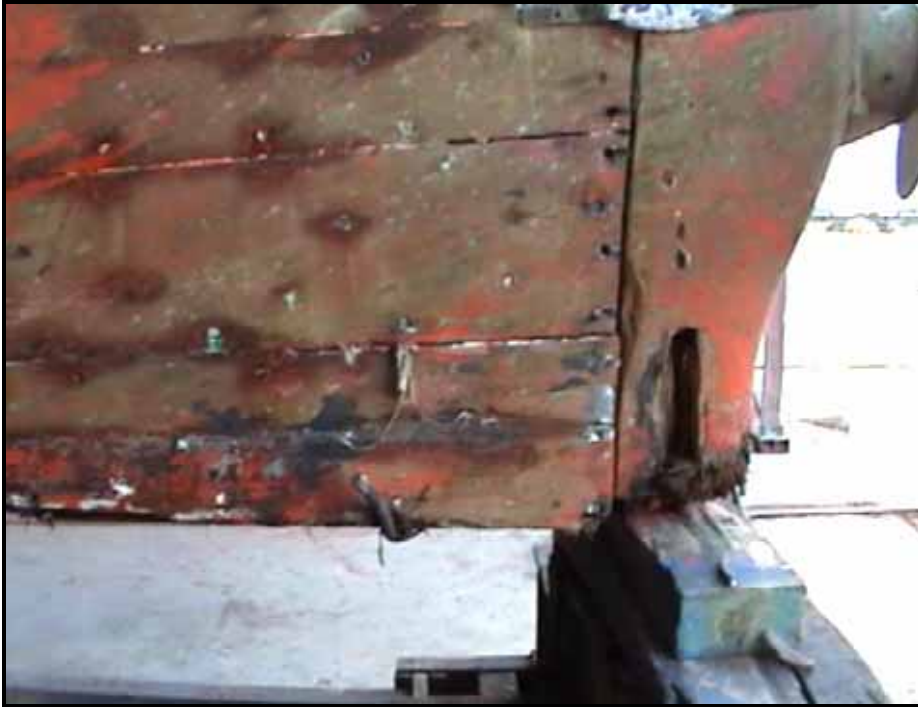
Photograph 5
Sternpost. The sternpost has been critically damaged as a result of the loss of the skeg.

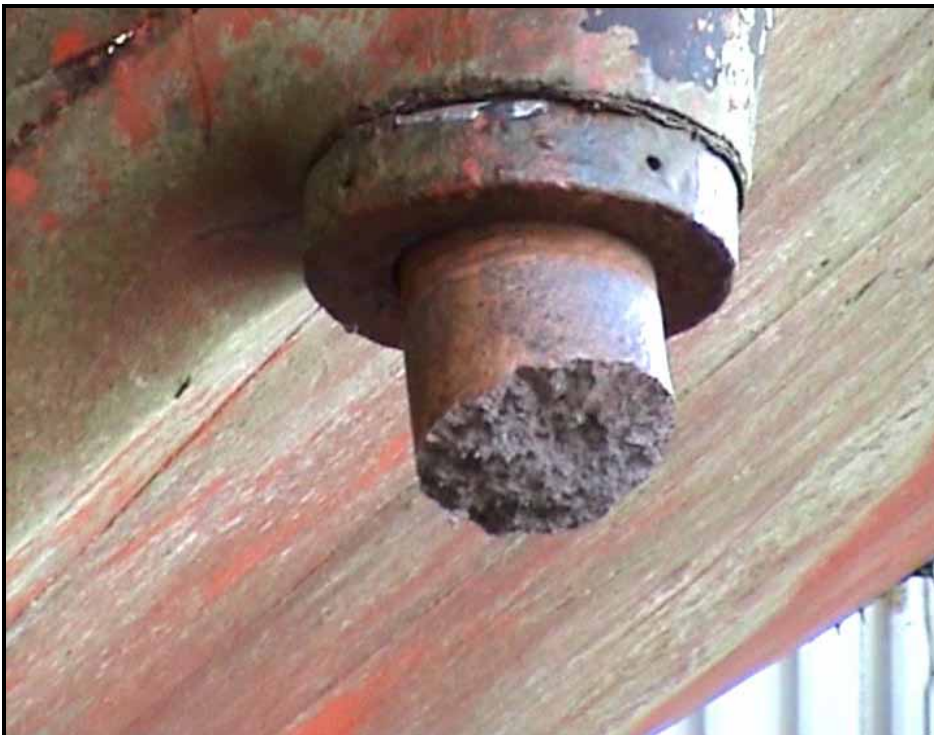
Once clear of the rocks, the Skipper made a second Mayday call to Bluff Fisherman's Radio. This was because the steering was not answering to the helm. It was later determined that the rudder had sheared off during the grounding.

Photograph 6
Rudder. The rudderstock has been sheared off with a cant to port indicating a blow from the starboard side.

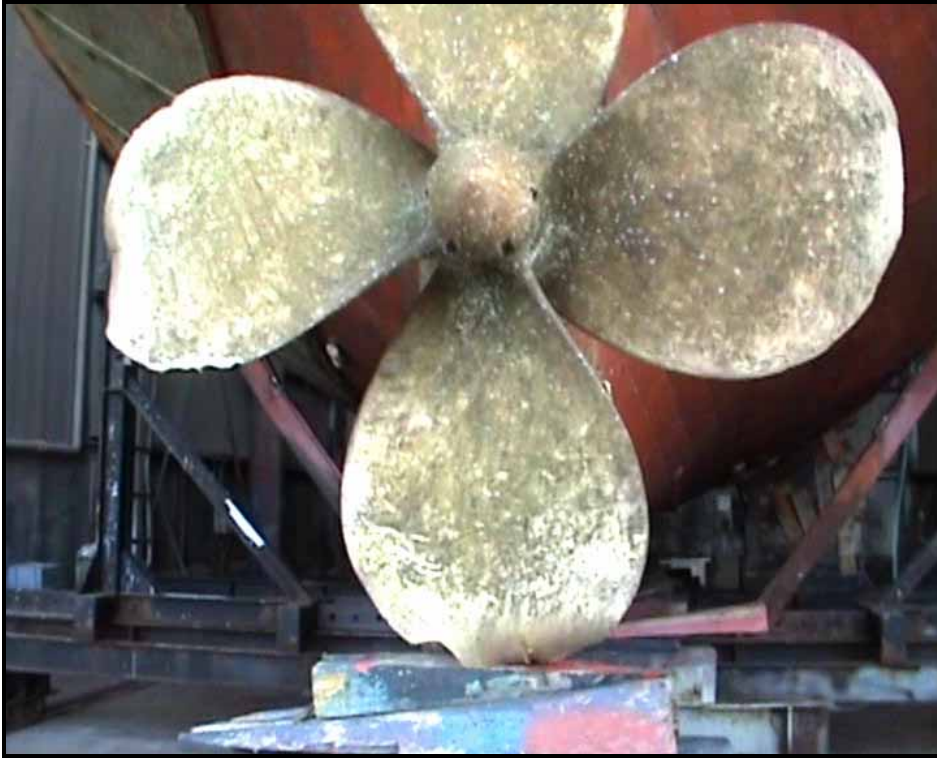
Photograph 7

Propeller. The propeller has moderate damage on most blades.

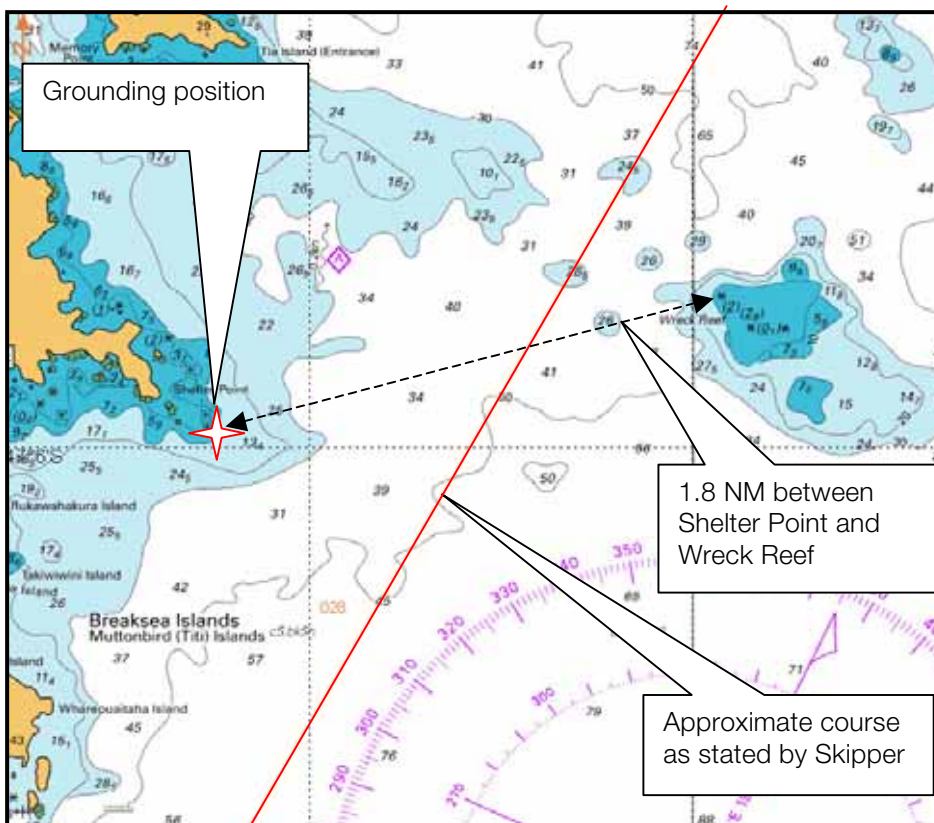
Figure 4

Local fisherman familiar with the area state that with experience, passage can be made between the outlying rocks east of Shelter Point and the land. They also note that there would not have been a noticeable influence (set) on the vessel caused by the tide shortly before the grounding.

The Skipper was on deck for 10 minutes after making his course adjustment. The vessel was travelling at 9 knots; they would have covered a distance of 1.5 NM during this time. During this time the vessel must have tracked along an incorrect course to the grounding position. The Skipper cannot have made any attempt during this time to monitor the vessel's navigation as otherwise he would have been aware of the danger of grounding.
