Class B Accident Report

Audax

Grounding

Kenepuru Sound on 8 January 2005

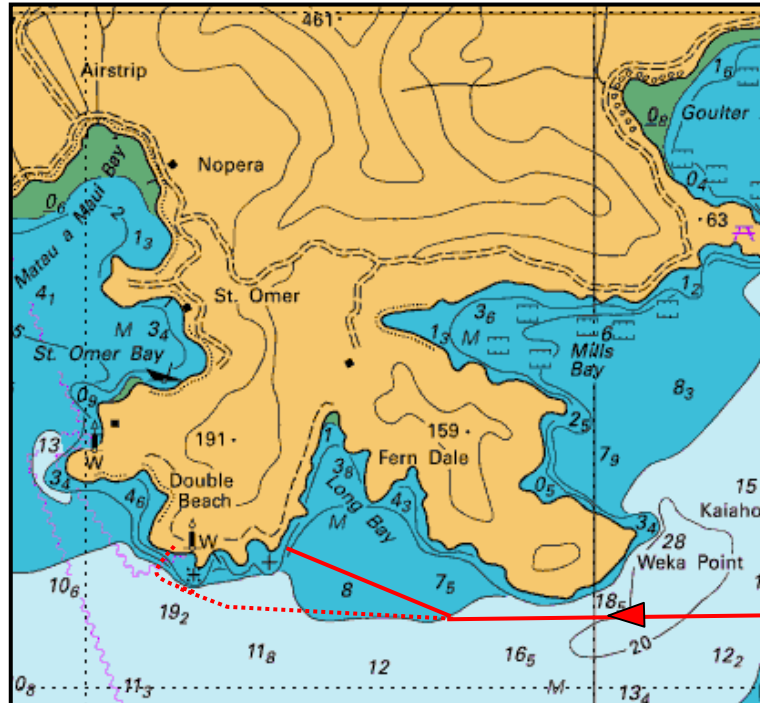
APPROXIMATE TRACK AND POSITION OF GROUNDING

Audax grounded in Kenepuru Sound whilst transiting from Portage Bay to Double Beach at about 0020 hours, New Zealand Daylight Time (NZDT), on 8 January 2005. Onboard were the Skipper, his wife, their two sons and a friend of one of the sons.

Audax hit the rocky shoreline at approximately 15-20 knots, narrowly missing the sheer cliffs to starboard and a potentially disastrous outcome. The vessel ended up almost completely out of the water. The passengers had to be evacuated by another vessel and taken back to their bach. *Audax* was re-floated on the high tide the next day. None of the family sustained any injuries but the vessel was badly damaged.

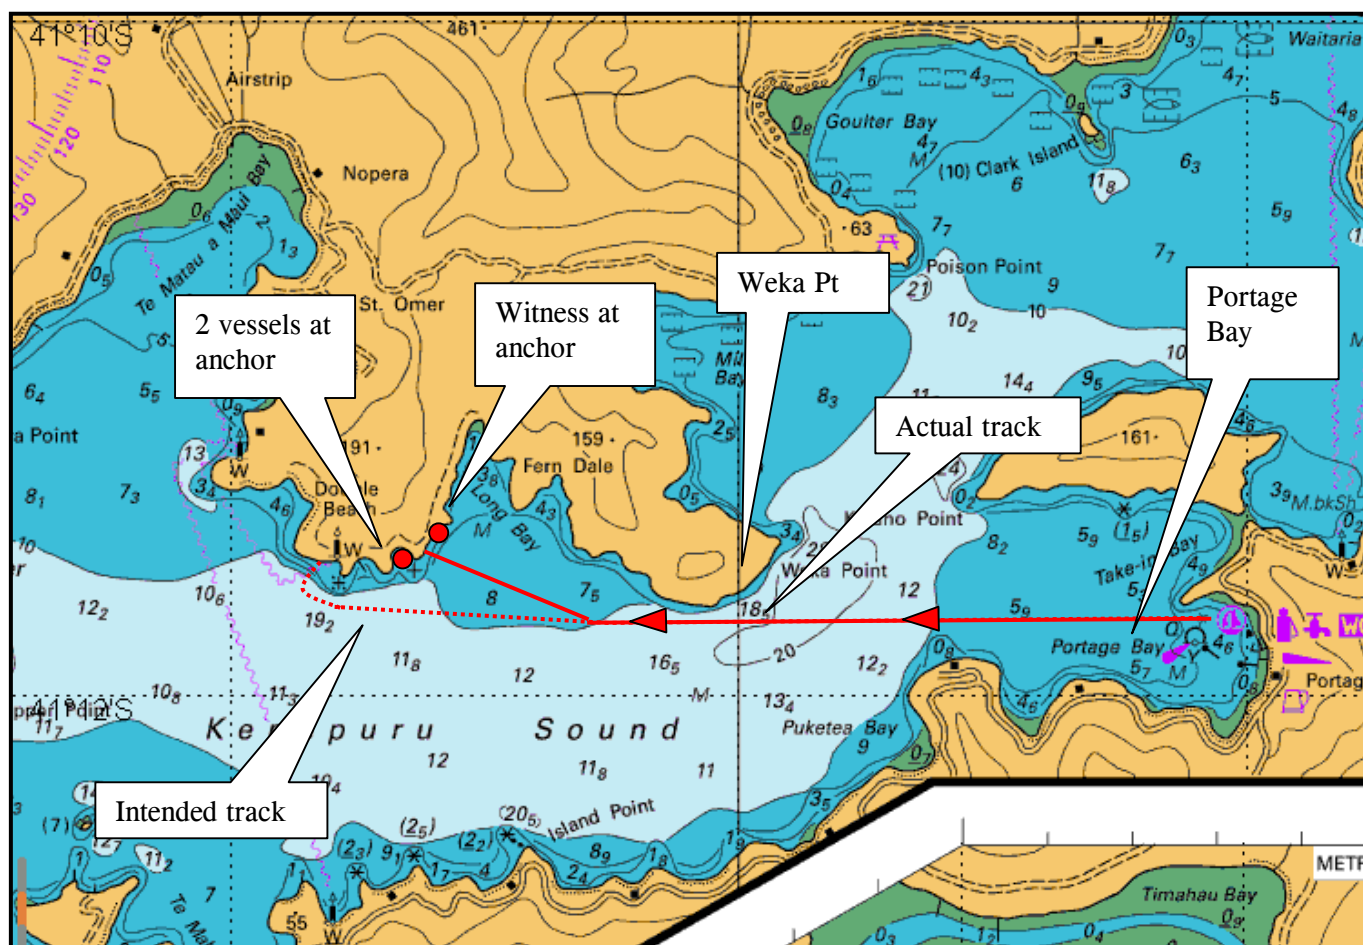
APPROXIMATE COURSES AND POSITIONS OF *AUDAX*

After rounding Weka Point the Skipper observed the port and starboard navigation sidelights of another vessel right ahead. The vessel appeared to be on a reciprocal course to *Audax*. The vessel also appeared to veer slightly to port and then back onto a reciprocal course again. The Skipper of *Audax* presumed that the vessel was heading to an anchorage position in Fern Dale Bay.

As the Skipper tried to identify the intentions of the oncoming vessel he took the vessel out of autopilot and steered the vessel manually. He then altered course to starboard to avoid passing too close to the vessel.

While the Skipper was concentrating on the oncoming vessel he lost his orientation in relation to his planned track. Too late he realised that he was standing into danger before reducing speed. As he reduced speed the shoreline appeared in the vessel's lights ahead and they grounded.
