Accident Report  
Collision with Submerged Object  
*Black Diamond*  
28 July 2006  
Summary Report

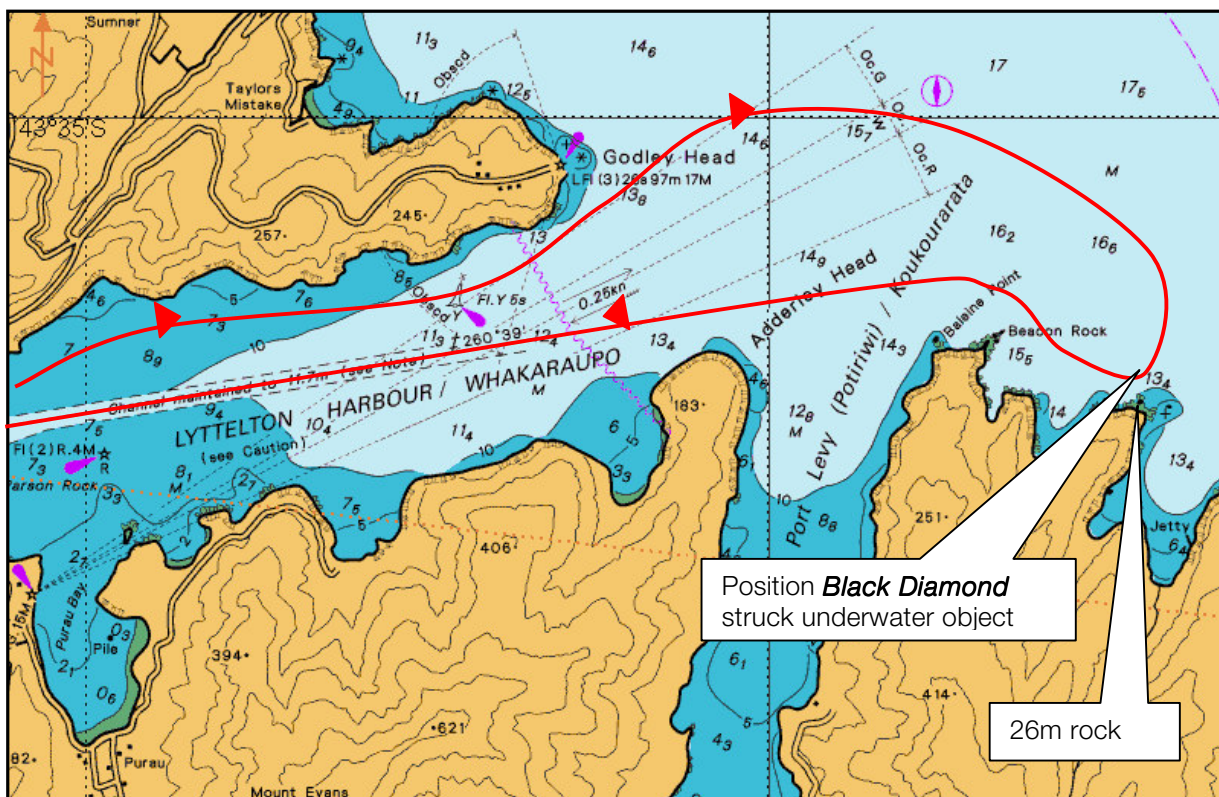
Figure 1

The Skipper followed his usual passage around the harbour and gave a commentary as he went (See *Figure 1 - Approximate track of Black Diamond*). As they reached the Heads, they crossed to the other side of the Heads, as it was a good area to sight dolphins.

The Skipper lined his bow up with the charted 26 metre rock located east of Beacon Rock (See Figure 1). As he approached he commenced a turn to starboard. The vessel's speed was about 13-14 knots. The vessel was about 80-100 metres off the reef situated at the end of the 26 metre rock and in 15 metres of water when the Skipper and passengers heard two consecutive thuds. The Skipper then felt a vibration coming from the port engine shaft and propeller. He immediately stopped the port engine.

Chart extract from Land Information New Zealand (LINZ) chart NZ 6321 showing the approximate course of **Black Diamond**

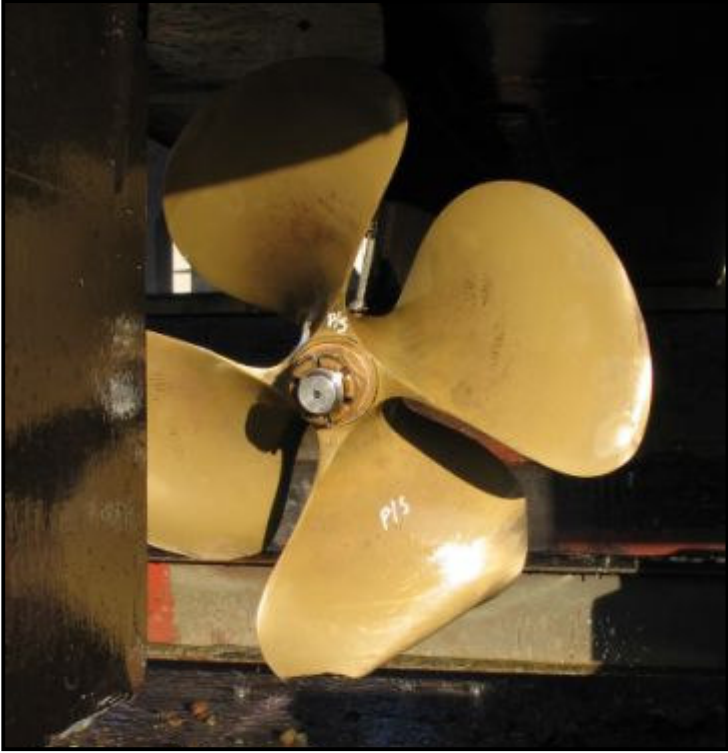
When the vessel returned to port the passengers disembarked. The vessel was then slipped. It was found that **Black Diamond** had sustained serious damage to the port propeller (See *figure 2*), rudder, shaft and engine.

**Figure 2**  
Port propeller

It is not known what ***Black Diamond*** struck. It may have been a submerged log, or other objects. The Skipper did not visually sight anything before or after striking the object. There was no disturbance on the surface of the water to indicate the presence of any underwater reef or rock close to the surface.

The absence of any damage to the hull of the vessel coupled with the under keel clearance at the time of the accident is indicative of the vessel having struck an unknown floating object.
