# Accident report

Blue Dolphin

Collision resulting in one fatality  
and two persons missing,  
presumed drowned

**21 October 2009**

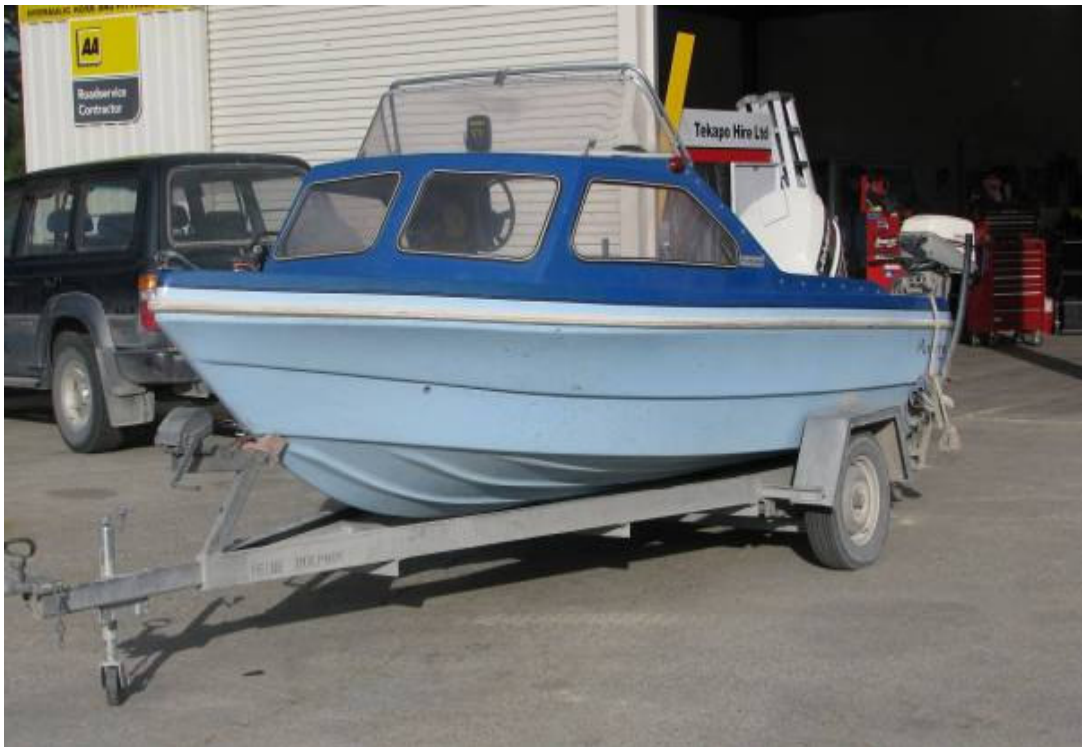
2. **Blue Dolphin** was recovered from the shingle bar on 22 October 2009. An examination of the vessel by Maritime New Zealand (MNZ) investigators determined that **Blue Dolphin** had collided with a solid object while underway.

Figure 1 **Blue Dolphin** post-recovery

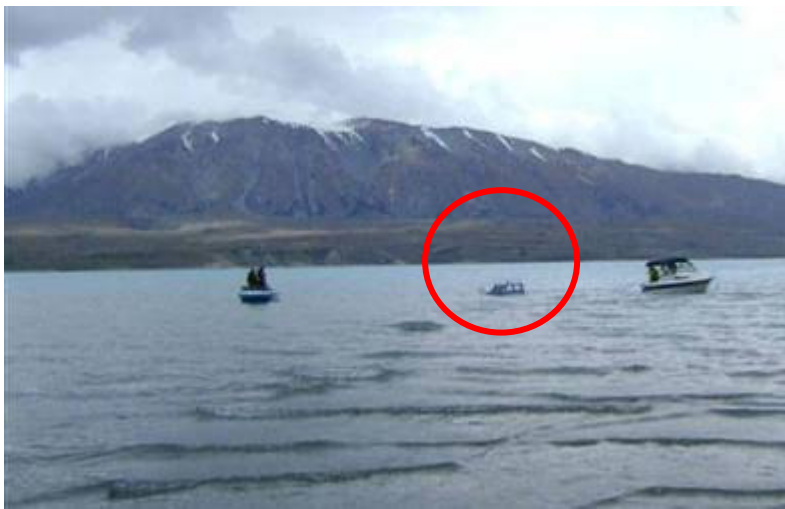
**Figure 2** *Blue Dolphin* at the mouth of the Cass River

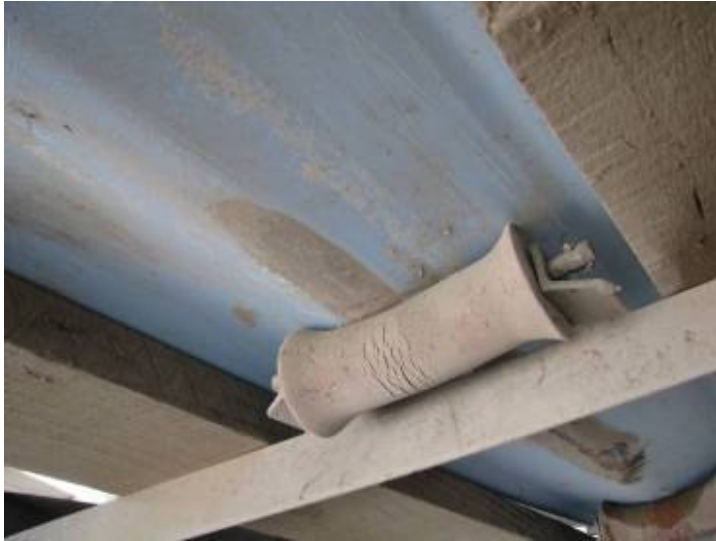
18. Although transported on an appropriate trailer, some wear was evident on the keel, and the gel coat in this area had worn through. The fibreglass in this area was also beginning to wear thin and several small areas had been patched.

**Figure 3** General wear on the keel

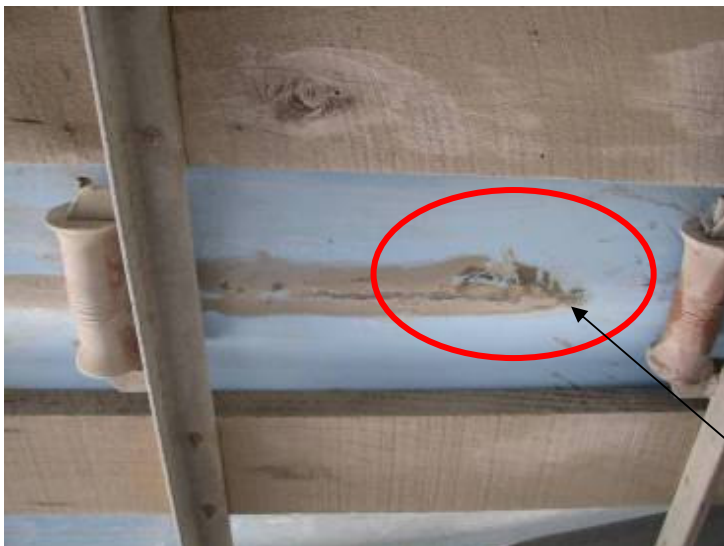
19. Several areas of impact damage were evident on the worn area of fibreglass. Two of these areas were leaking water held in the void space of the hull. They included a jagged crack of approximately 115mm, which appeared recent and is indicative of the vessel having struck a solid object.

**Figure 4** The 115mm jagged crack in the keel, midships

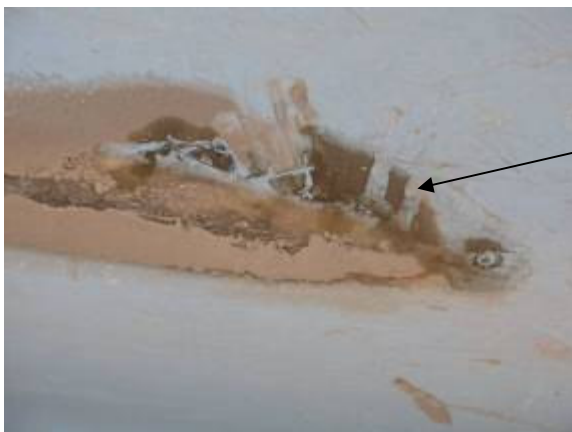
**Figure 5** An expanded view of Figure 4, showing the 115mm jagged crack in the keel, midships

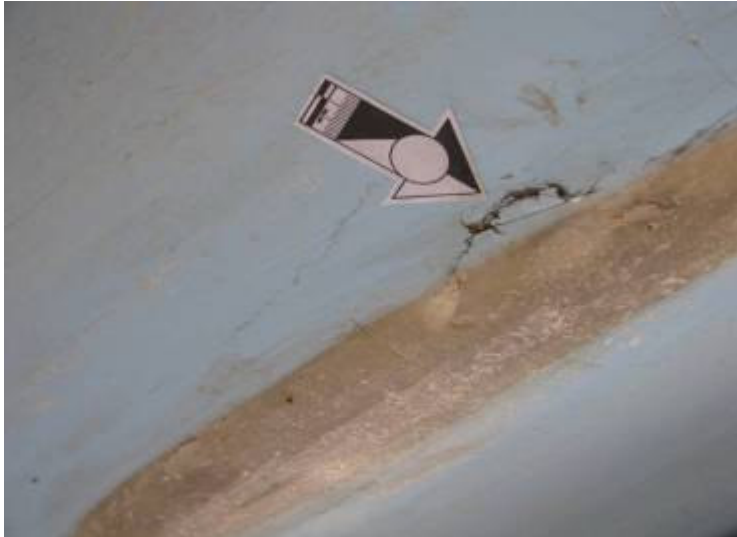
20. A smaller area of recent impact damage was situated slightly forward of the larger crack shown in Figure 5. This damage is consistent with the vessel striking a solid object.

**Figure 6** Impact damage on the keel

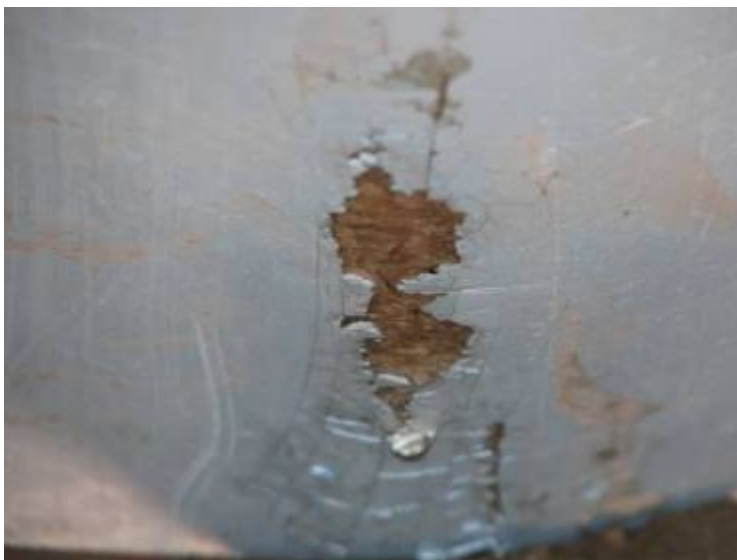
21. In front of these two areas of damage was an area approximately 190mm long of eggshell-like cracking. The force involved in causing this damage was sufficient to smash away the gel coat altogether, and water held in the void space was dripping through.

**Figure 7** Impact damage on the keel

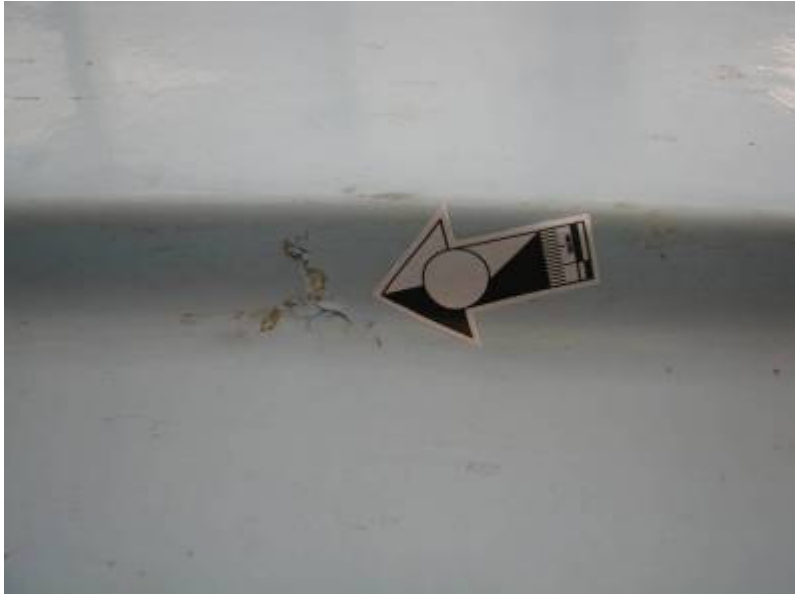
22. A stress fracture was located on the exterior port side of the hull. This damage corresponded with a similar-sized stress fracture in the interior of the vessel, at a junction with the seat combing.

**Figure 8** Exterior stress fracture

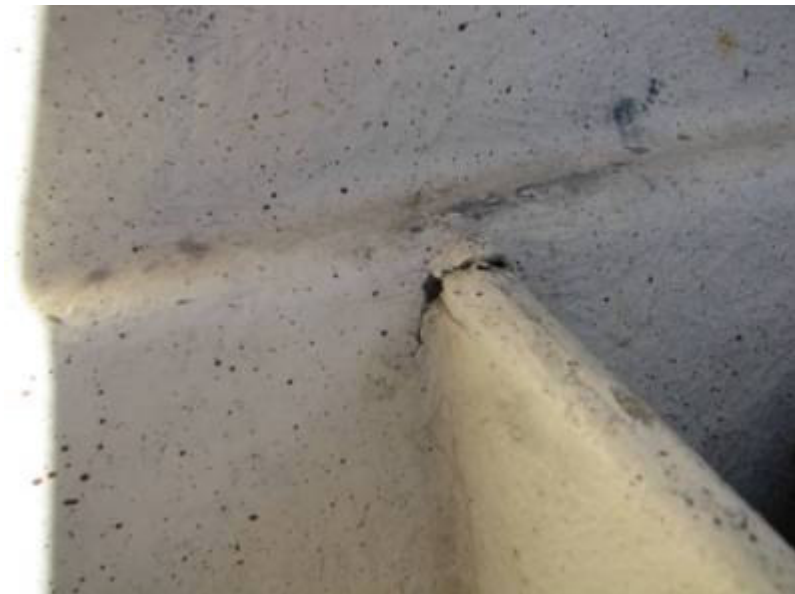
**Figure 9** Corresponding interior damage

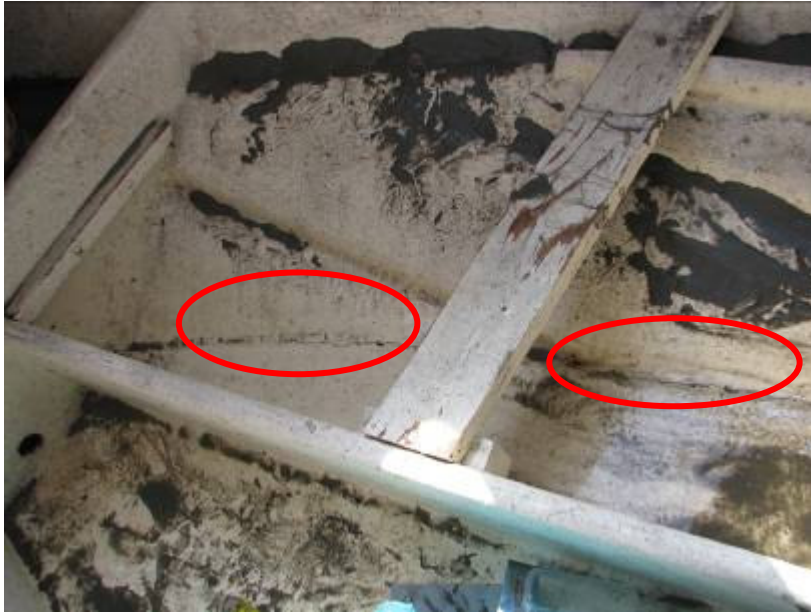
23. Two other similar fractures, measuring 190mm and 210mm, were present in the floor on the starboard side, beneath the seating squabs.

**Figure 10** Fractures in the fibreglass floor beneath a seating squab

24. All of these areas of damage were recent, and are considered consistent with the vessel having struck a solid object.
25. Both bungs of the vessel were secured and watertight. However, investigators removed 155 litres of water from the void space beneath the floor. It is most likely this water came from waves entering the vessel as it sat on the shingle bar. The water would have easily found its way into the void space through an area of older damage found on the fuel tank combing (refer to Figure 11). When recovered, the vessel floated with this volume of water in the void space. This is not considered causative in the accident, and the damage simply explains how the water came to be there.

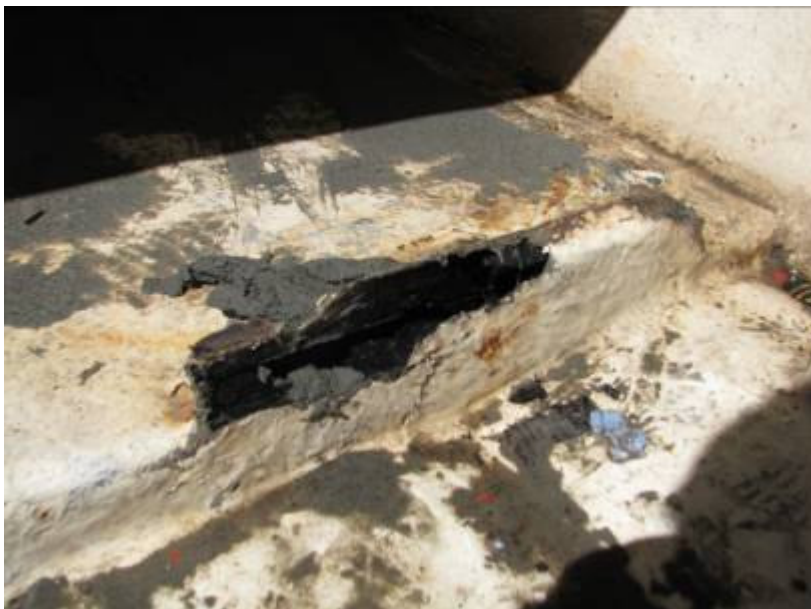
**Figure 11** Area of old damage on the fuel tank combing

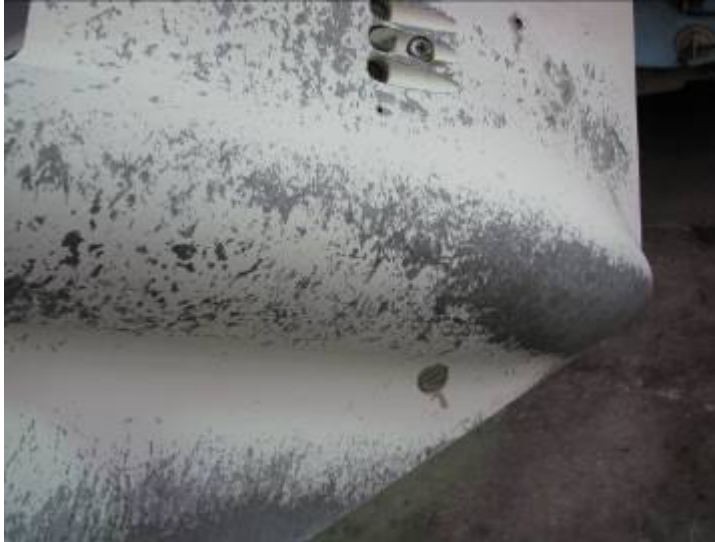
**Figure 12** The stern leg

28. Figure 12 also shows stone chips in the paint on the stern leg. This damage extended to beneath the anti-cavitation plate and trim tab. It is indicative of the propeller churning up stones on the shingle bar. MNZ investigators were unable to determine exactly how long the vessel may have been churning up stones on the shingle bar, although the extent of the damage indicates it was not something that occurred immediately.

29. Two stones were found wedged firmly in the water intakes (one on each side). These were held too firmly to have been sucked in, and show the vessel was driven into the shingle bar with sufficient force to wedge the stones.

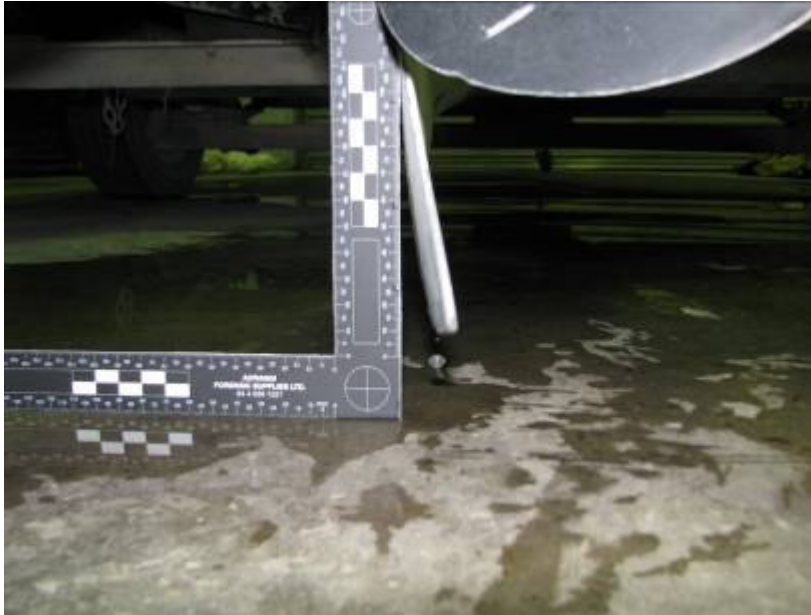
30. The skeg of the engine was bent approximately 10 degrees to starboard. This type of skeg is manufactured from alloy and is known to snap off or chip if run onto such things as rocks, stones or concrete boat ramps. However, the skeg was relatively undamaged, suggesting that it was bent by striking something other than rocks, the shingle bar or concrete.

31. The marine service supplier stated that the skeg was straight and undamaged at the time of fitting it to **Blue Dolphin**. A family member viewed the bent skeg and confirmed the skeg had been straight prior to the day of this accident. A significant amount of force would be required to bend the skeg, and this type of damage most likely resulted from striking a solid object such as a log or tree stump.

**Figure 13** The bent skag

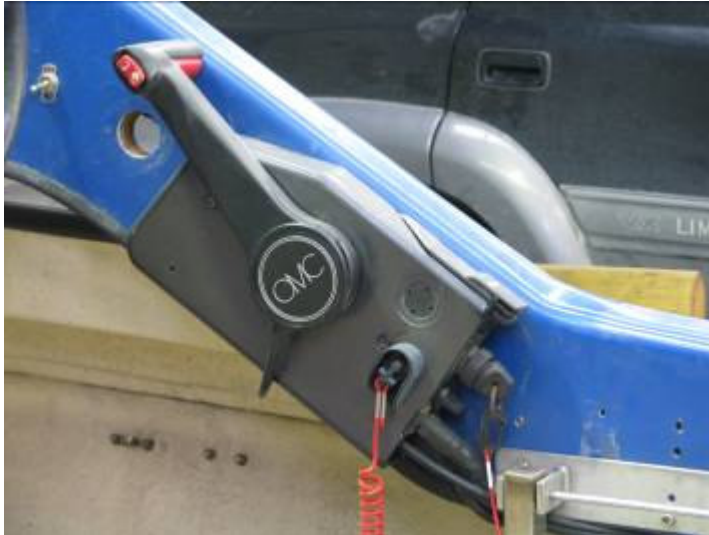
**Figure 14** Throttle control, emergency stop switch and lanyard

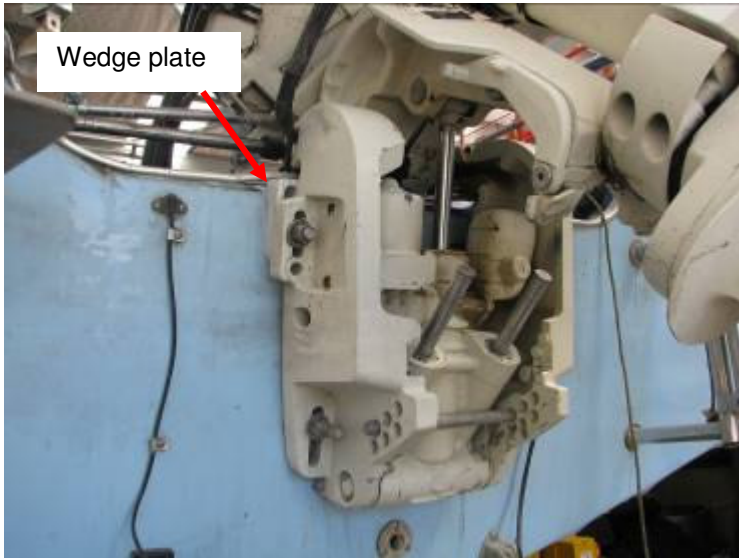
39. A wedge plate had been fitted to adjust the trim of the engine. This plate was placed between the engine mount and the transom, and secured with two bolts through all three components (refer to Figures 15 and 16). The nuts on the bolts were loose to the extent that they could not be measured by a torque wrench.

40. The nuts are self-locking, so any normal engine vibration is not likely to have loosened them. The nuts had not moved on their threads, so it is believed that the engine had received a substantial knock or struck a solid object with some force, so that the wedge plate was loosened.

**Figure 15** Engine mounting and transom

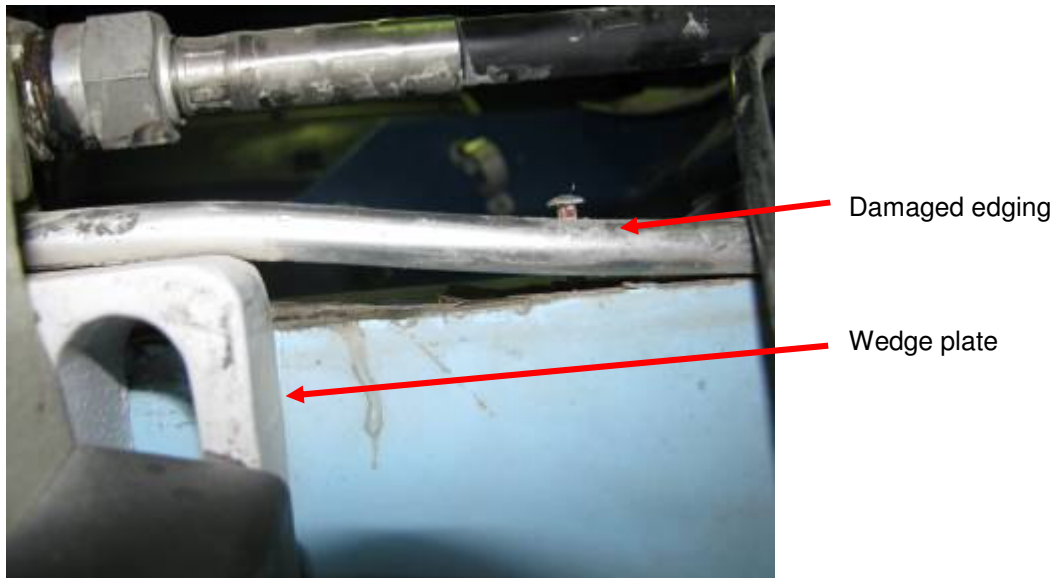
41. A length of edging positioned on the top edge of the transom had been forced upwards by the wedge plate, and markings on the transom showed how the wedge plate had shifted from its original position. This probably occurred through the application of substantial force.

**Figure 16** Edging on transom, forced upwards by the wedge plate

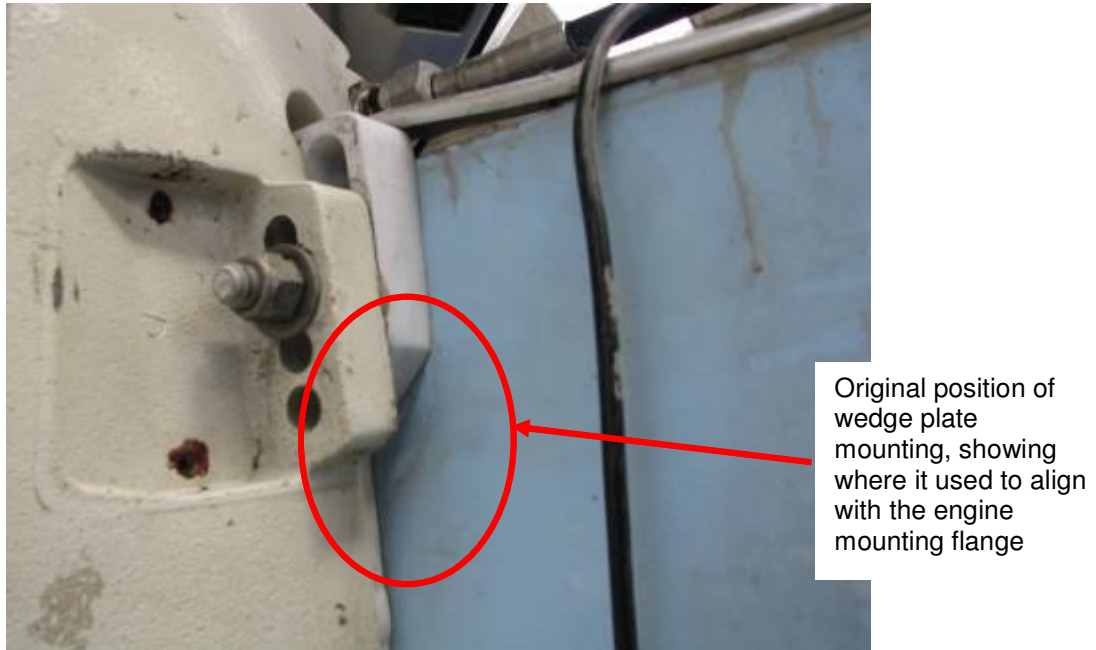
**Figure 17** Closer view of the engine mounting

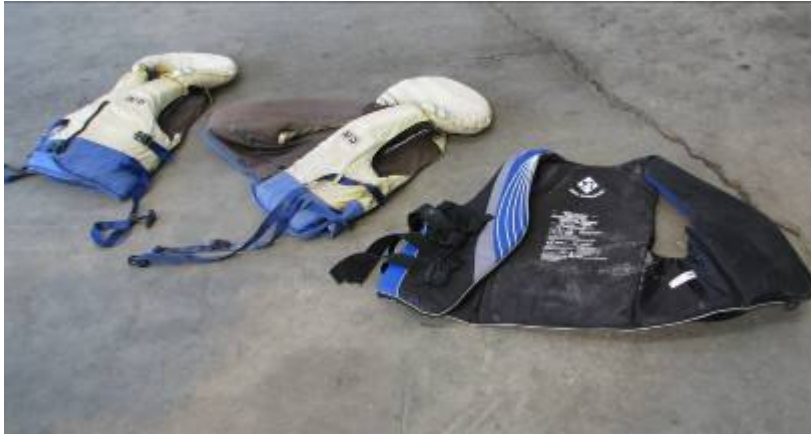
66. **Blue Dolphin** was known to carry:
- two Body Glove 405 buoyancy garments, size XXL
  - one Body Glove 405 buoyancy garment, size large
  - two RFD 402 PFDs.
67. One of the XXL buoyancy garments was located approximately 200m from **Blue Dolphin**. The other XXL buoyancy garment and the two PFDs were found stowed in the bow. The size large buoyancy garment has not been found. It will most likely never be determined whether or not this buoyancy garment was being worn. However, if it was being worn, the search team would probably have located the wearer floating in the water.
68. The Body Glove buoyancy garments were relatively new and in good condition. The RFD PFDs were old and well worn, although still functional. The reflective tape on the two PFDs had lost any reflective ability.

**Figure 19** Two PFDs and the Body Glove buoyancy garment

69. Type 405 buoyancy garments are not designed to act as modern lifejackets and are more suited to activities such as water skiing, where a person is expected to float for only a short period before being picked up again. They are not designed to turn an unconscious or injured person so that they are floating face up. These garments, as the label describes, are suited for:

71. Although far from ideal, the buoyancy garments, if worn, would have been better than nothing. Had the occupants of **Blue Dolphin** donned these before getting underway or when the conditions deteriorated, they would have significantly increased their chances of being rescued or recovered.
