# Accident Report

*Bounty*

Fire & Subsequent Loss

7 May 2006

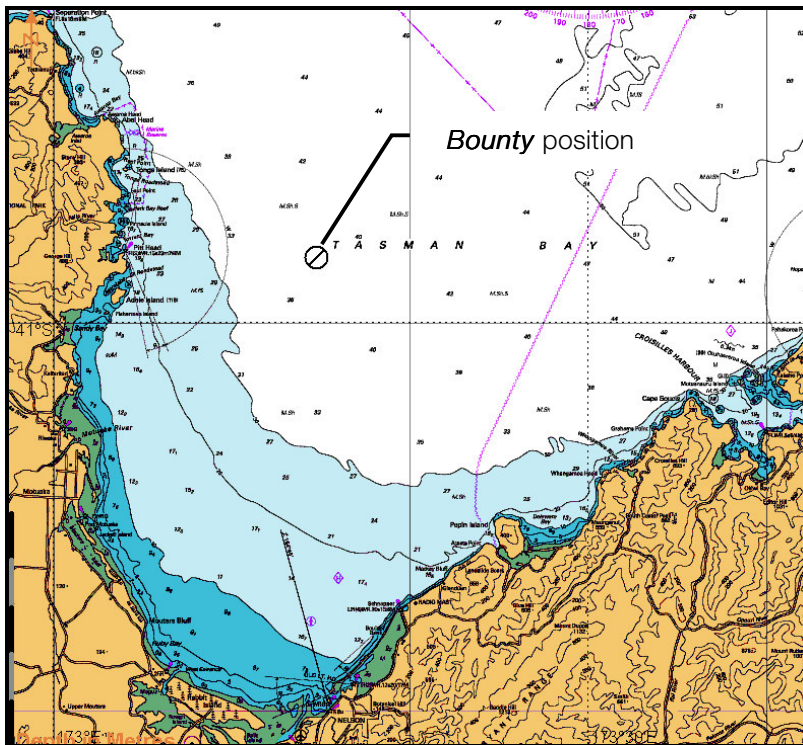
Figure 1

***Bounty*** sank at about 1030 hours, on 7 May 2006 in position 40° 57.22 ' S and 173° 14.760' E (See *Figure 1*).

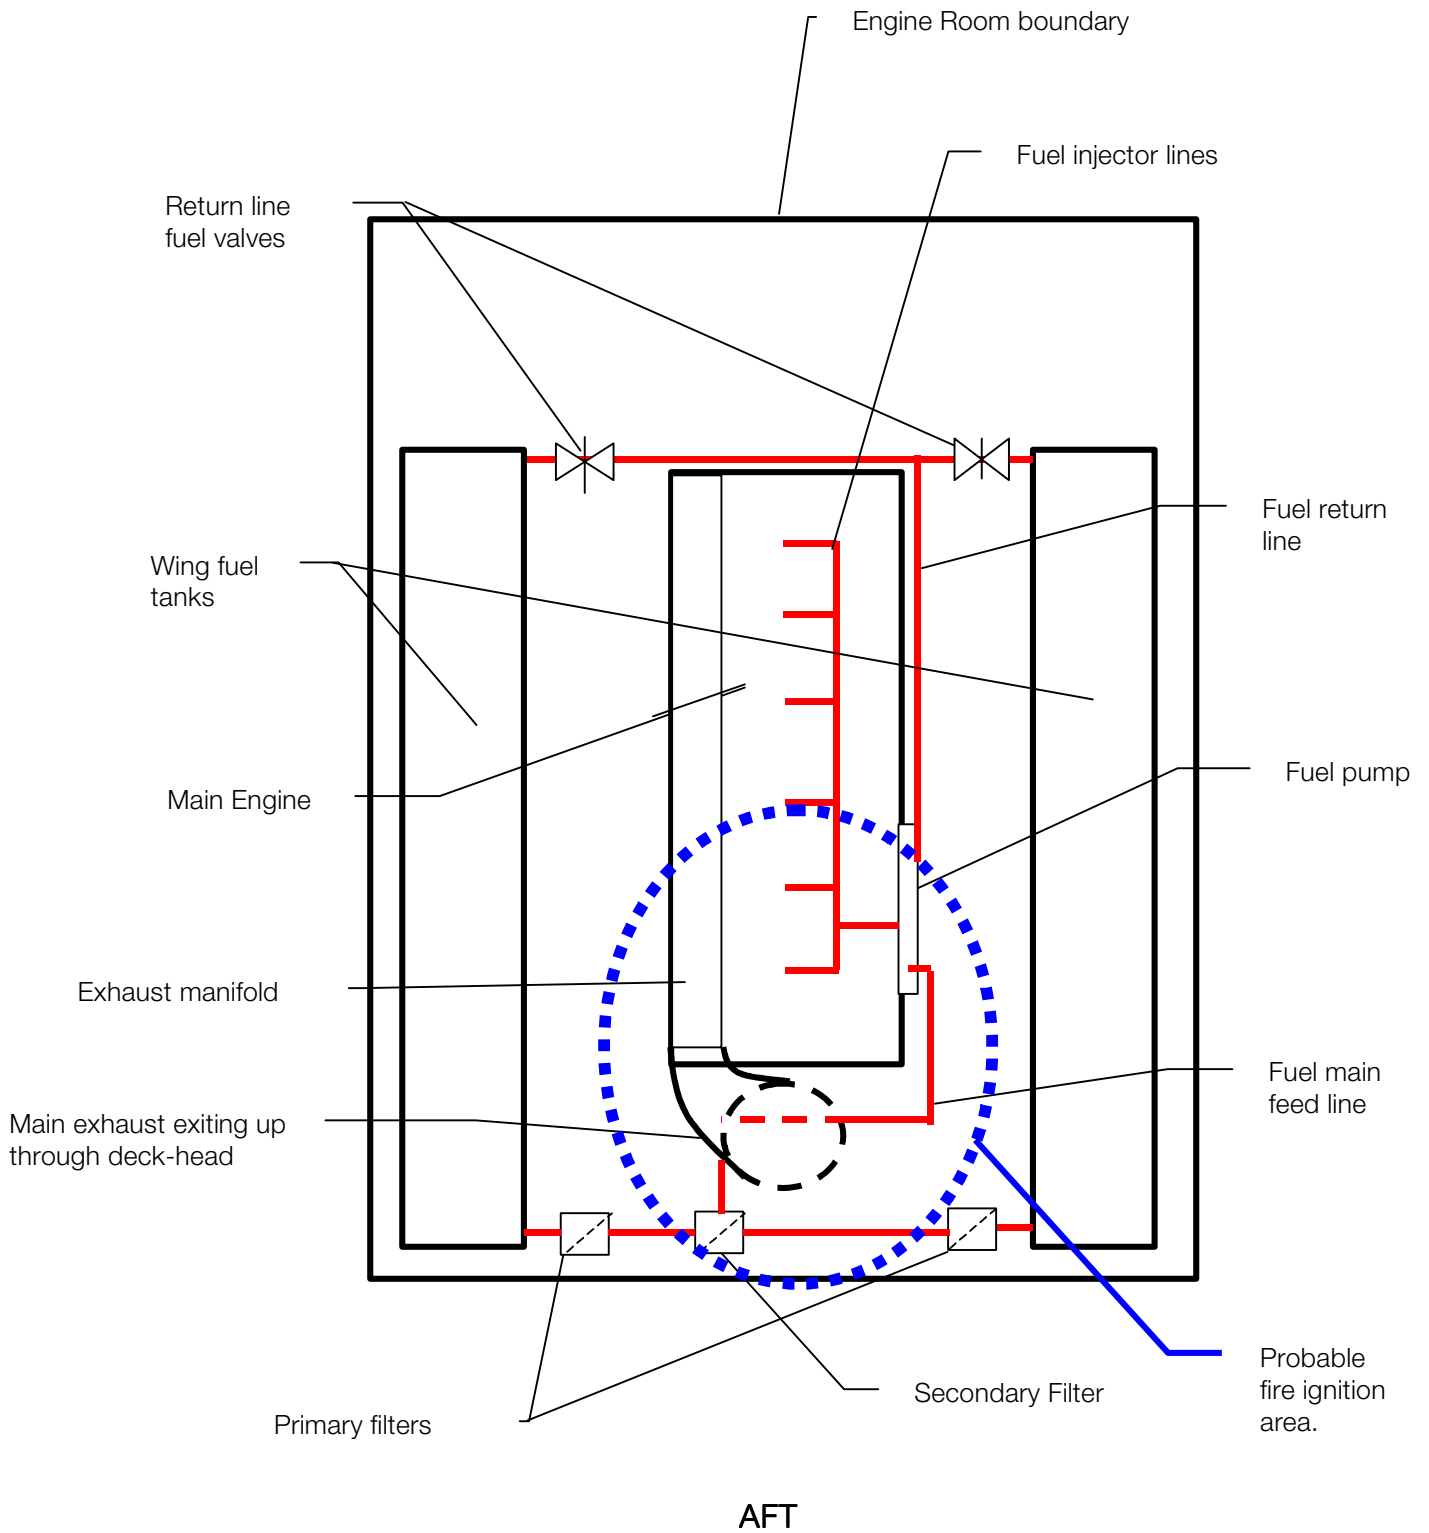
FORWARD

One crewmember stated that he had been able to get into the ER in the very early stages of the fire but he was not able to see much due to the amount of smoke at that time. He did however observe some sparking or flame activity along the aft bulkhead of the ER. This is where the main fuel lines from each wing tank 'T' into a primary filter and then onto the main engine fuel system.

The main engine could not be shut off from a remote station in the wheelhouse. Instead a governor lever had to be depressed in the ER on the main engine. There was no remote shut off for the fuel tanks.

A remote shut for the main engine would have reduced the amount of pressurised fuel that was feeding the fire. Shutting down the main engine, however, which in this case was the primary provider of 230V electricity and the fire pump, could have severely hampered any effort to fight the fire had there been time to do so.
