ASSESSMENT

Heavy Weather Passage
Challenger (Kaitaki)

24 October 2006

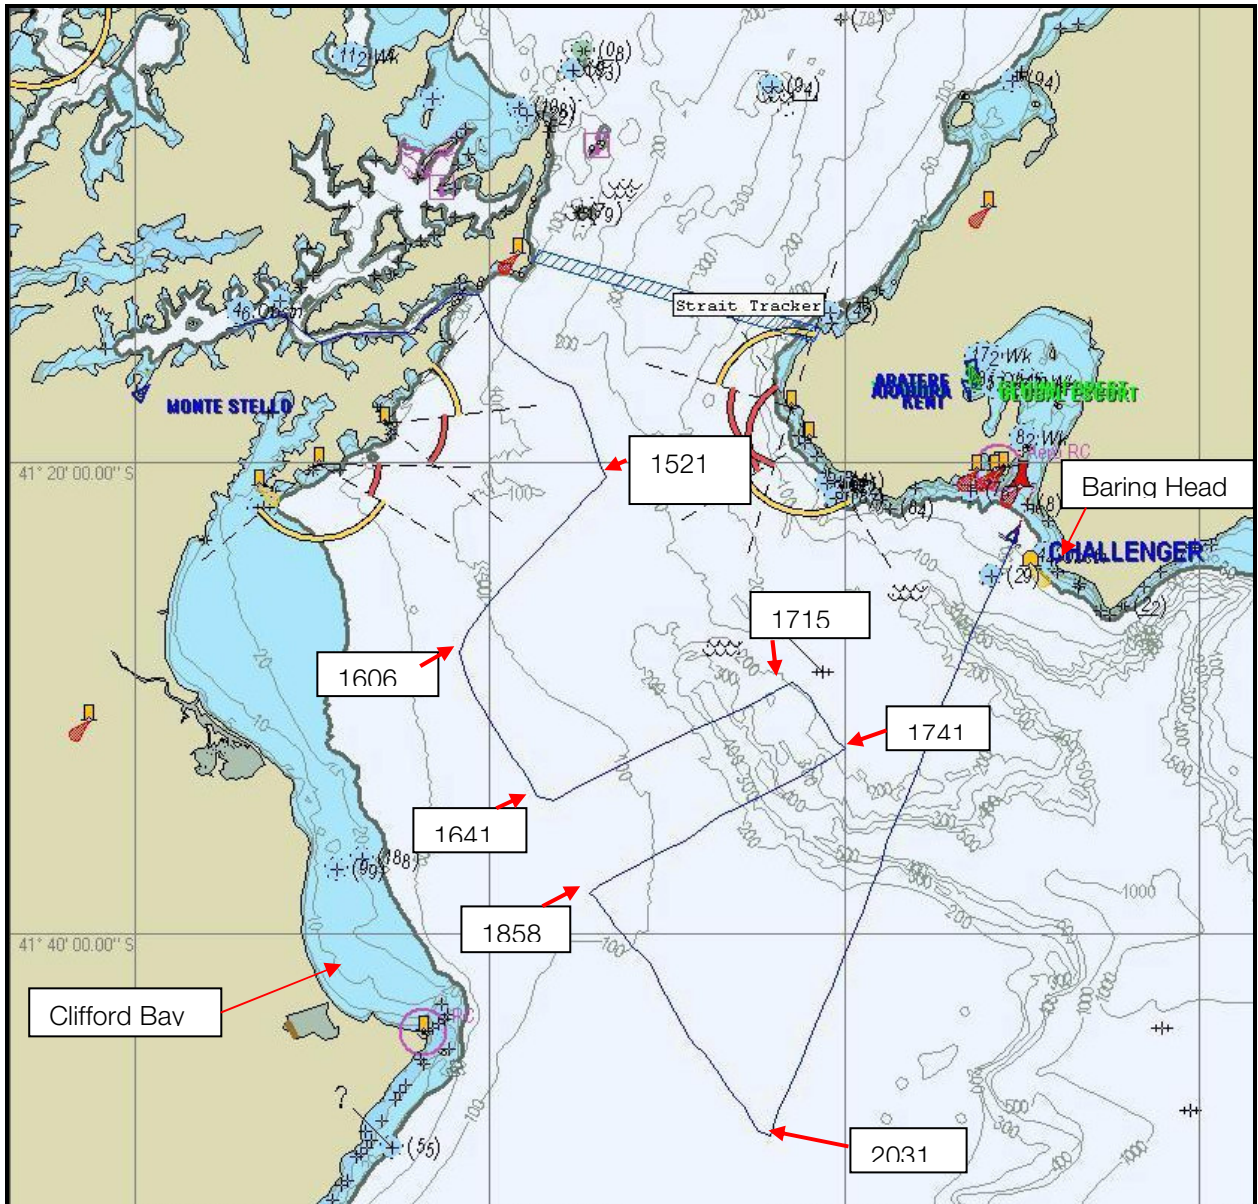
Figure 1 - Automatic Identification System recording of *Challenger's* track over the ground in Cook Strait

Due to the prevailing weather conditions, the Master decided to head in the direction of Clifford Bay, situated on the northern coastline of the South Island (see *Figure 1*). It was his intention, having approached closer to the land and obtained a lee from the prevailing weather conditions, that he would be able to turn safely to port and run up towards the entrance to Wellington Harbour with the seas and swell on the vessel's starboard quarter.

At 1521, the Master altered course onto a south westerly heading in the direction of Clifford Bay (see *Figure 1*).

At 1606, whilst still endeavouring to keep in the lee of the South Island, the Master altered course onto a south easterly heading in order to make more 'southing' before altering course towards the entrance to Wellington Harbour (see *Figure 1*).

At 1641, the Master altered the vessel's course onto a broadly east north easterly heading towards the approaches to Wellington Harbour entrance, putting the sea and swell on the starboard quarter (see *Figure 1*).

Following a discussion with the bridge team about the reported sea conditions at the entrance to Wellington Harbour, the Master decided to abort the approach to Wellington. The Master then altered course to starboard onto a broadly south easterly heading and put the seas and swell on the starboard bow (see *Figure 1*).

Due to the weather conditions causing the intermittent activation of the engine mechanical over speed trips, the Master decided to alter course to starboard onto a broadly south westerly heading and head back in the direction of Clifford Bay (see *Figure 1*). He informed the engine room of his intentions and said that he would not be taking the vessel into Wellington until the weather conditions had improved.

At 1858, the wind and swell conditions had eased sufficiently for the Master to decide to alter course to port and head in a south easterly direction so as to make more 'southing' before eventually turning to port and heading towards Wellington (see *Figure 1*).
