Incident Report
Close Quarters Situations
Challenger, Aratere & Lotus
21 February 2006

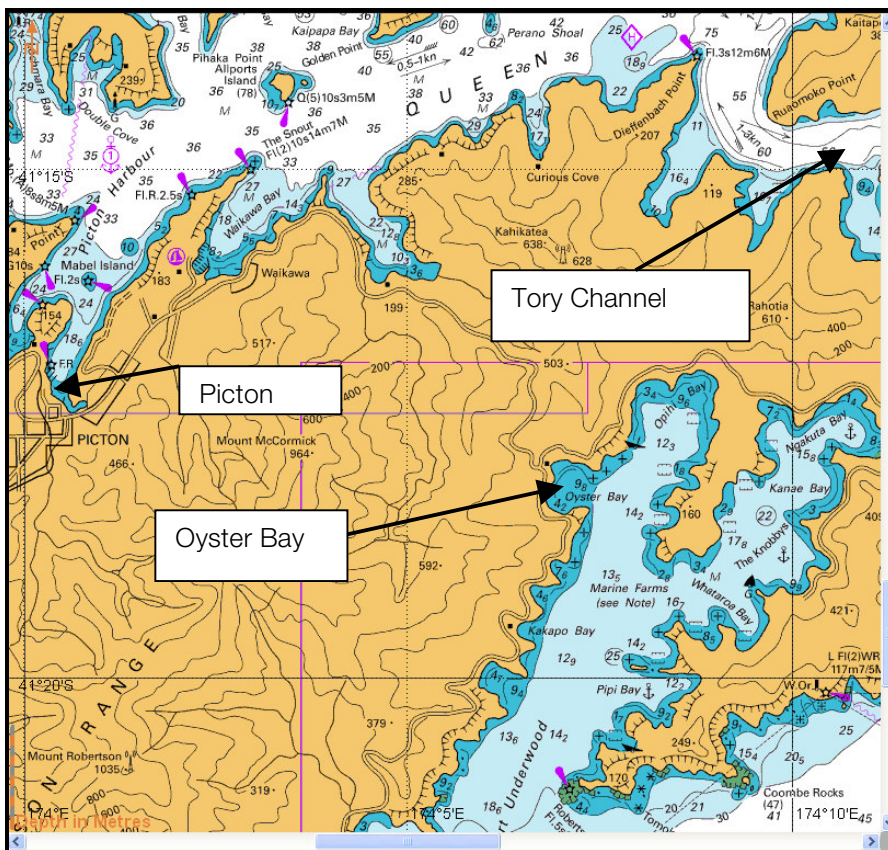
Figure 1
Extract from Chart NZ 615 Marlborough Sounds

On 20 February 2006, at about 1600 hours New Zealand Daylight Time (NZDT), a Skipper and an agent from KMS Repossessions Ltd¹ boarded the fishing vessel **Lotus** in Oyster Bay (See Figure 1 – Extract of Chart NZ 615 Marlborough Sounds, for position of Oyster Bay).

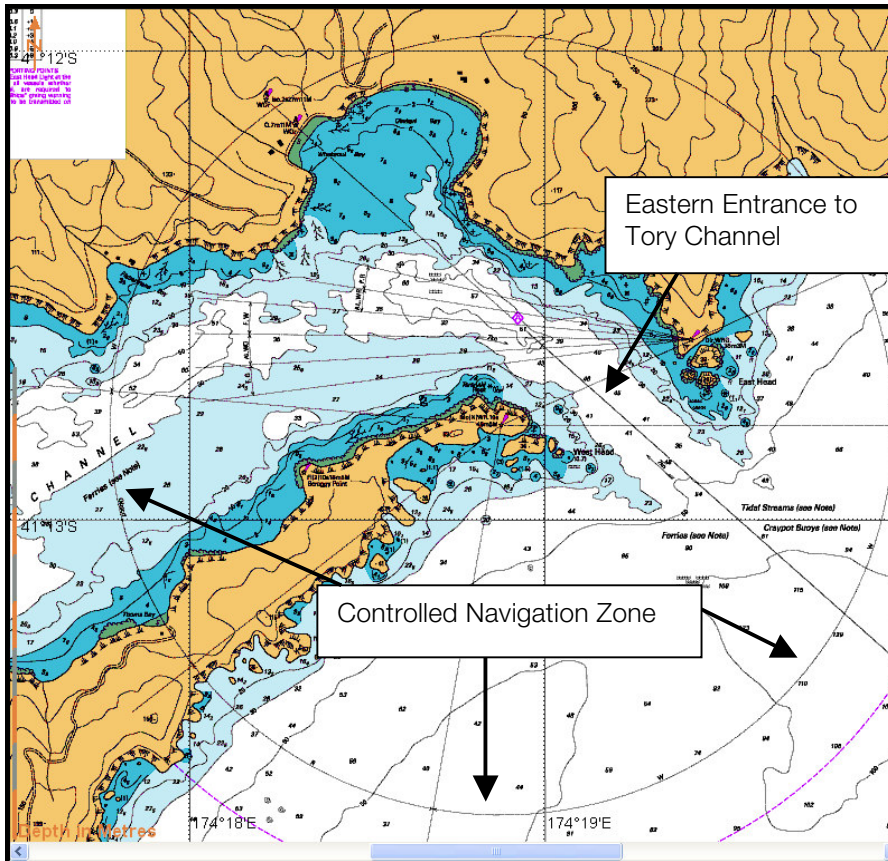
Figure 2
Extract of Chart NZ 6154 Tory Channel Entrance & Picton Harbour

At about 2250 hours, the Skipper broadcast a radio message on VHF channels 16 and 19 to all ships, giving a 10-minute warning of **Lotus'** entry into Tory Channel controlled navigation Zone³. At about 2320 hours, **Lotus** entered the Eastern Entrance of Tory Channel (See Figure 2 – Extract of Chart NZ 6154 Tory Channel Entrance & Picton Harbour).

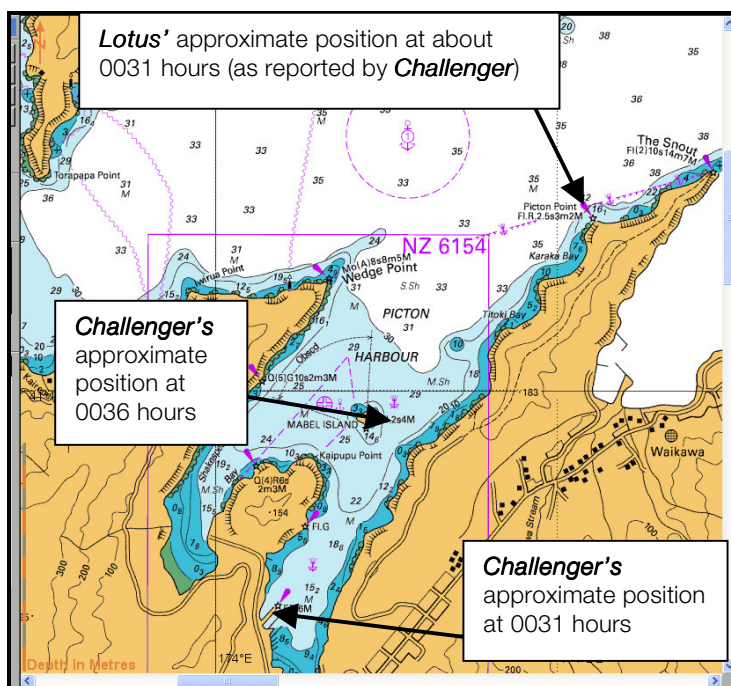
Figure 3
Extract of Chart NZ 6154 Tory Channel Entrance & Picton Harbour

At about 0031 hours, **Challenger's** Lookout reported to the Master the presence of a single white light that was clearing Picton Point (See Figure 3 – Extract of Chart NZ 6154 Tory Channel Entrance & Picton Harbour). The Master then instructed the Officer of the Watch (OOW) to acquire the target on both radars.

At about 0036 hours, **Challenger** passed Mabel Island abeam to port. Her SOG was about 12 knots at this time (See Figure 3). At this juncture, the OOW reported to the Master that the acquired target (**Lotus**) was showing a CPA of zero.
