Accident Report
Fire aboard *Cleansweep*
13 February 2008

Maritime New Zealand

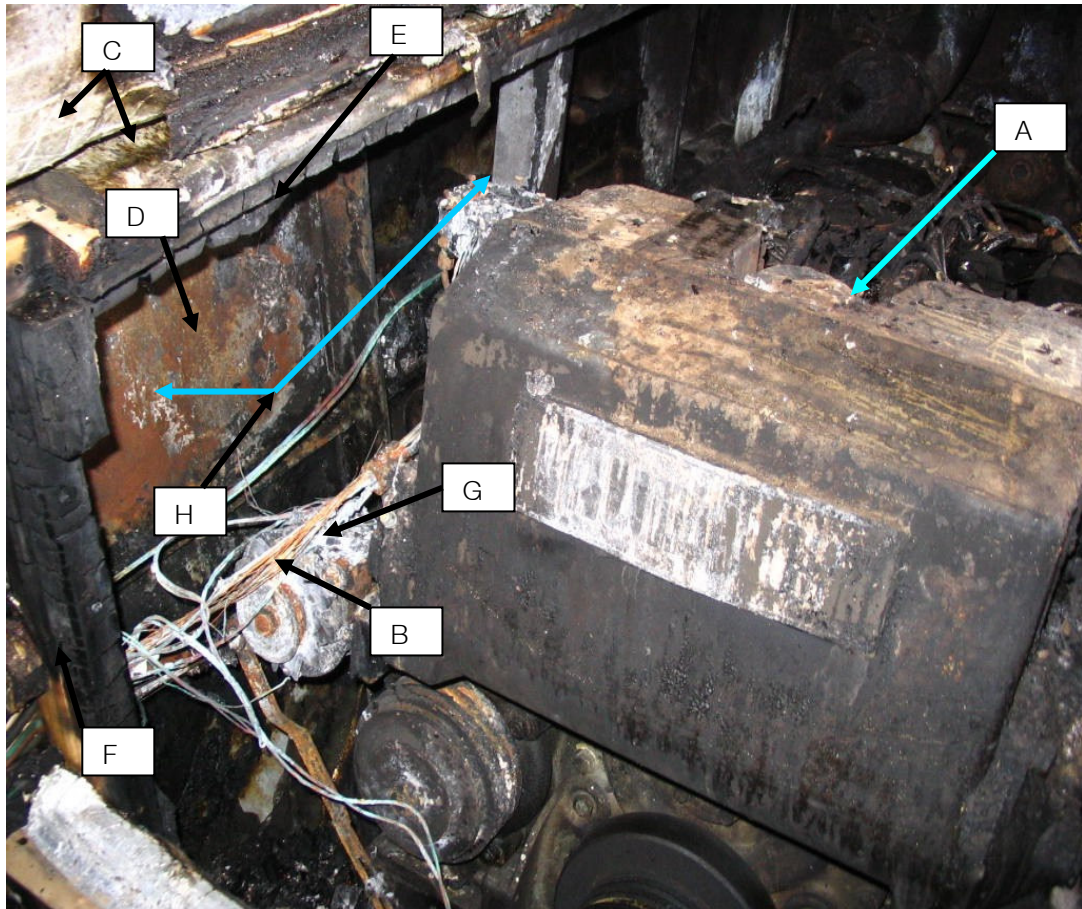
Figure 2

9. The exact cause of the fire is indeterminable, however, there are several common indicators that show the fire originated in an area containing the alternator and a bundle of wires that lead to the battery bank. These indicators include a classic “V” burn pattern visible on the inside of the hull and a heavy oxidation pattern on the outside of the hull.

10. It is common in a structural fire that V patterns are generated by a plume of flame spreading vertically from the base of the fire, and this, in consideration with all the other factors, is a commonly accepted technique used in determining the seat of a fire. On **Cleansweep** some oxidation is also present on the alternator, and there is no indication of this occurring elsewhere within the engine bay. Oxidation on a metal surface is known to indicate an area where the surface has been exposed to high heat or flame.

11. The area of heaviest charring is situated on the wooden framework above the alternator, with the top of this structure suffering only smoke damage. This indicates that the heat source came from beneath and the depth of the charring indicates that it burnt for some time.

12. The vertical engine bay framing situated near the alternator has suffered charring on the interior, with an area of undamaged framework visible on the exterior. This again indicates that the fire originated near the alternator and wrapped around the framework before travelling vertically along the framing.

13. Overall, the area containing the alternator and bundle of wires is the area with the most damage, with the remainder of the engine bay suffering only secondary heat and smoke damage.

14. The plastic coating of the bundle of wires lying on the alternator has completely burnt away, up to an area where it extends from a hole in the wooden framework. From then on the wire is undamaged, suggesting that this area was protected from the fire. Some oxidation is present on the exposed wiring. These factors again indicate that this area was the seat of the fire.

- a) Heat damage caused from heat being reflected downwards from insulated hatch cover
- b) Bundle of wires leading to battery bank
- c) Smoke damage only
- d) Oxidation on hull, indicating the height of the fire
- e) Area of heaviest charring
- f) Undamaged area, indicating the fire originated from the other side at around this height and wrapped around before travelling vertically along this beam
- g) Alternator, showing an area of oxidation
- h) The blue arrows show the V pattern and direction of the fire spread, which lead back to the seat of the fire

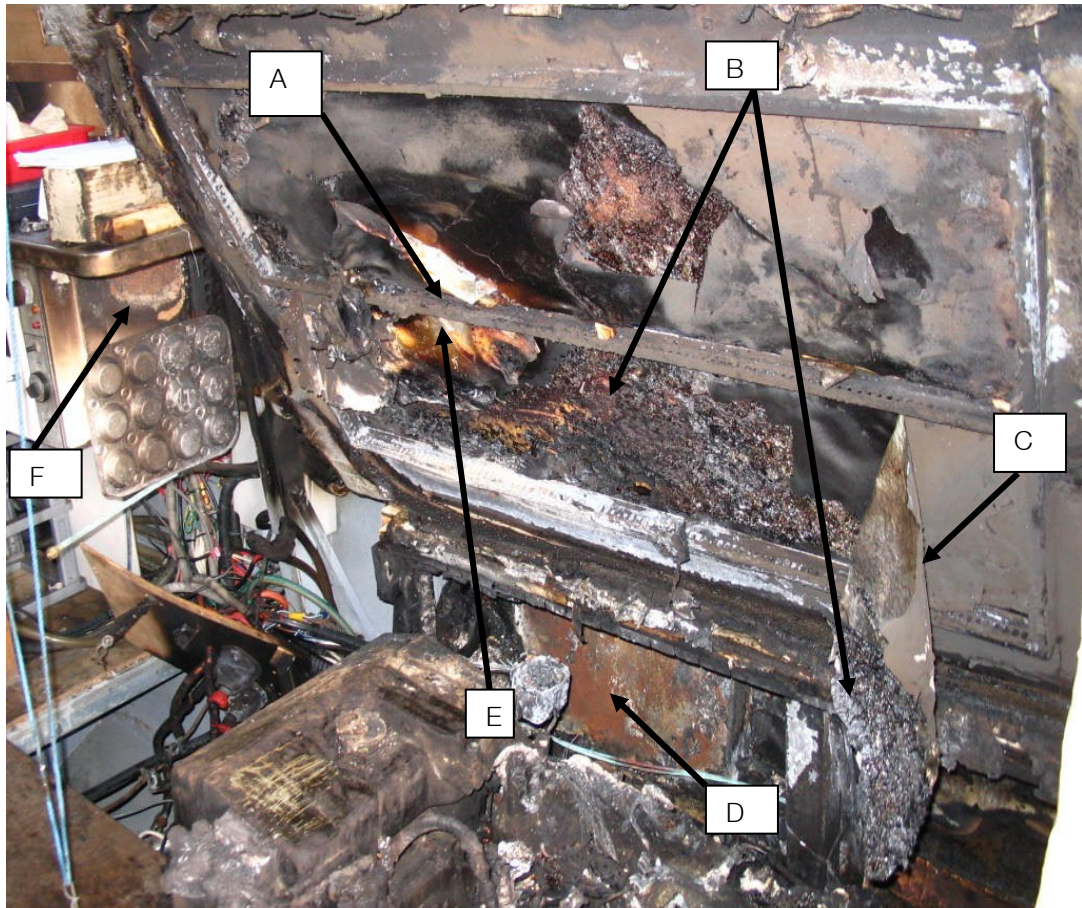
15. Most telling is the damage shown in figure 2, which shows an area of high heat damage situated directly above the alternator area. This supports the conclusion that this was the seat of the fire. Figure 2 also shows the way in which the noise insulation burnt away. A thin metal support beam divides the noise insulation, creating a join where the insulation meets the beam. A join like this creates a gap through which fire can penetrate and ignite rubber backing. It is highly likely that this occurred, as the seat of the fire was directly below the join.

16. It is apparent that the silver foil of the insulation remained intact, although it appears to have suffered some minimal charring around the edges while peeling away from the rubber foam backing, which was destroyed.

20. In either scenario, it is clear that the fire then penetrated the join in the noise insulation, igniting the rubber backing and producing the dense toxic smoke. This may have occurred before or after the cover was lifted. It is most likely, however, that the sudden intake of oxygen when the cover was lifted would have greatly intensified the fire and the rate in which it was spreading.

- a) Join in insulation running along structural beam where fire may have penetrated to ignite rubber backing
- b) Burnt rubber backing
- c) Silver lining peeled away from rubber foam backing
- d) General seat of fire, indicated by oxidation on hull
- e) Area of high heat damage, indicating the source of the fire was directly below
- f) Secondary damage, most likely to have occurred when cover was open
