Accident Report

Collision

Deep Star & Red Pepper

14 January 2006

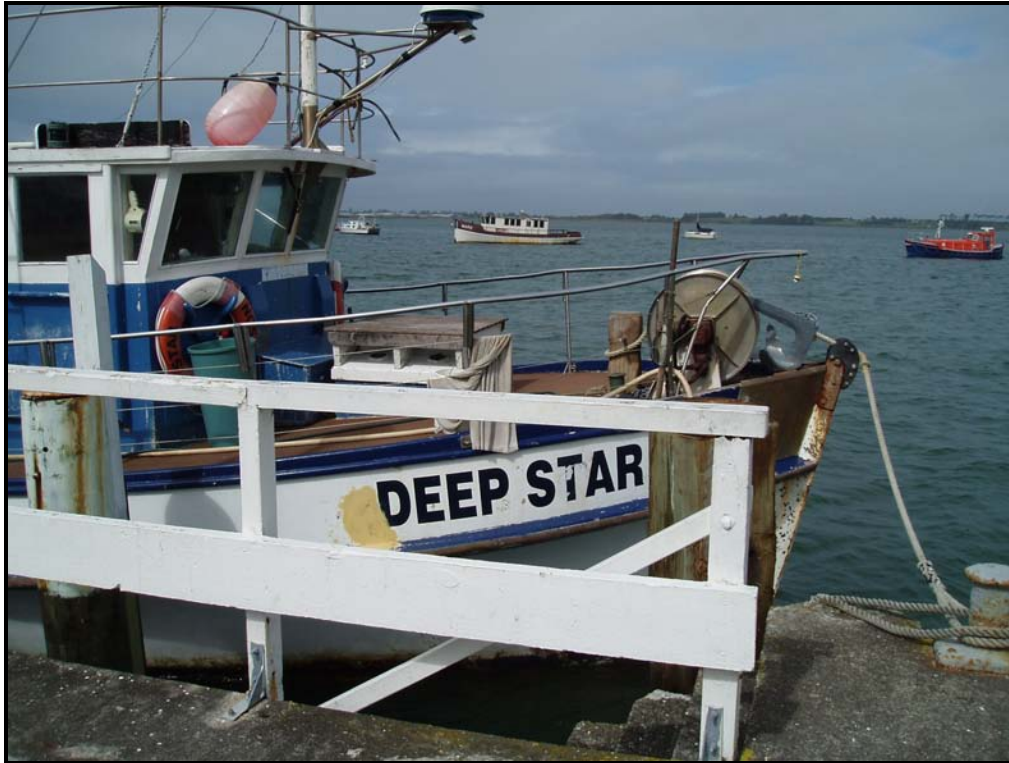
Photograph 1
Deep Star alongside Coronation Pier, Tauranga

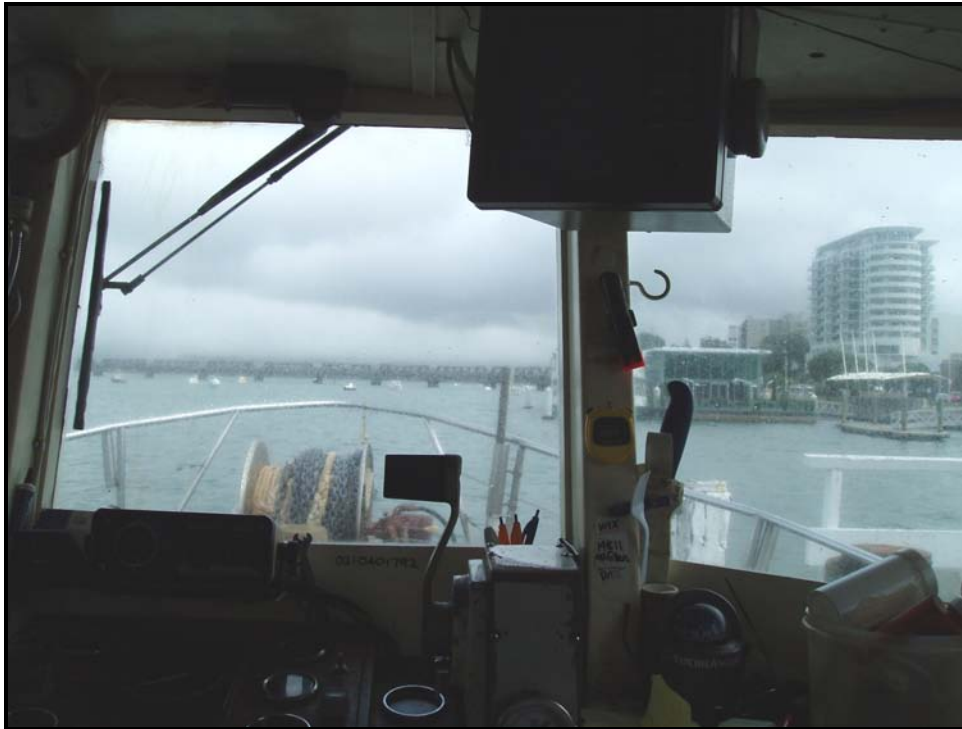
Photograph 2

Deep Star was making a speed of about 7.5 knots. The weather was good with a 20 knot south-west wind and a short choppy sea. The sun was on the starboard bow. Although it was glinting off the sea, it was not in the Skipper's eyes. The view ahead from the Skipper's seat was reasonably unobstructed as shown in *Photograph 2*. Spray, coming over the bows, may have reduced his visibility.

View from the Skipper's seat of *Deep Star*

1. It is recommended that Maritime New Zealand censure the Skipper of ***Deep Star*** for failing to keep a proper lookout. The letter of censure should suggest the following ways to improve the lookout:
 - Making the lookout a priority and giving it the full attention required.
 - Moving about to ensure the view is not obscured by window frames or the boat's fittings.
 - More use of radar.
 - Using binoculars to scan the horizon.

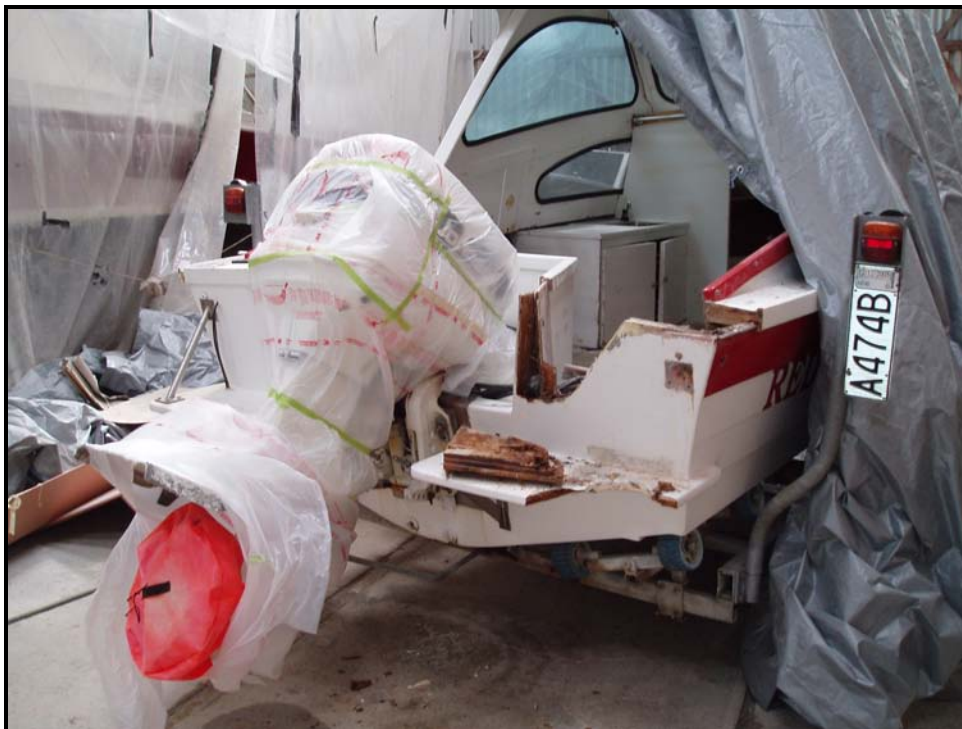
Damage to *Red Pepper* was as follows:

- Cracks to the structure by the bunks, internally
- The cabin was racked and was cracked
- The transom was damaged
- The outboard bracket was broken and the auxiliary outboard engine lost
- The casing of the main outboard engine was damaged
- Damage to the gearbox was suspected
- The bilge pump would not work
- The steering was stiff
- Various articles, such as fishing rods and a wallet were lost.

Photograph 3
Damage to the transom of *Red Pepper*
