Accident Report

Diane

Person Overboard

REPORT NO: 04 3461

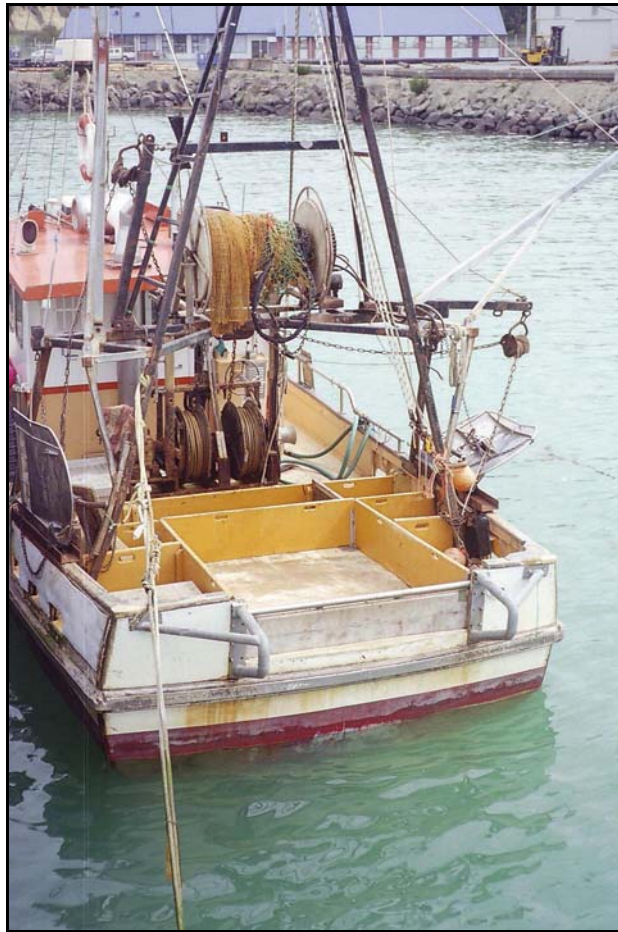
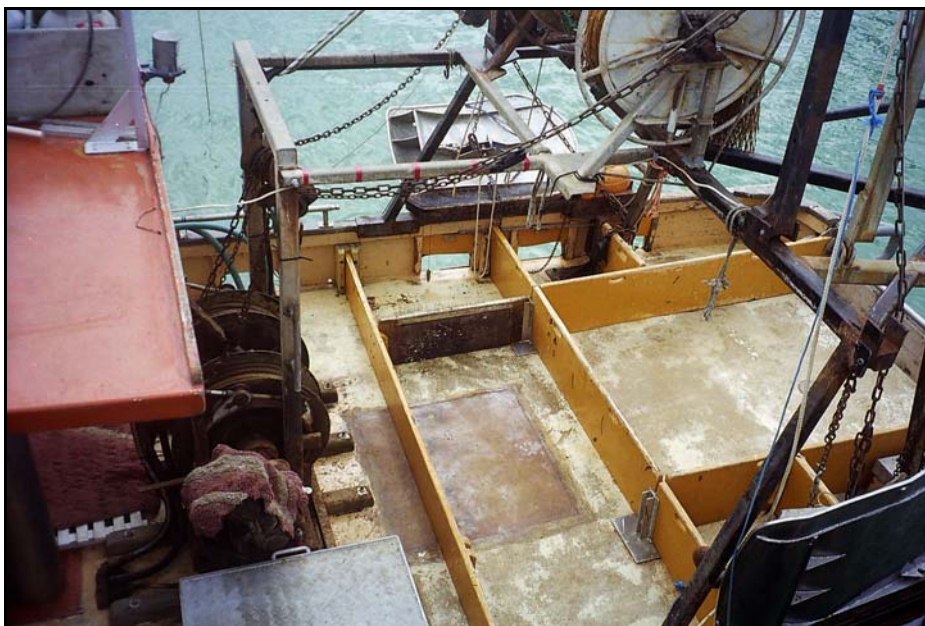
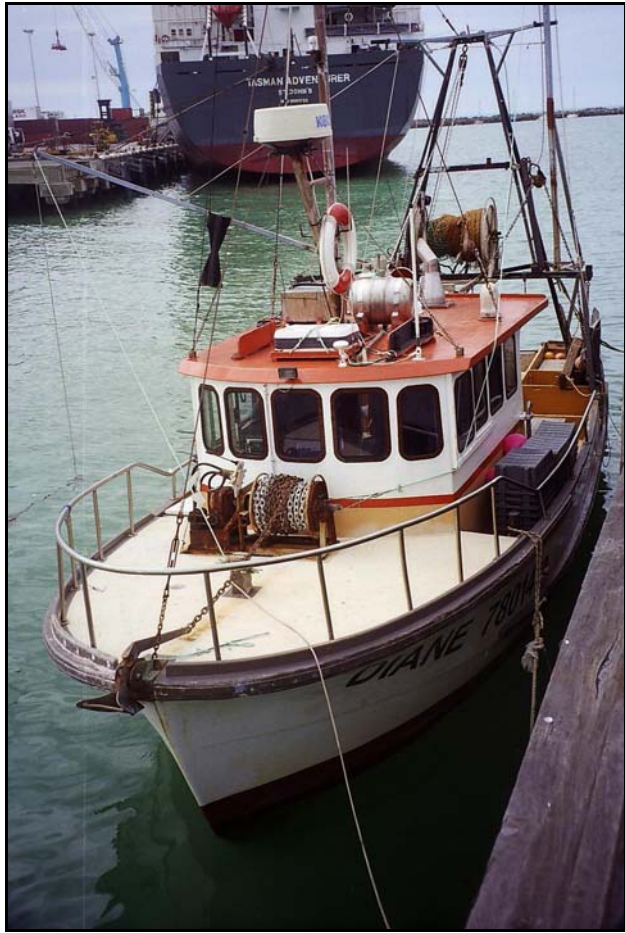
APPENDIX 2
PHOTOS OF VESSEL

2.2 Particulars of *Diane* (See Appendix 2 – Photographs of Vessel).

Inspection of the vessel by the MSA Investigator, showed that all the above equipment and the vessel itself were in good condition and well maintained.
