**Accident Report**  
Serious Harm Injury to Passenger  
aboard Dolphin Discovery V  
**4 January 2010**

## **Maritime New Zealand**

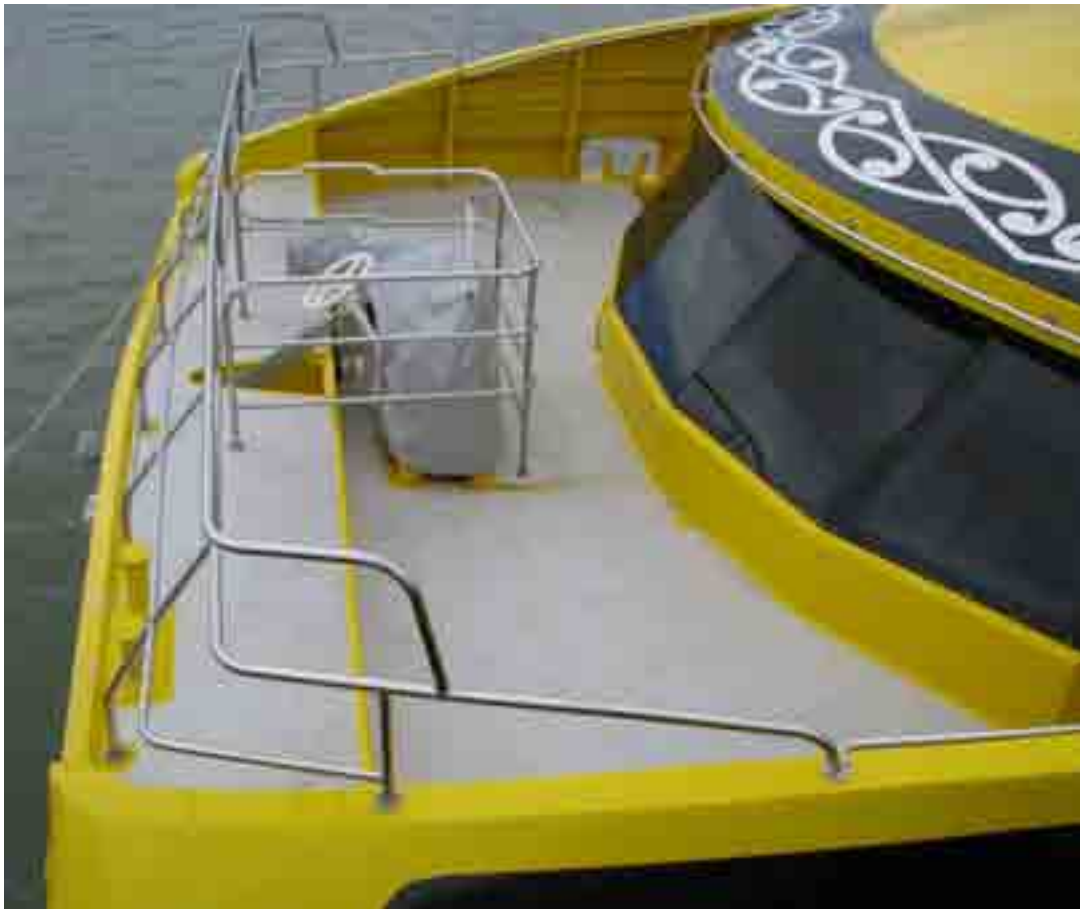
**Figure 2** Bow deck of vessel

15. Inadequate communication between skipper and crew
  - skipper cannot see all of the foredeck from the helm station and has to rely on communication from the crew, which in his own admission was inadequate on the day in question; anecdotally a significant number of the passengers were suffering from motion sickness.

- passengers commented that safety briefings were vague and lacked essential detail.
17. Passenger Supervision
  - There was no close monitoring of the foredeck during the period of rough weather conditions.

20. It is recommended that Explore NZ implements the following:
- a) Improved communication systems which enable the skipper to be fully aware of passenger whereabouts and welfare at all times. This would allow for two way communication with crew.

- iii) Effective communication to non-English speaking people.
  - c) Crew operating procedures are reviewed to include improved monitoring and supervision of passengers at all times, particularly in hazardous areas and when in adverse conditions.
