Accident Report

Gas Explosion

Double Trouble

29 September 2007

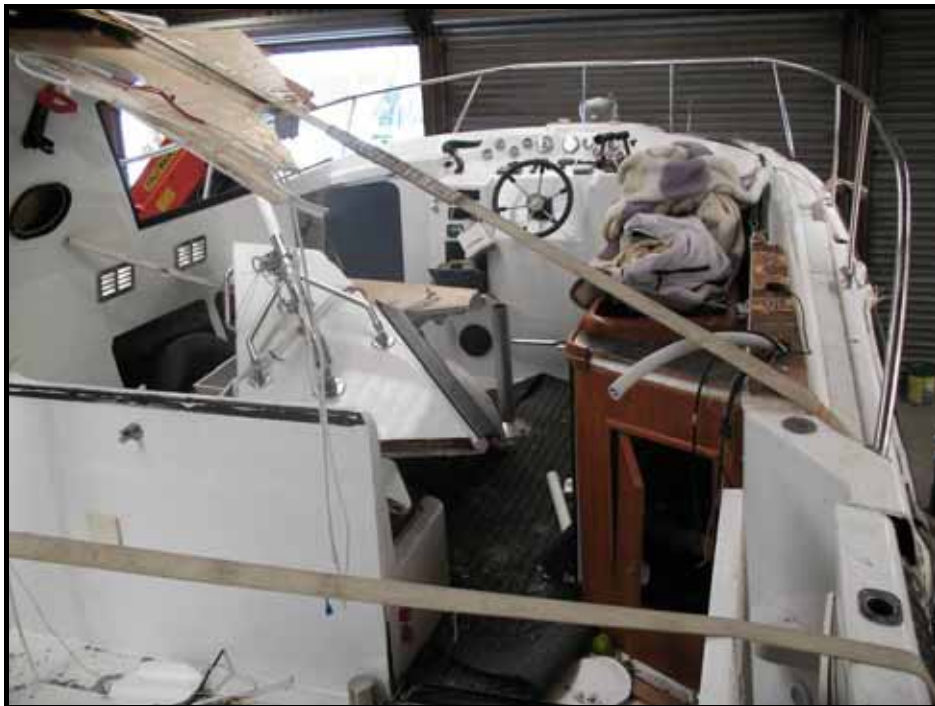
Photograph 2

- 1.1.4 The vessel was effectively destroyed in the blast with sections of the cabin blasted from the hull (*See Photograph 2*).
- 1.1.5 The Skipper and crew suffered serious burns of varying degrees. The Skipper also sustained broken ankles.

- 3.1 Gas leaked from the spare LPG bottle in the forward locker from an improperly sealed ullage valve.
- 3.2 It is likely that the ullage valve was not properly sealed when filled the previous day at a local gas station.
- 3.3 The gas drainage hole in the locker was unable to discharge all the gas to the outside of the hull.
- 3.4 Due to the expansion rate within the locker the gas travelled through the unsealed duck pipe and accumulated in the cabin area.
- 3.5 The explosion occurred when either the califont or stove ignited.
