Class A Accident Report

# Louisa & Emma J

## Collision

At Golden Bay on 7 November 2004

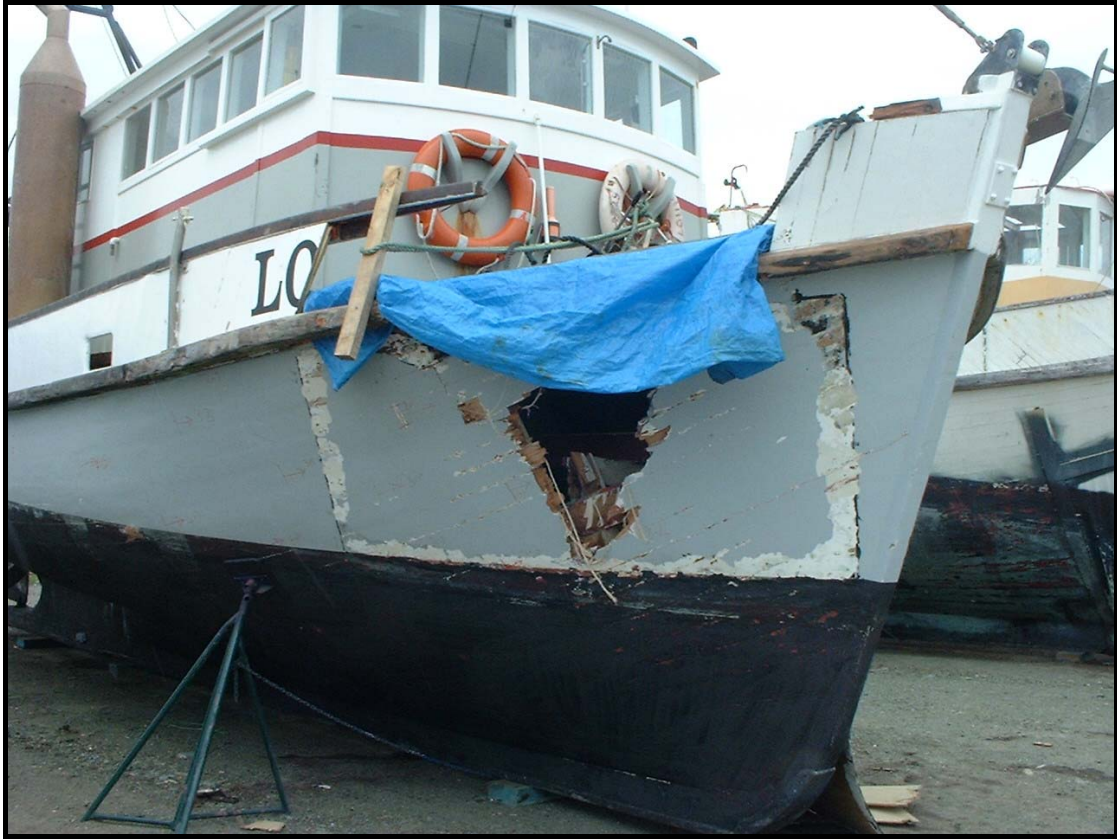
LOUISA

*Louisa* sustained extensive damage to the starboard side planking, ribs, beam shelf, deck beams, deck crash bulkhead, stringer, bull-works and capping rail.

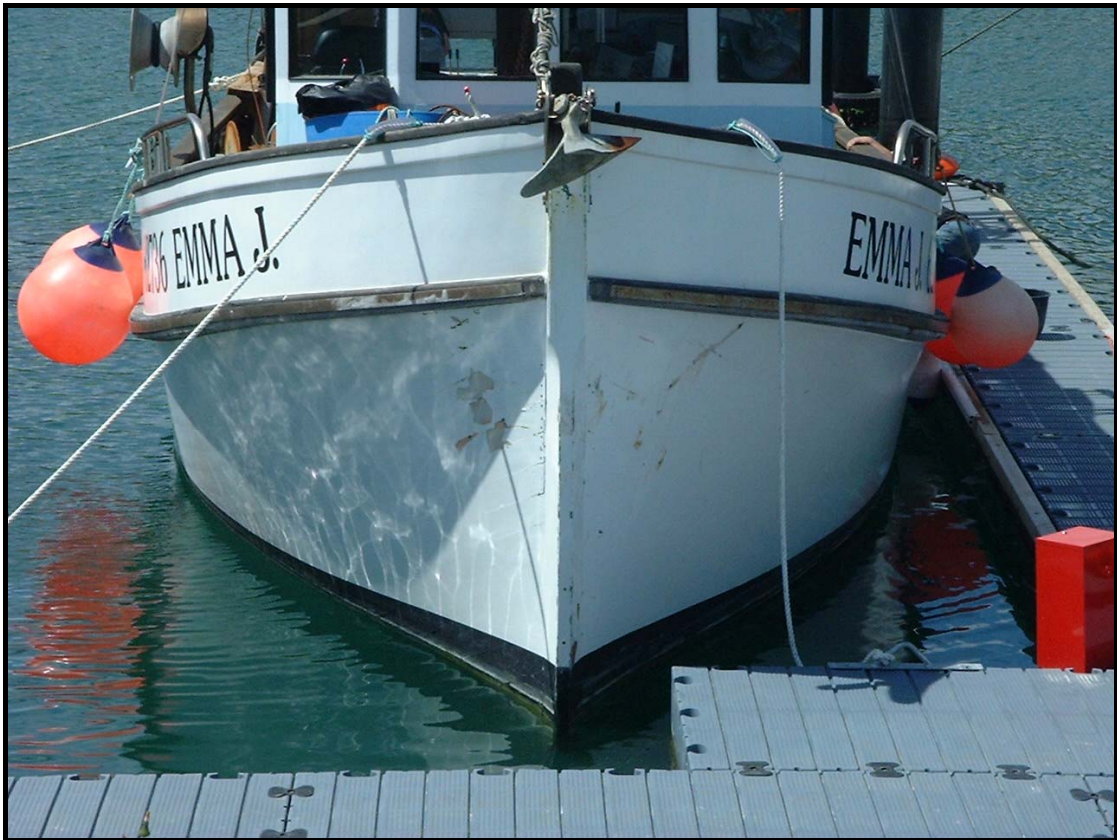
EMMA J

*Emma J* sustained very minor damage to the paint work around the stem post.

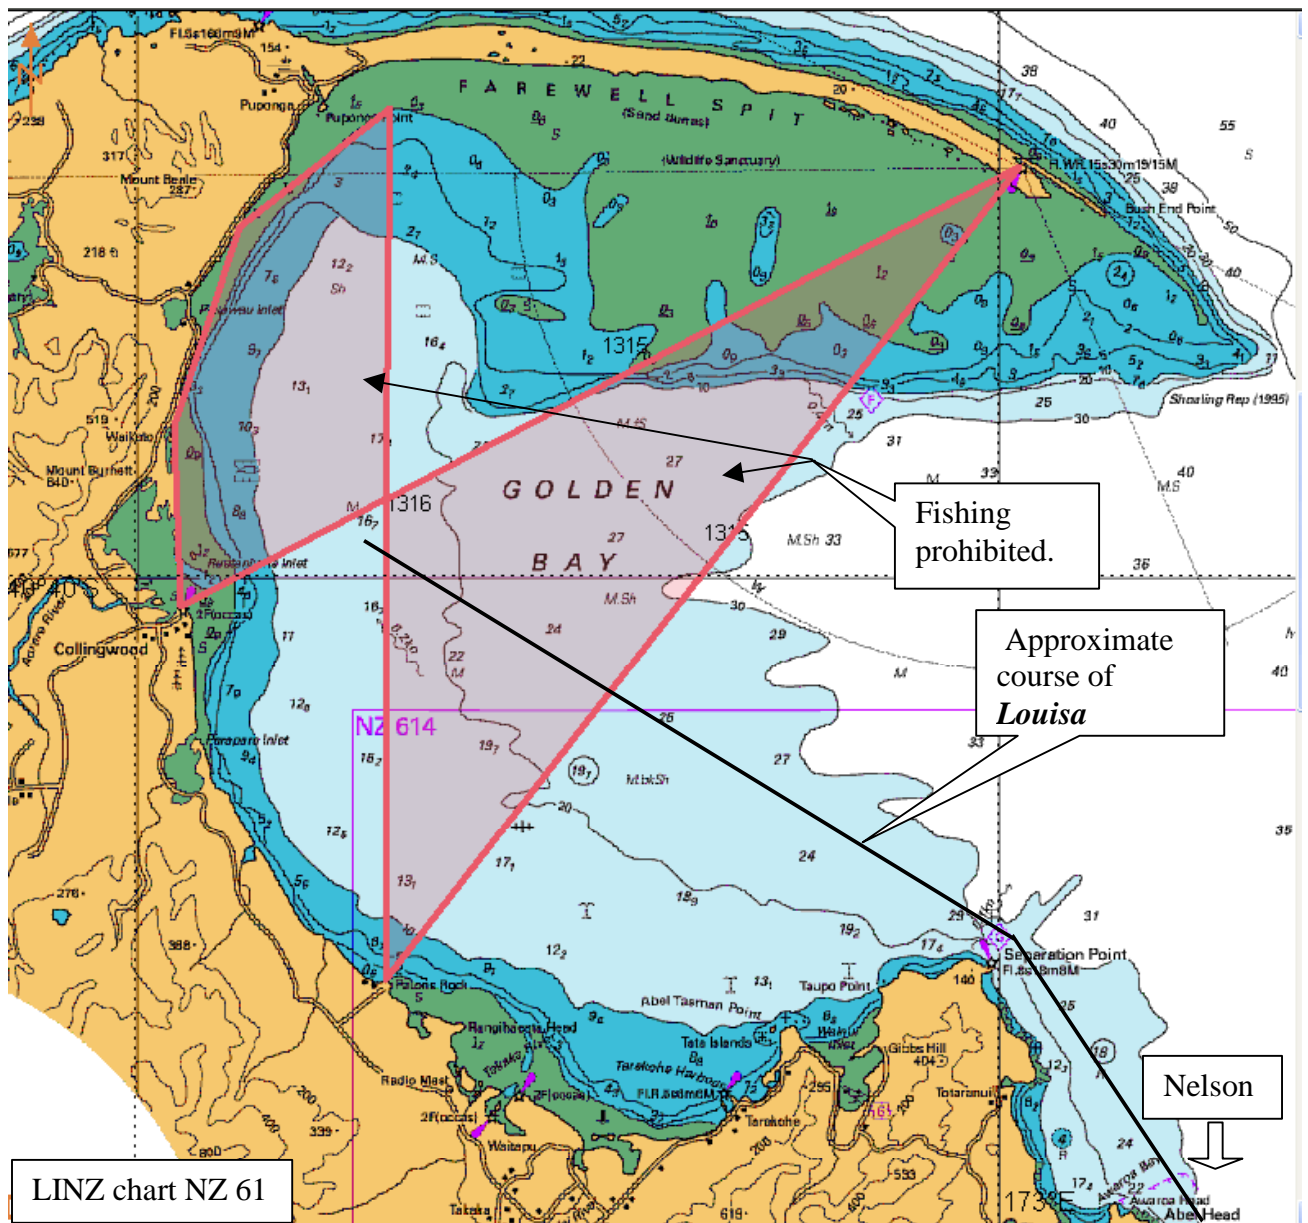
LINZ chart NZ 61

Approximate course of *Louisa*

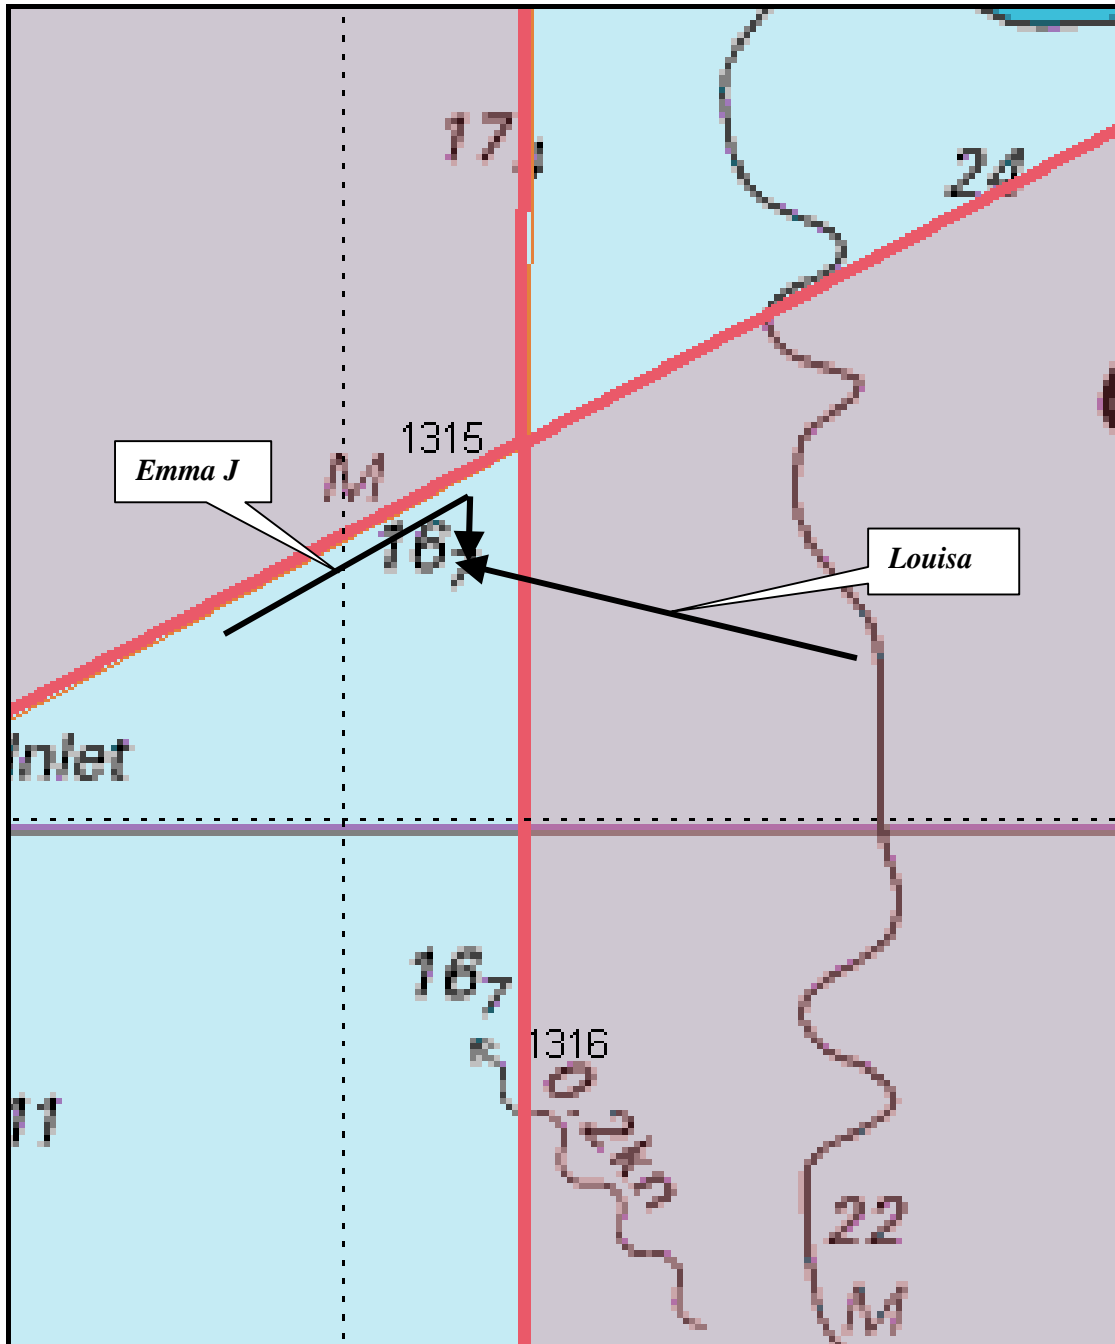
Chart NZ 61

*Emma J* had been towing in a northeasterly direction along the northern boundary of the fishing prohibited area. The Skipper wanted to turn the vessel onto a reciprocal course when he neared the northeastern corner. At the same time *Louisa* was on a nearly reciprocal course but slightly to the south of track of *Emma J*. The Skipper of *Emma J* went into the wheelhouse and applied 40° of starboard helm then went back to the tray. This alteration closed the distance between the vessels; the angle of impact was almost 90°, with the stem post of *Emma J* striking the starboard shoulder of *Louisa*.
