Accident Report

Man Overboard
Formosa Thirteen

12 June 2006

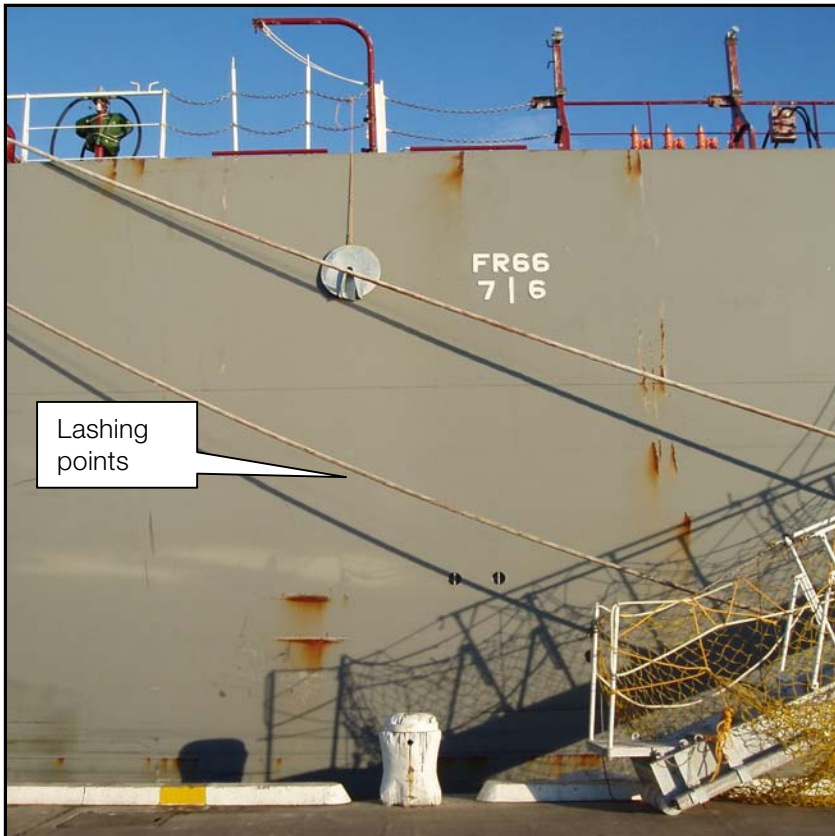
Figure 2
Gangway and lashing points

At 1608 hours, Mr Yanlei descended the accommodation ladder so as to undo a rope lashing that was attached between the bottom of the ladder and a cleat that was recessed in the ship's hull and used to hold the ladder against the hull (See Figures 2 & 3 – Photographs). He was wearing overalls and a dark blue raincoat, over trousers steel cap safety boots, gloves and hardhat. He was not wearing a lifejacket or harness. Deckhand 1 did not watch Mr Yanlei once he had started to descend the accommodation ladder.

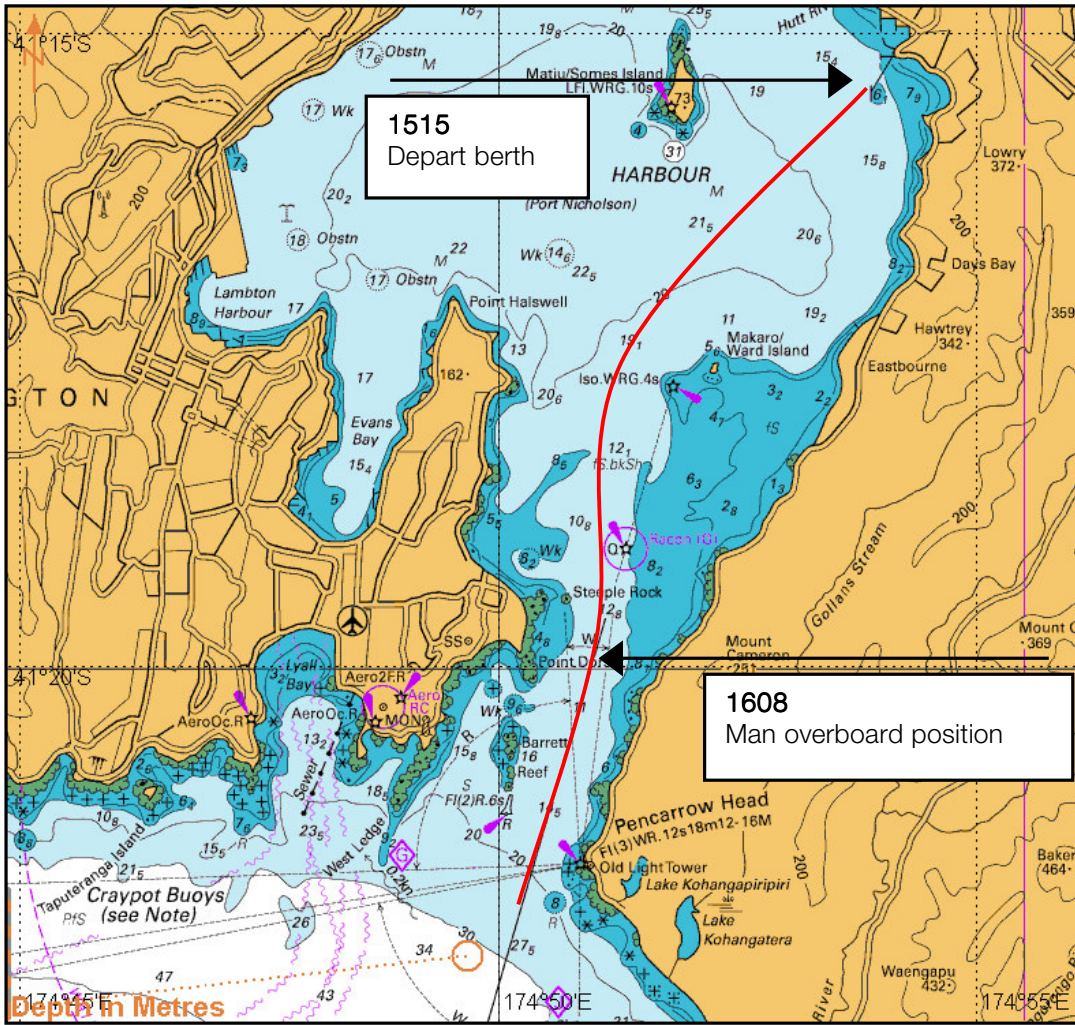
Figure 4
 Extract from LINZ Chart NZ 463 – Wellington Harbour – Showing approximate track of *Formosa Thirteen*

At 1608 hours, the vessel was abeam of Point Dorset, steering 197°(T) at a speed of about 8.9 knots (See Figure 4). The Pilot observed Deckhand 1 by the starboard gangway, shouting and gesticulating to the bridge and to the stern. The Pilot quickly realised there was a man overboard. He looked astern and saw Mr Yanlei in the water about 50-100 metres astern of the vessel. He was waving with one arm and appeared to be riding quite high in the water. At about this time the man overboard alarm was sounded.

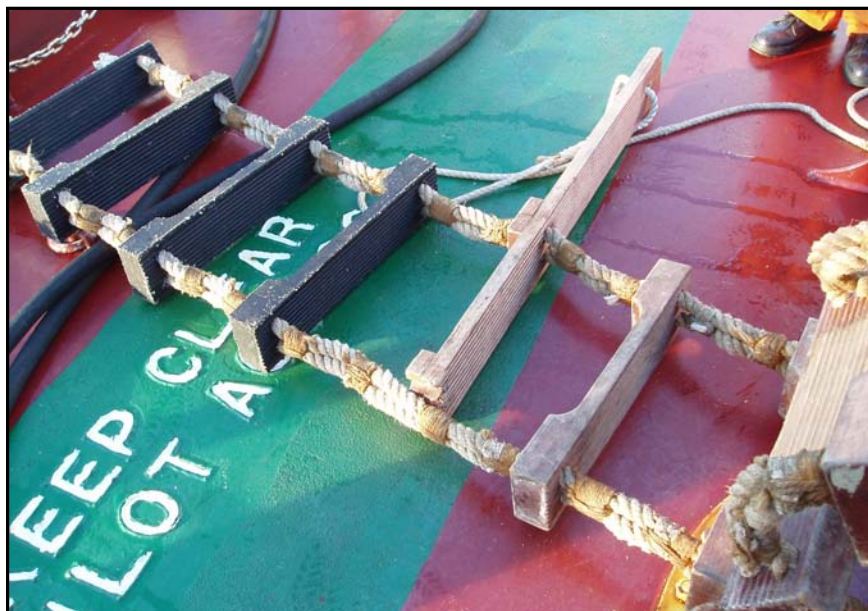
Figure 5
Broken rung from Starboard Pilot ladder

The fifth and the fourteenth rungs and spreaders of the pilot ladder were found to be broken when it was recovered. It is not known exactly when these were broken. They may have been broken by the action of the sea and waves as the vessel left Wellington.

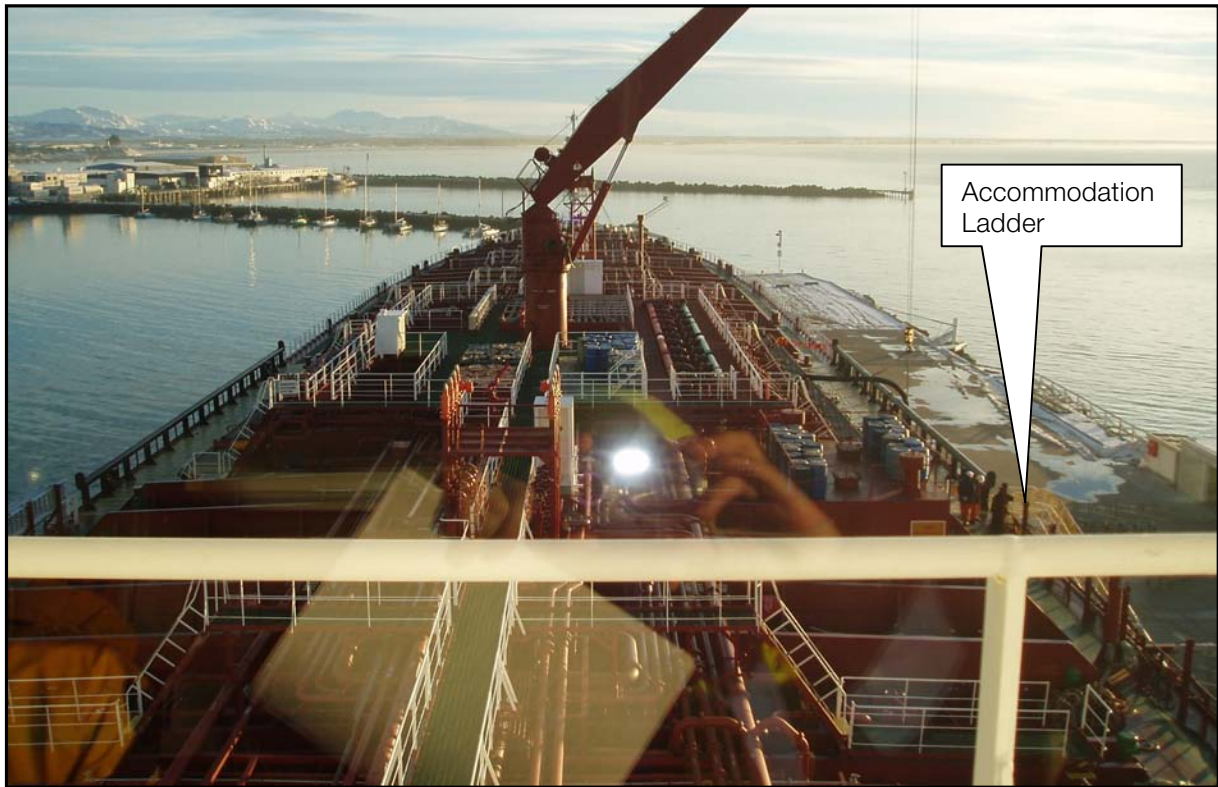
Figure 6
View from the Pilot's position on the bridge

The combination accommodation and pilot ladder was visible from the starboard bridge wing. None of the bridge team checked to see whether it was safe to raise the accommodation ladder, when the order for this was given.
