Accident Report

# Glen Rosa Flooding

Auckland Harbour on 20 March 2004

**REPORT NO: 04 3438**

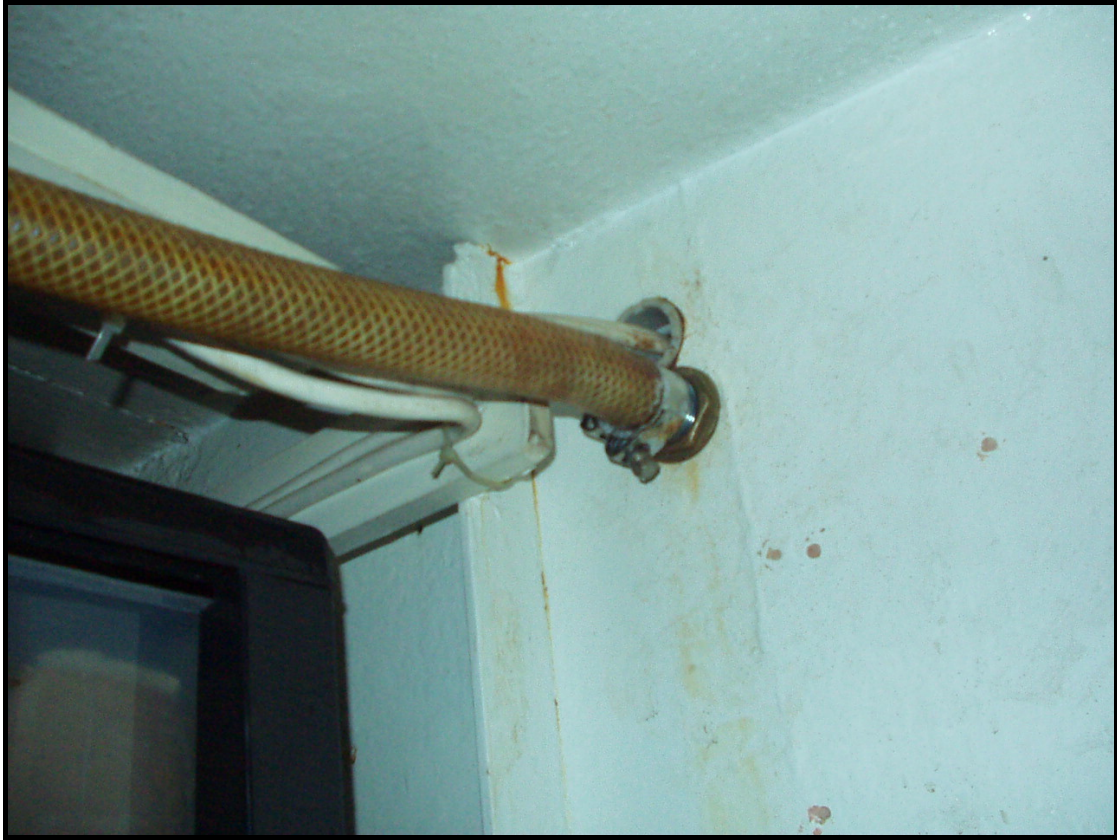
- 1.9 On inspection of the engine room, it was found that a reinforced plastic pipe, fitted to the discharge pump for the salt water engine cooling, had become disconnected at the point where it passed through the after engine room bulkhead.

- 2.4.1 The flooding started when a reinforced plastic pipe, connected by a jubilee clip, to the salt water-cooling system, came away from an after bulkhead fitting after the jubilee clip loosened (*See Appendix 3 - Photograph of fitting*). The fitting consisted of a one-inch diameter tail pipe that passed through an aperture in the bulkhead. The reinforced plastic pipe was attached to the tail pipe with a jubilee clip, which was found, on inspection, to be free of rust.
- 2.4.2 It was the opinion of the Owner that the jubilee clip had loosened due to the vibration of the centrifugal cooling pump.
- 2.4.3 After the flooding, the tail pipe was changed to a six-inch stainless steel tailpipe, extending three inches on either side of the bulkhead. The pipe was then re-attached with two jubilee clips on either side.

- 4.1** The failure of the jubilee clip holding the salt water-cooling pipe to the aft bulkhead fitting.

**2.6.1** The overboard discharge line has been diverted from passing through the aft bulkhead to a through hull fitting in the main engine room.

- 5.8 It is recommended that the following matters be attended to by the owner of *Glen Rosa* within 2 months of the report being finalised namely:
- That all saltwater overboard discharge piping be constructed of metal in accordance with **Maritime Rule 40A.35(6)**.
