Accident Report

Sinking (1 fatality)

Hard Out

23 February 2008

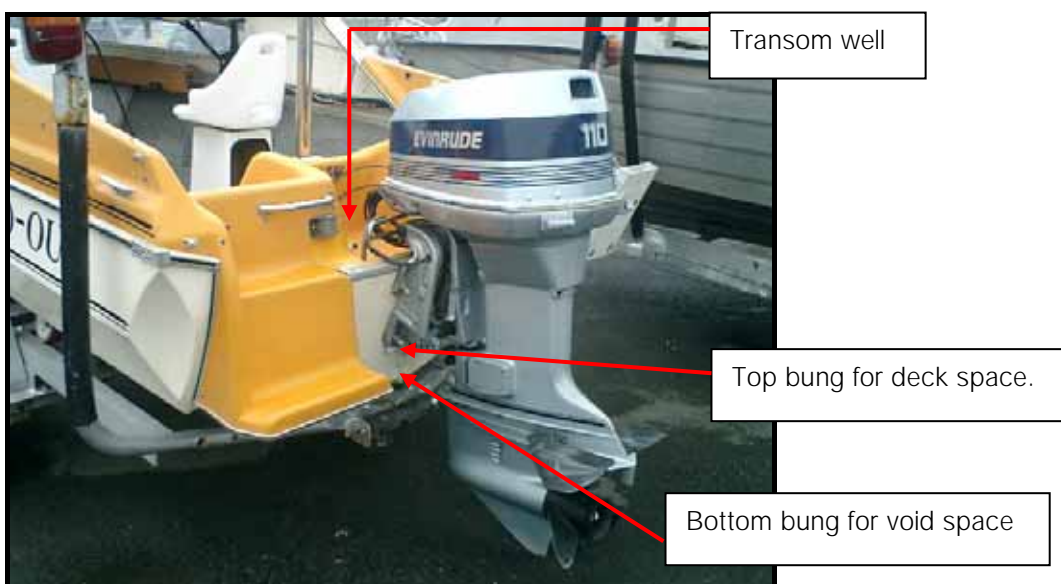
Photograph 2
Hard Out - transom position of bungs indicated above.

- 3.22 The void space between the hull and deck was fitted with a bung in the transom to drain the void if required.
- 3.23 There was also a bung in the transom fitted just above the level of the interior deck level to drain the interior of the boat when hauled out of the water. In addition, there was a drain hole in the transom well to drain any water that may slop in (*See Photograph 2 - showing the transom and bungs*).

- 3.24 The owner reported that he had replaced both bungs when he purchased the vessel, because the top bung had started to perish and he believed that it was not sealing too well. He also indicated that he had put silicone around the new bung *"to make sure it was all ok"*.
- 3.25 The owner pressure tested the bungs to check the water tight integrity of the vessel. He stated:

- 3.27 This method of testing may have stressed the hull and transom causing possible fractures. The fractures may have been latent and become active when the boat was flexing in a seaway causing the void space to flood. This view is supported by the manufacturer.

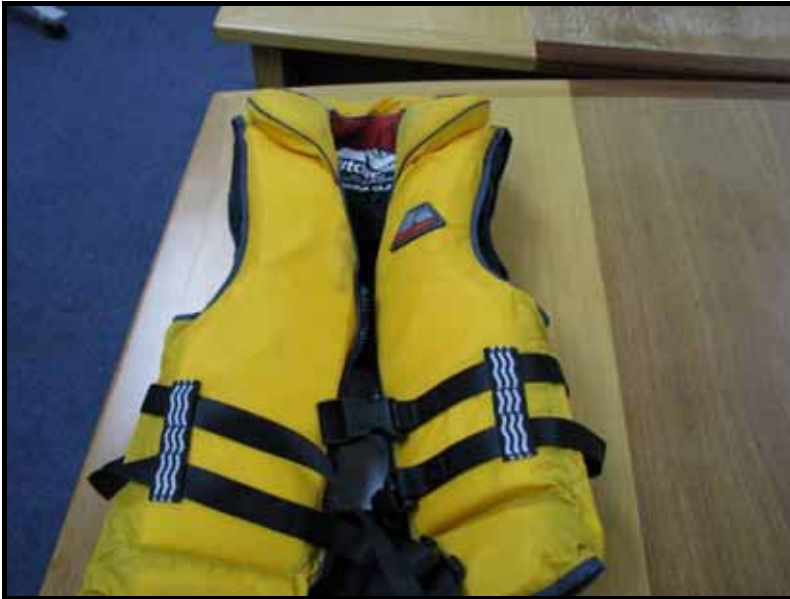
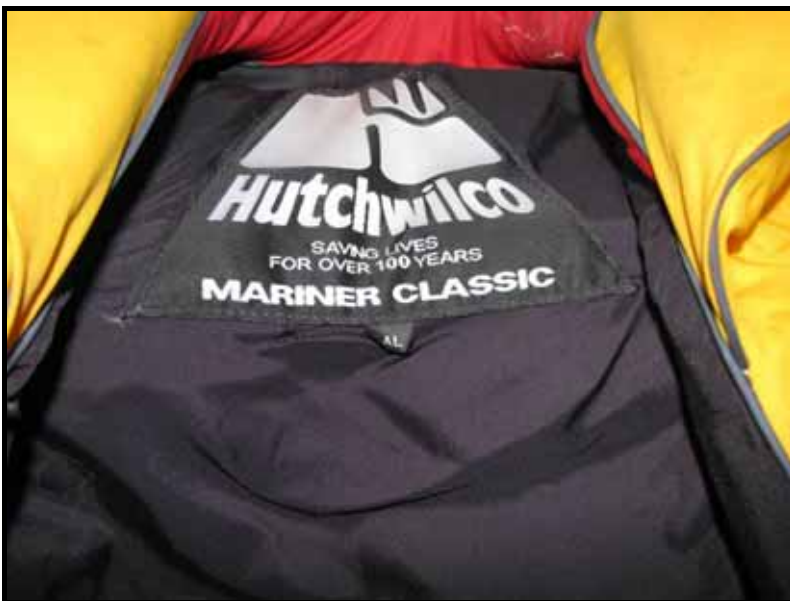
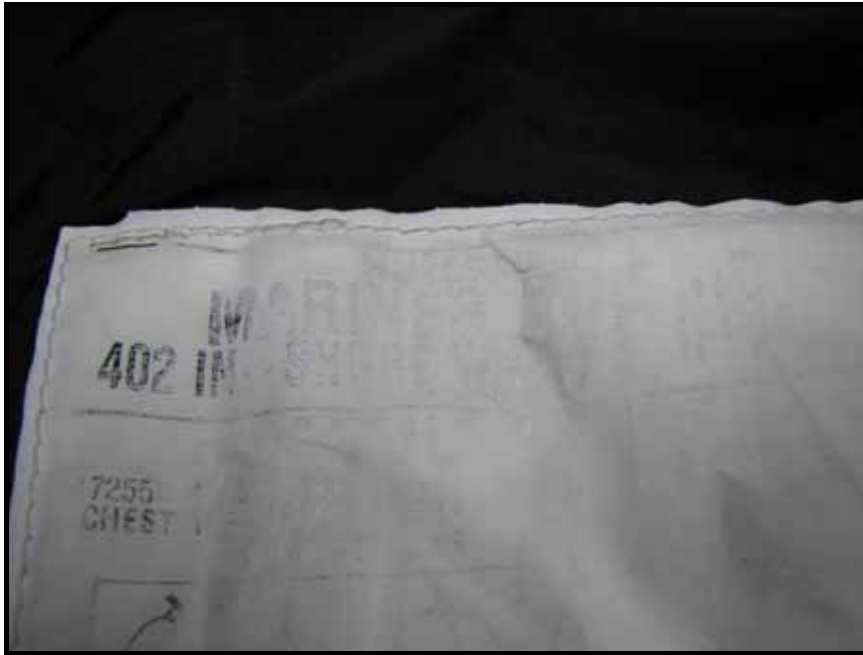
3.62 The passenger wore a Hutchwilco Mariner Classic, adult large, of New Zealand Category 402 (See Photographs 3, 4 & 5 – Passenger's PFD).

- Hutchwilco Mariner Classic, adult large of New Zealand category 402.

- Showing brand and size label on inside

- Label on the inside of the lifejacket. The lifejacket is marked '402 In-Shore waters'

3.63 These photographs of the passenger's PFD, confirm that it is Category 402 designed for inshore waters, defined by NZSM 5823:2005 as a location *'Where an early rescue may be anticipated'* and was previously referred to as *'Sheltered Waters'*. This PFD is not the correct jacket for use in open sea.

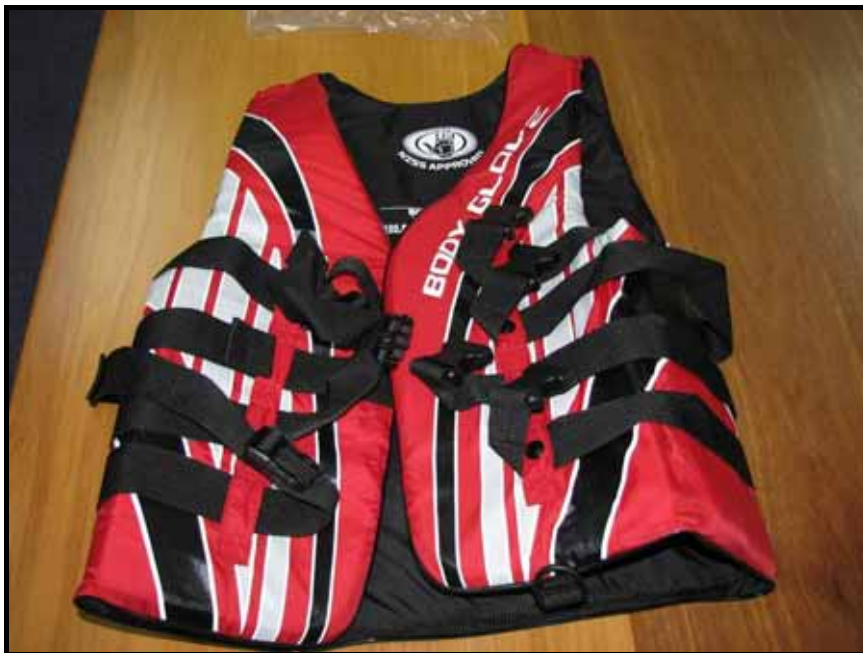
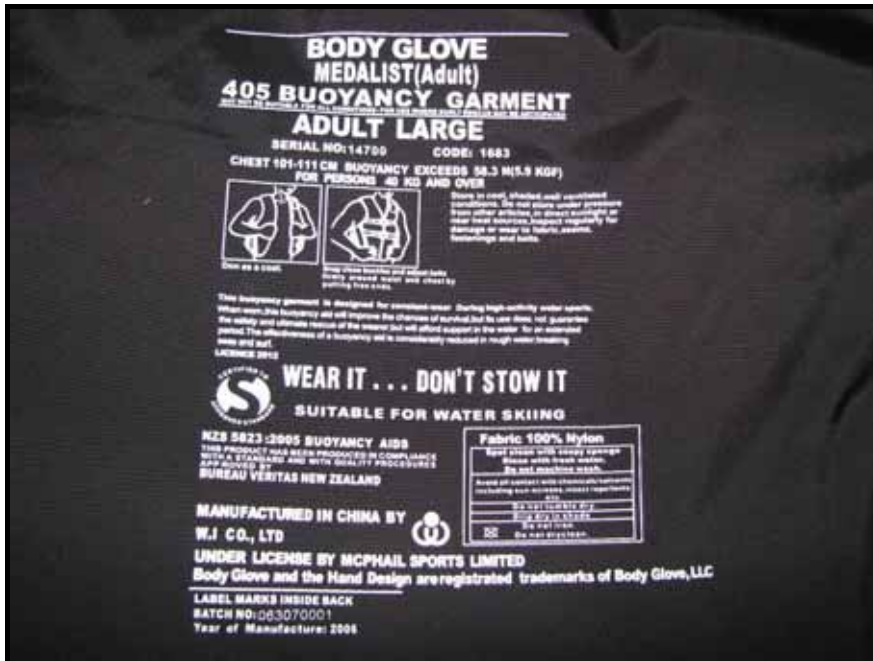
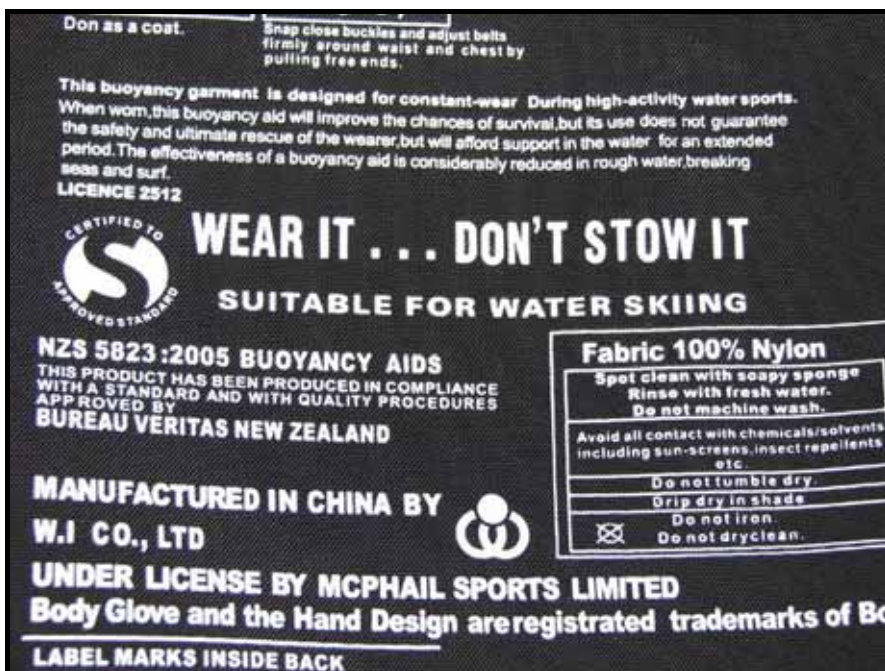
3.64 The owner was wearing a Body Glove Personal Flotation Device Category 405 (See Photographs 6, 7 & 8 – Owner's PFD).

- Inside Label

- Magnified view of inside label

3.65 The PFD worn by the owner was designed to be worn on the body when the wearer is at risk of short term immersion in water.

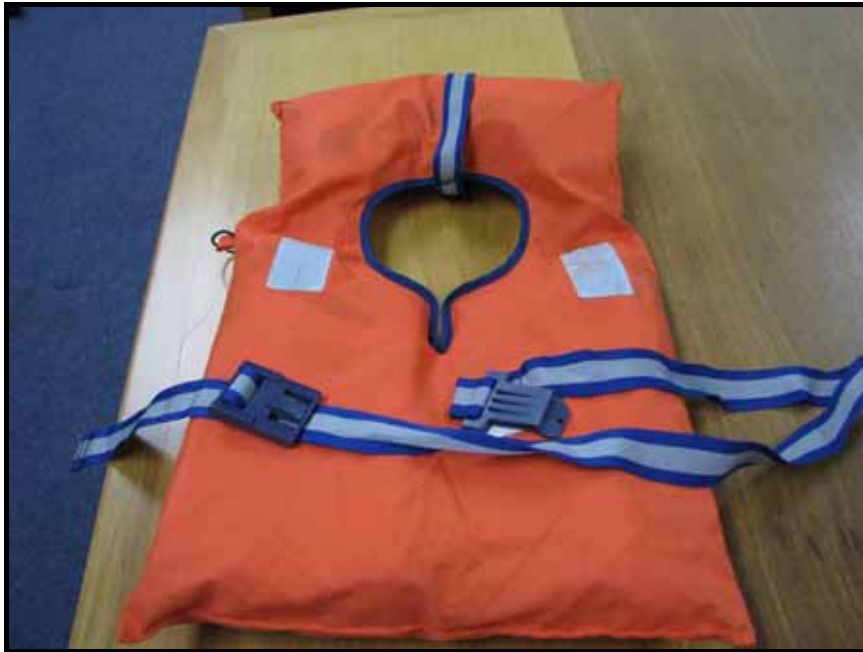
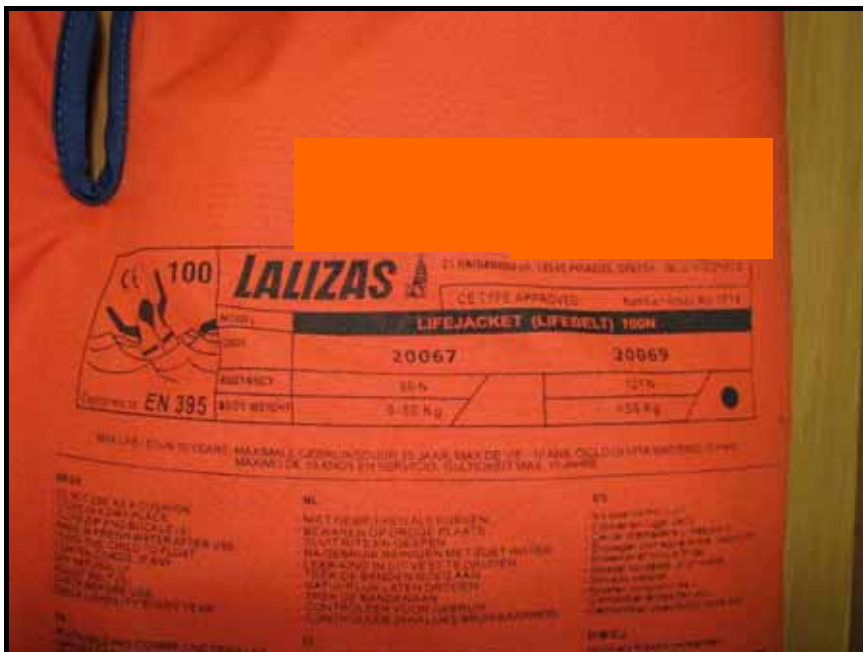
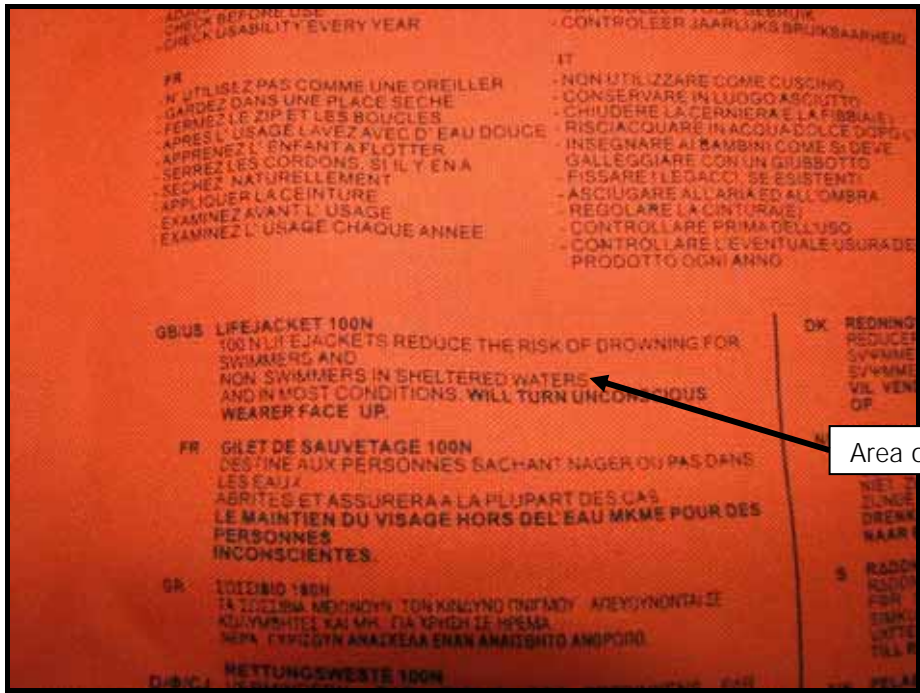
3.67 The PFD worn by passenger 2 was a LALIZAS 100 N (*See Photograph’s 9 & 10 – showing Passenger 2’s PFD*).

- 3.68 New Zealand Standards and European Standards differ in their definition of the attributes of a lifejacket.
- 3.69 The European Standard EN395 (the PFD worn by passenger 2) calls a buoyancy aid with 100 N a lifejacket.
- 3.70 The comparative New Zealand standard for a lifejacket refers to the device as having to exceed 100 N plus 10%. The term lifejacket is commonly used to describe all forms of buoyancy aids. It should be noted that although the common term may be lifejacket, it may be a buoyancy aid which does not reach the specified standards for a lifejacket.

- Area of use

- 3.71 The PFD worn by passenger 2 was designed for the average adult and is intended for use in sheltered waters. Using either the European Standard or the New Zealand Standard, this PFD is not designed for use in open seas (*See Photograph 11 - area of use.*)
- 3.72 On *Hard Out* there was an additional PFD which was retained by the occupants when they were in the water. This PFD was used as additional support for passenger 2.
- 3.73 The additional PFD was an older AK1 model kapok filled lifejacket, manufactured in the 1970s (*See Photographs 12 & 13 – additional PFD.*)

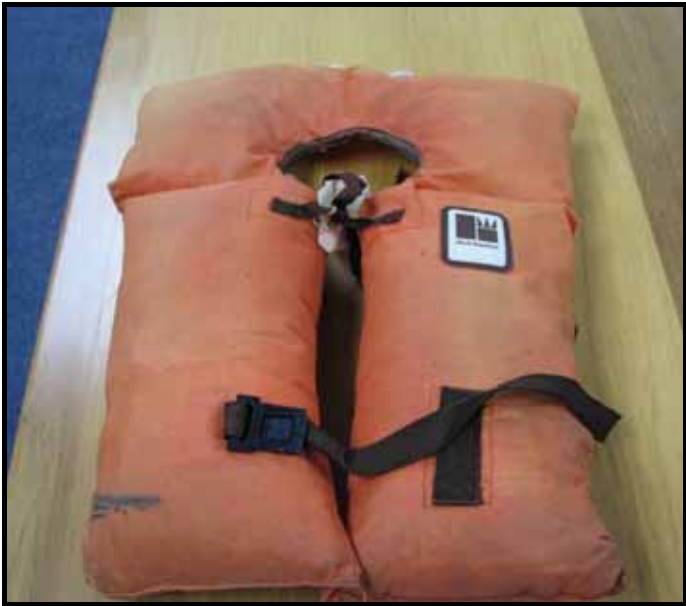
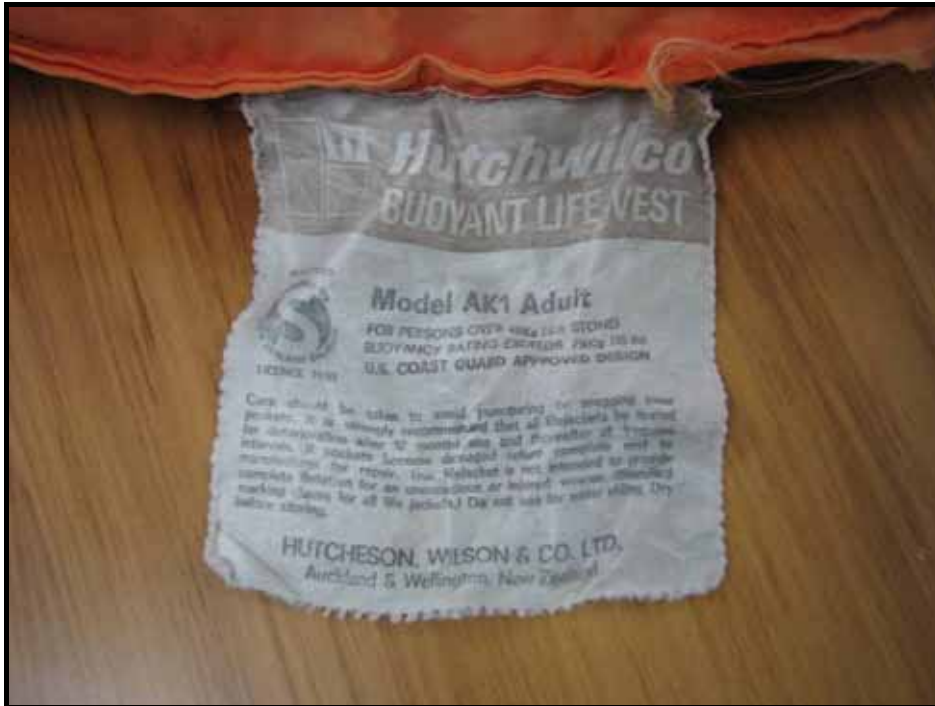
- 3.74 The manufacturer recommends that this PFD is periodically checked to ensure fabric and fittings are in good condition. This is to ensure that water ingress is not present which would result in the saturation of the kapok and reduce its buoyancy.
