# Accident Report

Grounding

*Huntress*

8 November 2006

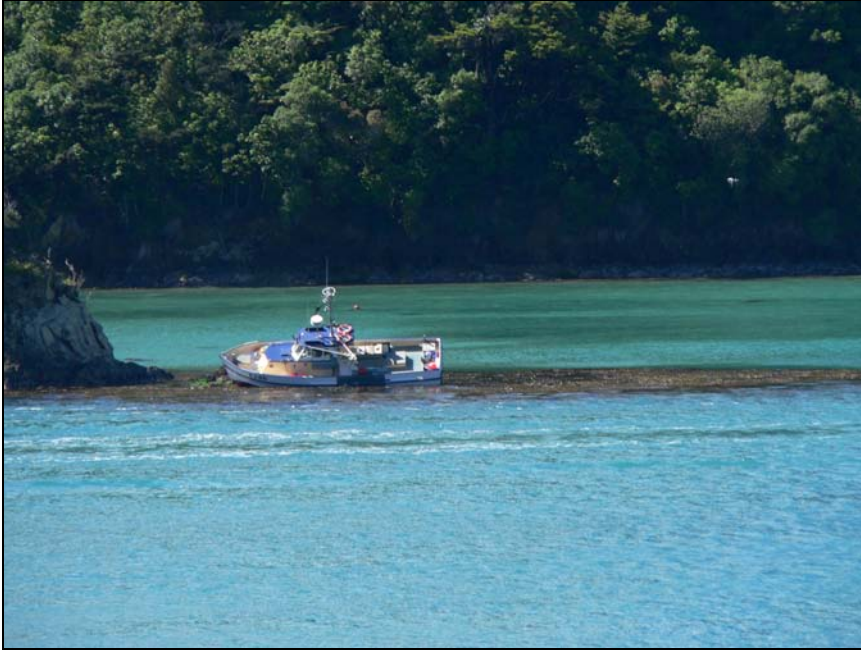
*Fig 1, Huntress aground on Wiriwaka Point*

While the Skipper was on deck the vessel was influenced by tide and wind resulting in the vessel being set to starboard and onto a rock shelf at Wiriwaka Point.

1. That the Skipper be censured for his failure to navigate safely in this situation. He clearly should have either: -
  - (a) Left the bin where it was.
  - (b) Tied it down properly from the start.
  - (c) Not scrubbed the bin.
  - (d) Stopped the vessel to ensure its continued safety throughout any activities on deck.
  - (e) Navigate the vessel further out into the channel to allow a greater safety margin.

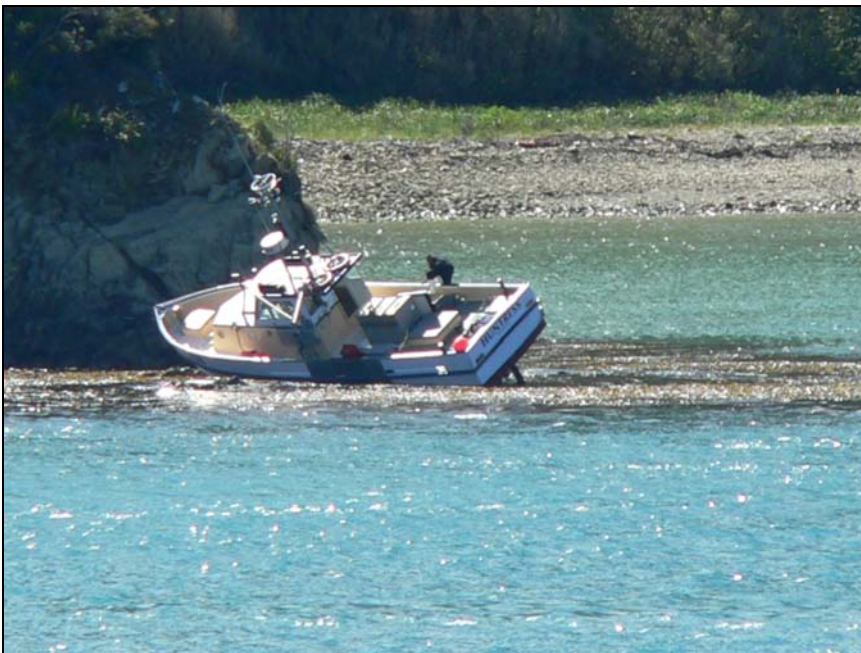
*Fig 2, Huntress aground.*
