Investigation Report
Jay Penelope
Severe weather incident
13 August 2010

Maritime New Zealand

Published August 2011

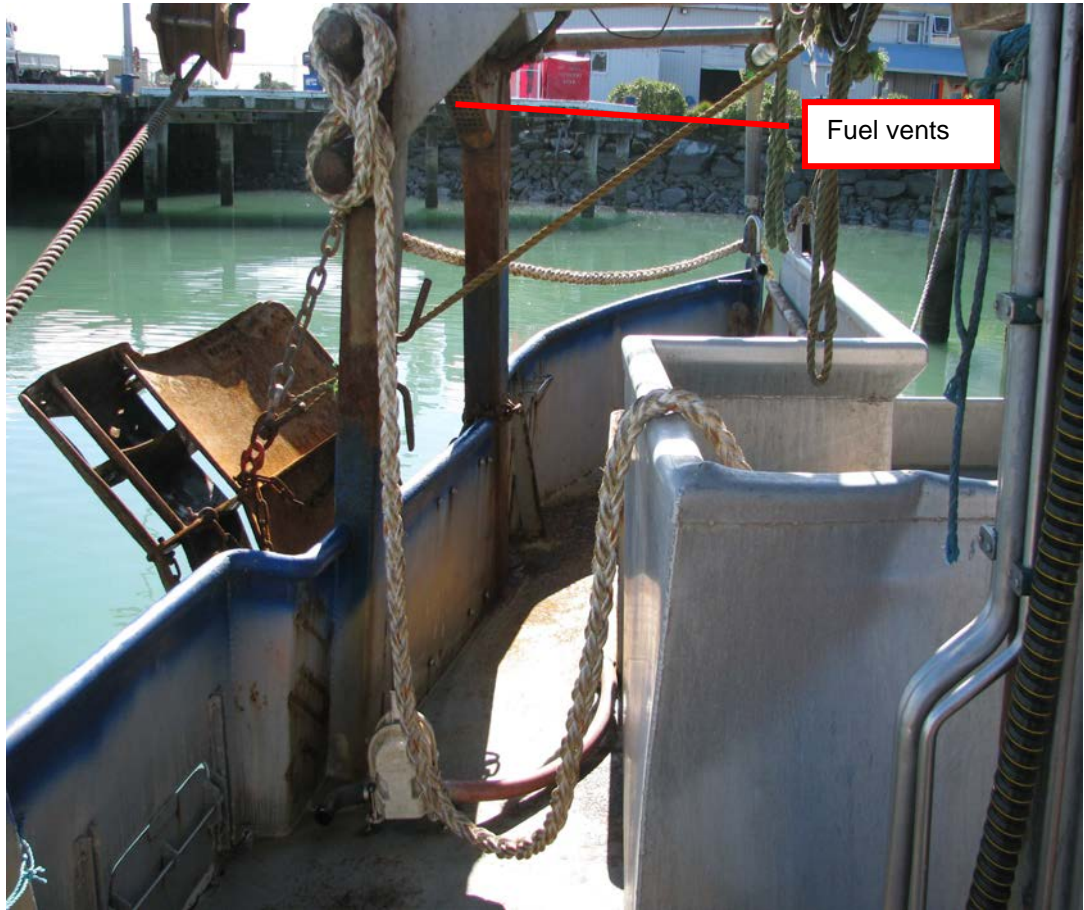
Figure 3 Fuel vent on the gantry

20. Several vessels sustained damage and all decided to exit the bay at about 0200 hours on 13 August.
21. **Jay Penelope** was struck by a number of large waves, which caused some of the fish to move as part of a free surface effect in the hold, creating a list. This list was perpetuated by water entering the starboard fuel tank and accommodation area.

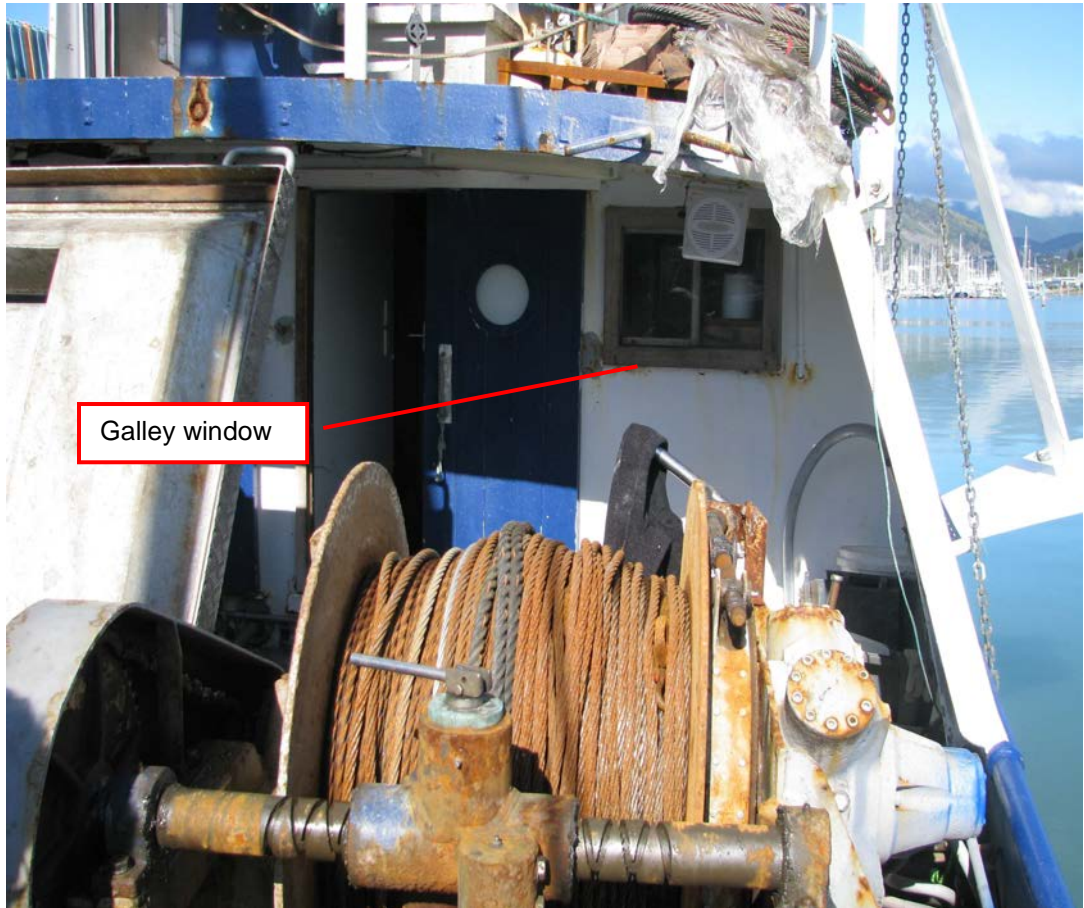
Figure 4 Galley window

16. Due to the list, sea water was able to enter the vessel galley and mess area through a window, which was also situated about 1.8 metres above deck. Significant water damage occurred in the accommodation area.
