Accident Report
Serious Harm Injury
Kawau Kat
14 April 2007
Class A

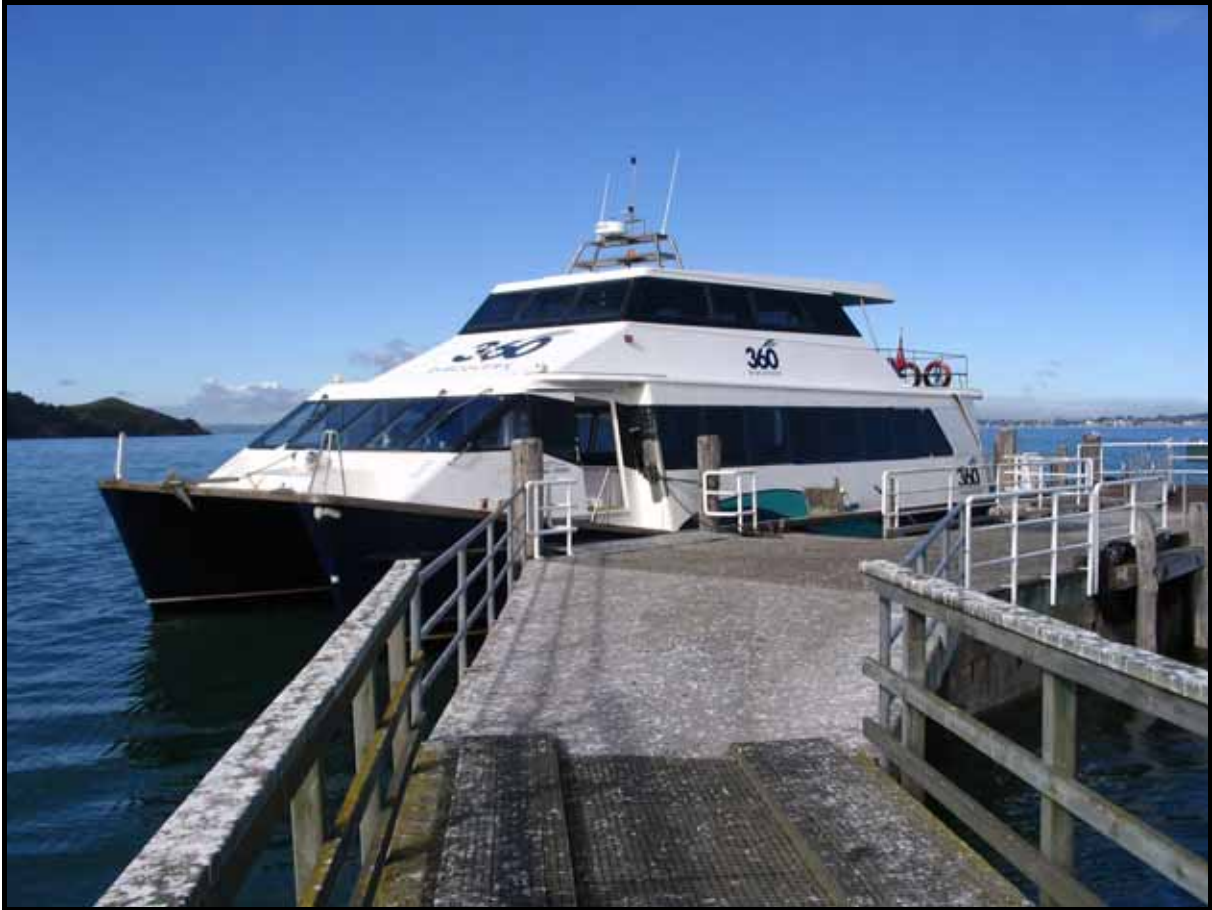
Photograph 1
Kawau Kat alongside Motuihe Wharf at high tide.

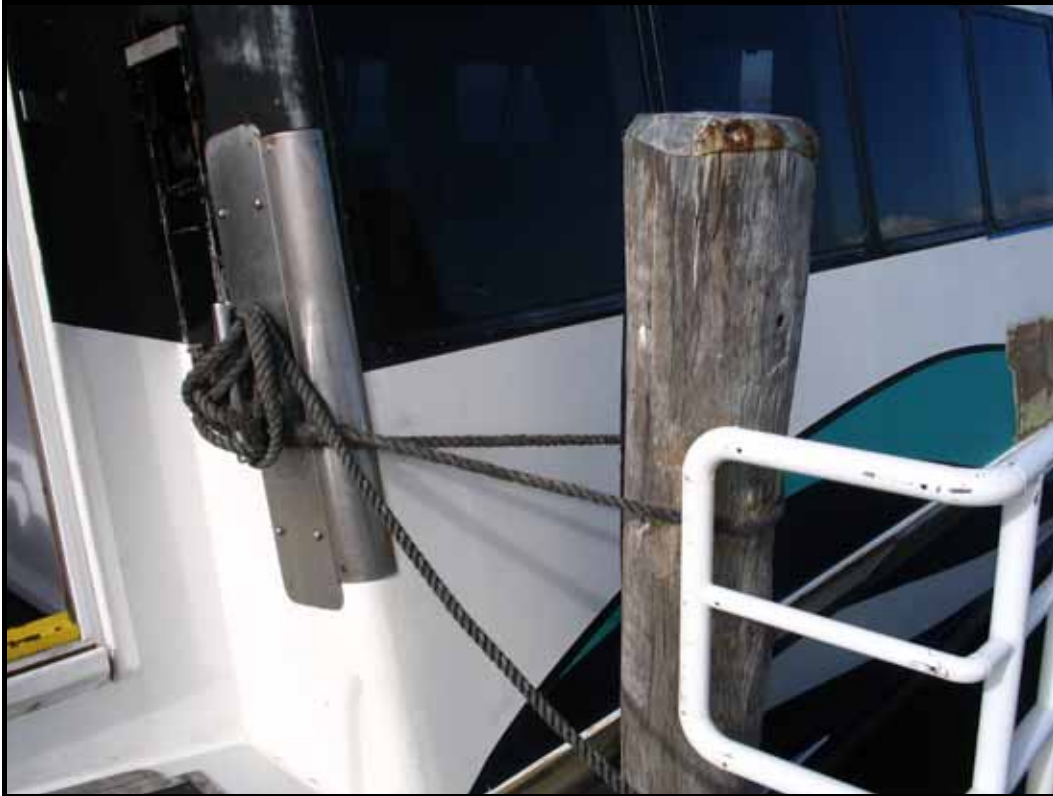
Photograph 2

3.1.2.8 On examination after the accident, minor damage, in way of an indentation in the timber construction, was found to the vessel in the vicinity of the mooring cleat. It is thought probable that this indentation was caused by the mooring cleat contacting the vessel when it recoiled after failing.

Mooring cleat on *Kawau Kat* with the same rope used in the accident.

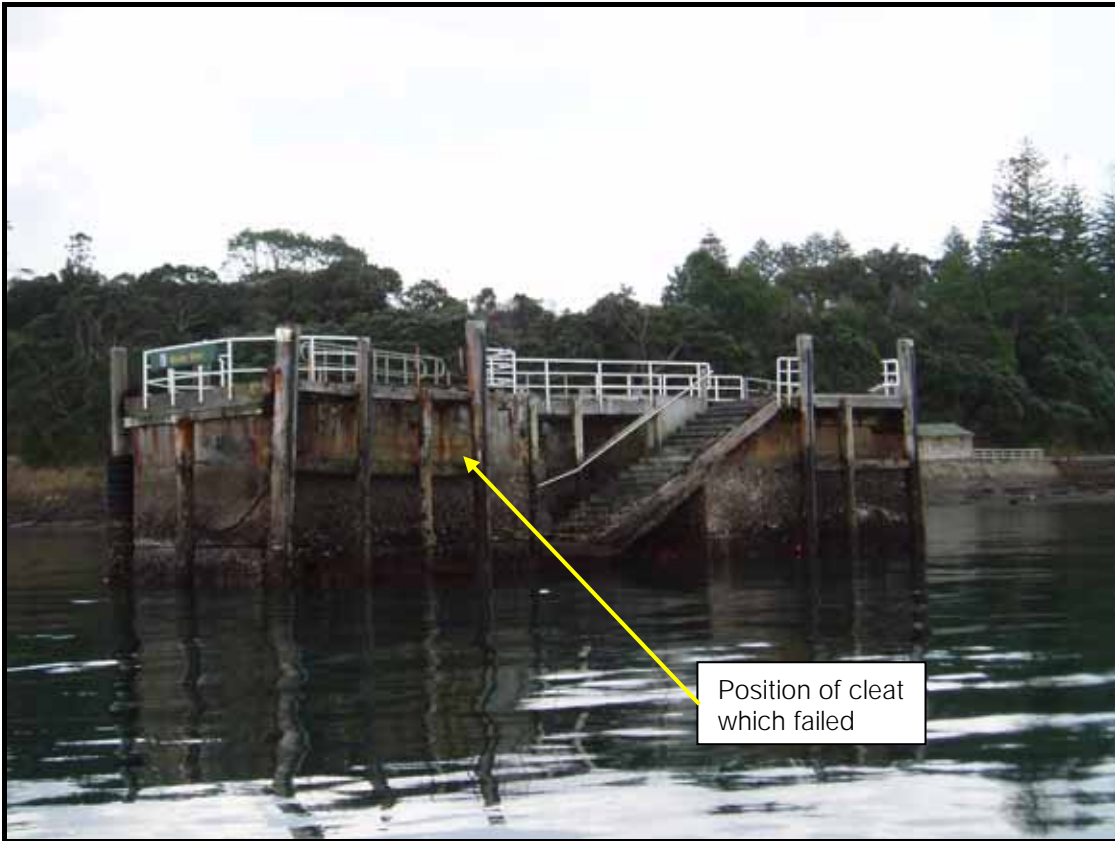
- 2.5 The Skipper repositioned the vessel and made another approach to the wharf. This time, the vessel's port bow was close enough for the Deckhand to be able to land the eye of the spring line over the wharf's mooring cleat (*See Photograph 3*). He promptly made the spring line fast to the cleat located on the port side of *Kawau Kat*. When turned up, the spring line was approximately 3 to 3.5 metres in length. The Skipper put the helm hard to starboard, port engine ahead and the starboard engine astern and attempted to maintain tension on the spring line in order to bring the vessel alongside.

3.1.3.4 On the wharf, there are three different types of mooring equipment. There are two large bollards, a medium sized bollard and a large cleat positioned on the wharf's deck and four smaller mooring cleats on the steps. On the lower timber waling (horizontal timber) are two medium sized bollards and the cleat that failed.

Photograph 3
Motuihe Wharf

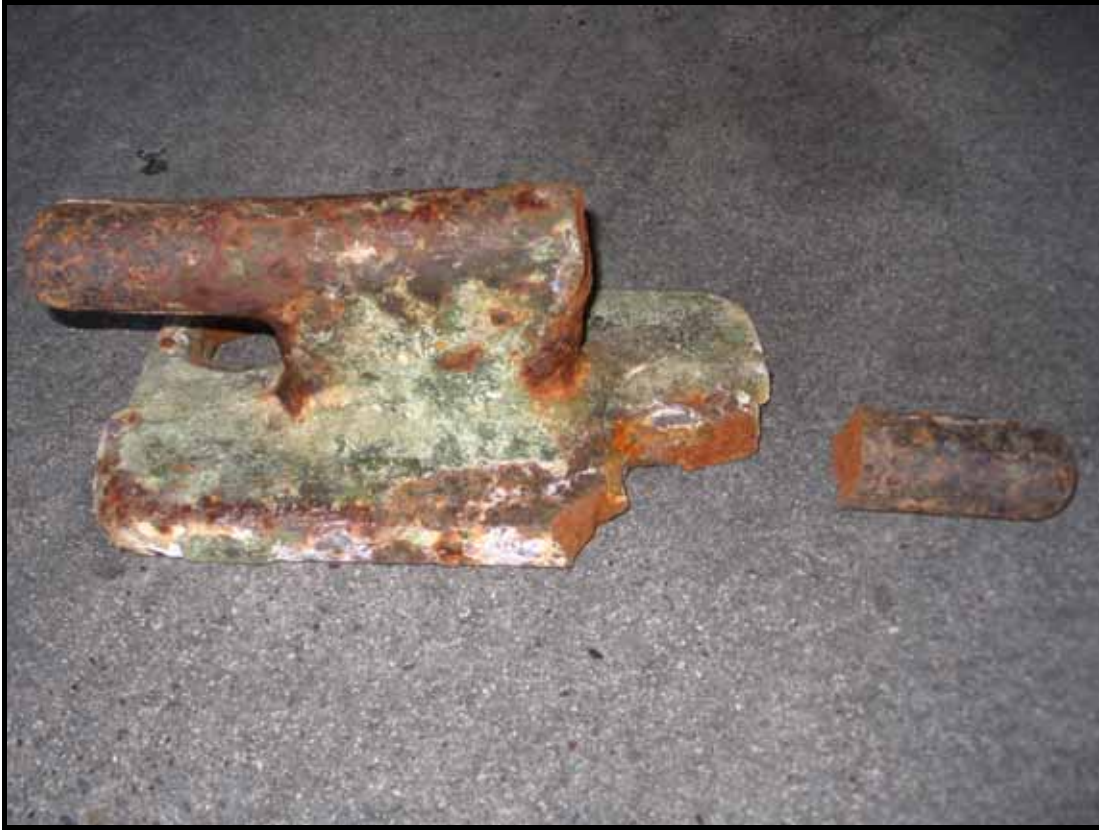
Photo 4
Mooring Cleat and Detached 'Horn'

- 3.1.4.9 When examined after the accident, it was found that one side of the cleats 'horn' had been broken off and the seaward corner of the base had broken off across the bolt hole. The underside of the cleat's base showed evidence of pitting where it had been in contact with the treated timber to which it was affixed. It is likely that there has been a cathodic reaction between the cast iron cleat and the copper present in the treated timber.

- 3.1.4.10 The rear bolthole was found to be oversize (approximately 30mm, compared to the normal 22mm for a 20mm bolt). This is probably due to corrosion caused by a cathodic reaction from the cast iron being in contact with the treated timber or the bolt, which was constructed of a dissimilar metal. Another possibility is that the bolt hole was oversize for the 20mm bolt when the cleat was first fitted and that the gap was obscured by the washer below the nut.

- 5.1 It is recommended that the Department of Conservation replace the remaining cleats of the same type on Motuihe wharf as a matter of urgency. *In commenting on the draft report DOC stated that they had engaged their consulting engineers to carry out an unscheduled inspection of the cleats and bollards with a view to the removal and replacement of suspect items. DOC are also further discussing with their consulting engineers a new design and fabrication of a mooring point/cleat/bollard fixing method that will withstand the rigours of use and corrosion.*

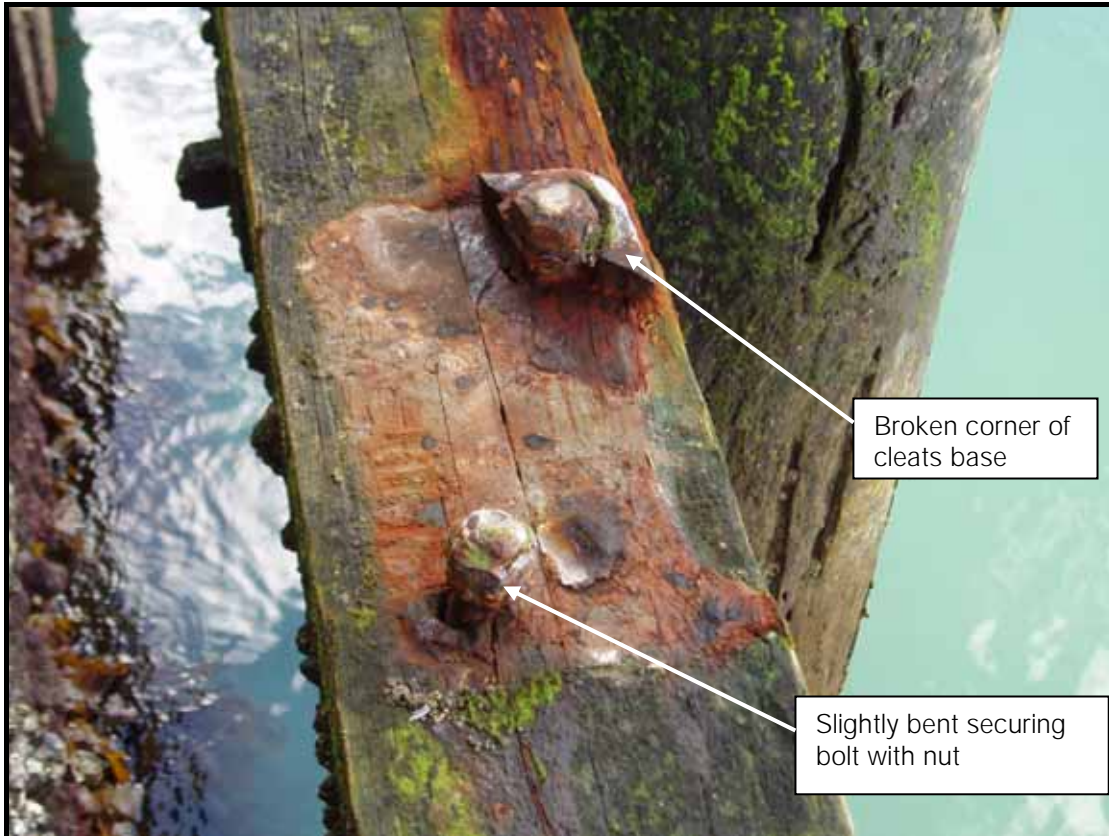
Photograph 5
Cleat's Position Prior to Failure

- 3.1.4.12 The corrosion around the bolt hole probably allowed the cleat to be pulled over the bolt's nut and in doing so breaking the washer. The lifting of the rear of the cleat placed stresses on the casting causing the seaward corner, which was still effectively attached by its bolt, to fracture. This corner section of the base remained in position on the wharf.
- 3.1.4.13 The cast nature of the cleat's construction means that prior to the moment of failure; the cleat would not have given any indication of its impending fracture.

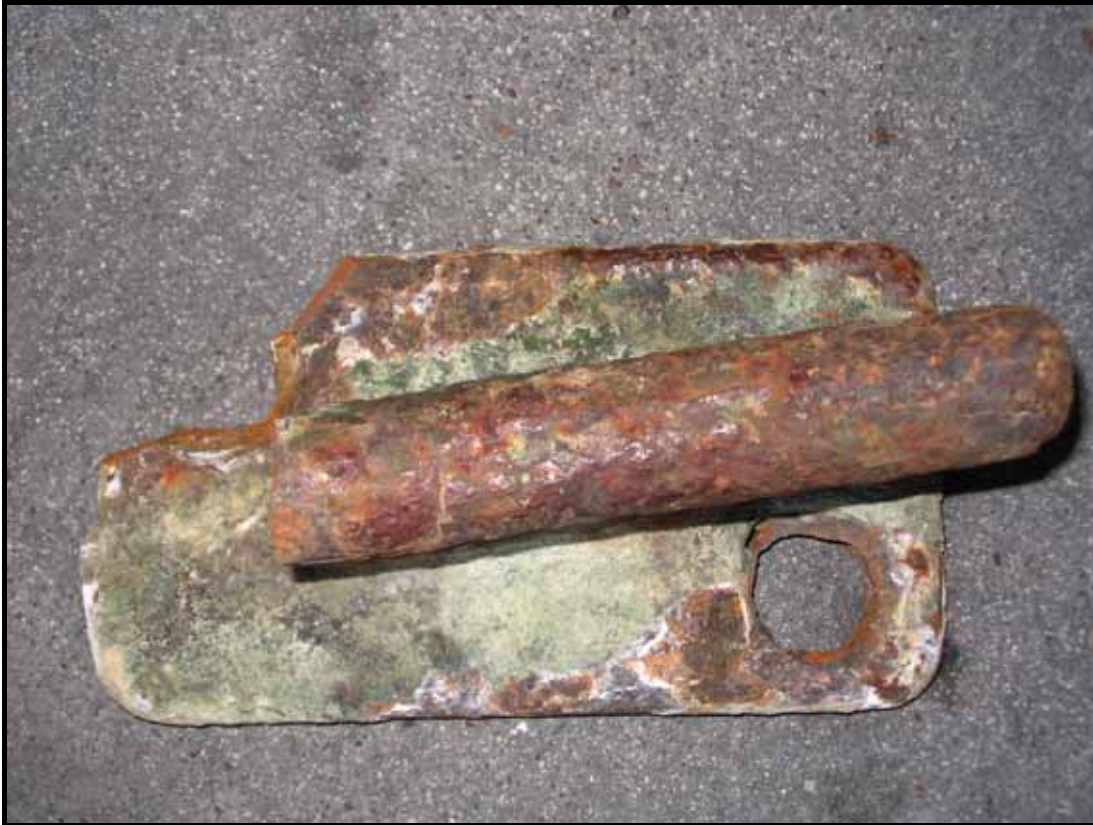
Photograph 6
Mooring Cleat Showing Corrosion Around Bolt Hole

- 4.1 The mooring cleat was able to be pulled off its bolts due to corrosion. This subsequently caused the cast iron to fracture.
- 4.2 The possible causes for this corrosion are the cathodic reaction between two dissimilar metals in seawater, either between the cast iron and the copper present in the treated timber to which the mooring cleat was affixed, or between the mild steel bolt and the cast iron. *In commenting on the draft report the Department of Conservation (DOC) stated it would bring Conclusions 4.1 and 4.2 to the notice of their consulting engineers and that they would be replacing all cast brackets with mild steel as per their consulting engineers inspection report.*
