Accident Report

Serious Harm
Kawau Kat III

16 September 2005

Kawau Kat III

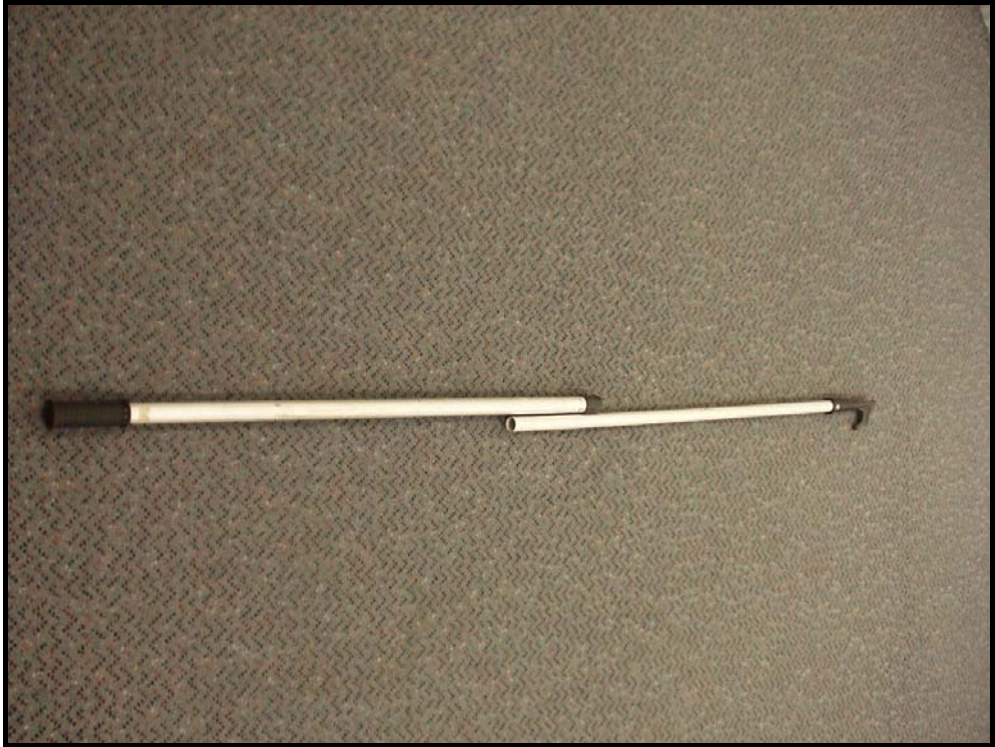
Figure 2
Photograph of Boat Hook

Kawau Kat III was equipped with a 212 cm long boathook pole. This was removed from the vessel during the investigation and on examination found to be defective. The hook comprises two sections of aluminium pole one of which extends from inside the other. The hook section is 116 cm in length. A twist lock mechanism is intended to prevent the two sections from extending or telescoping whilst in use. It was found the locking mechanism was defective and there was nothing to prevent the hook end of the pole from detaching from the other section. The last SSM company inspection form, dated 25

January 2005, indicated the boat hook was in good order. A senior crewmember stated he recalled using the boathook one week prior to the accident and found it to be in good order (See Figures 2 & 3 - Photographs of boathook). The cleat was constructed of stainless steel (See Figure 4 - Photograph of cleat).

Before being injured she made several attempts to use the boat hook whilst telescoped but found it extended further as she attempted to pull the line in. As she feared she would lose the hook end of the boathook she had to release the line. It was necessary for her to lie on her stomach to reach the line with the unextended boathook. Before the final attempt she partly extended the boat hook and bound the joining section with tape to prevent the hook end from sliding out. This was unsuccessful and she disconnected the two sections and used only the hook end section. She then succeeded in recovering the line from the water. As she was attempting to place the loop of the line over the cleat she heard the Master shout at her to get her fingers out. She stated she reacted “pretty much immediately” and attempted to pull her hand clear. When her fingers were caught she pulled hard. She stated that had she not reacted as soon as she did her injuries would have been more serious. She considered she would have been able to secure the line on the first attempt had the boat hook been working properly.

1. The company is severely censured for failing to ensure the boat hook was operational.
2. New crewmembers are carefully monitored even after completing training to ensure they are competent to safely operate line whilst berthing.
3. The danger of injury whilst berthing be listed in the hazard identification checklist
4. A requirement be incorporated in the crew training sign off sheet requiring all crew to read and understand the safety information in the SSM manual.
5. The company put in place procedures that provide for the utilization of wharf personnel to assist in handling lines in adverse conditions.
6. Maritime New Zealand publishes a safety bulletin on the hazards associated with crew handling berthing lines.

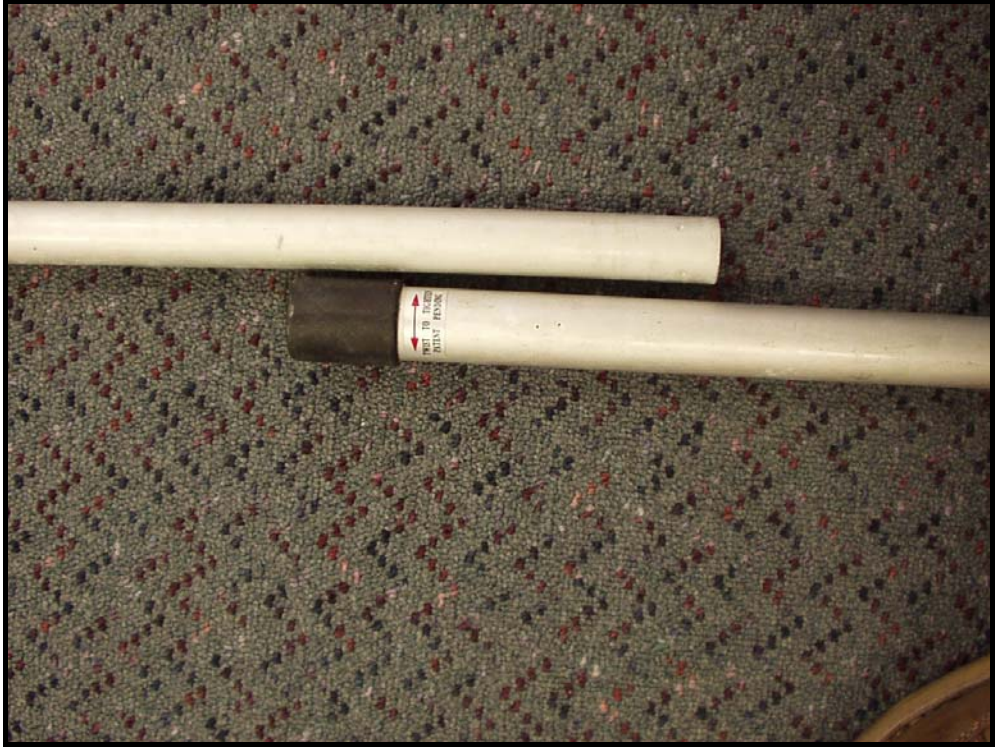
Figure 3
Locking Section

The Company failed in its obligations under the Health & Safety in Employment Act to ensure that plant commonly used in berthing operations, namely the boathook, was fully operational.

The defective boathook, whilst it may have compromised the ability of the Crewmember to secure the berthing line, was not the immediate or primary cause of the accident.

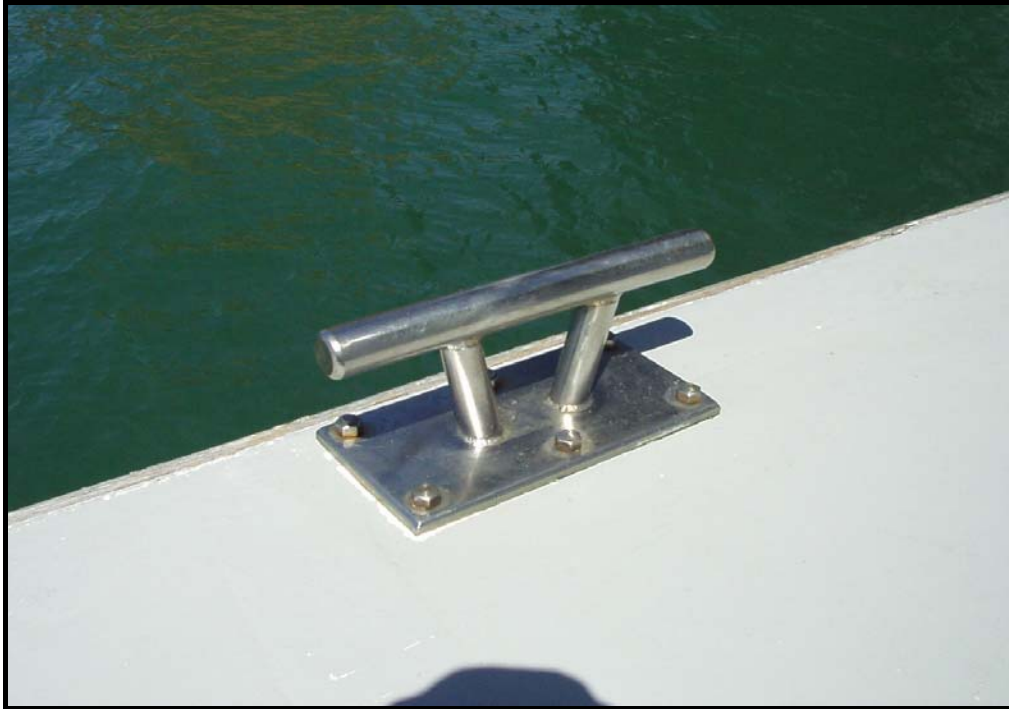
Figure 4
Photograph of Cleat

After a series of approaches, the Crewmember managed to secure the loop end of the line over the forward horn of the cleat. Whilst she was doing this vessel was blown off the face of the wharf and tension started coming on to the line. She attempted to secure the loop over the aft horn of the cleat. The Master shouted at her to remove her hand. The line tightened and her fingers were caught between the line and the cleat causing serious injuries.

The crewmember suffered a degloved distal phalanx left little finger and crush injury to her left ring finger. The little finger was amputated at the level of the DIP J (top joint). The ring finger was dressed. At the time of writing this report the injuries were healing well.
