# Accident Report

Collision

*Torea II & Lady Anna*

16 October 2005

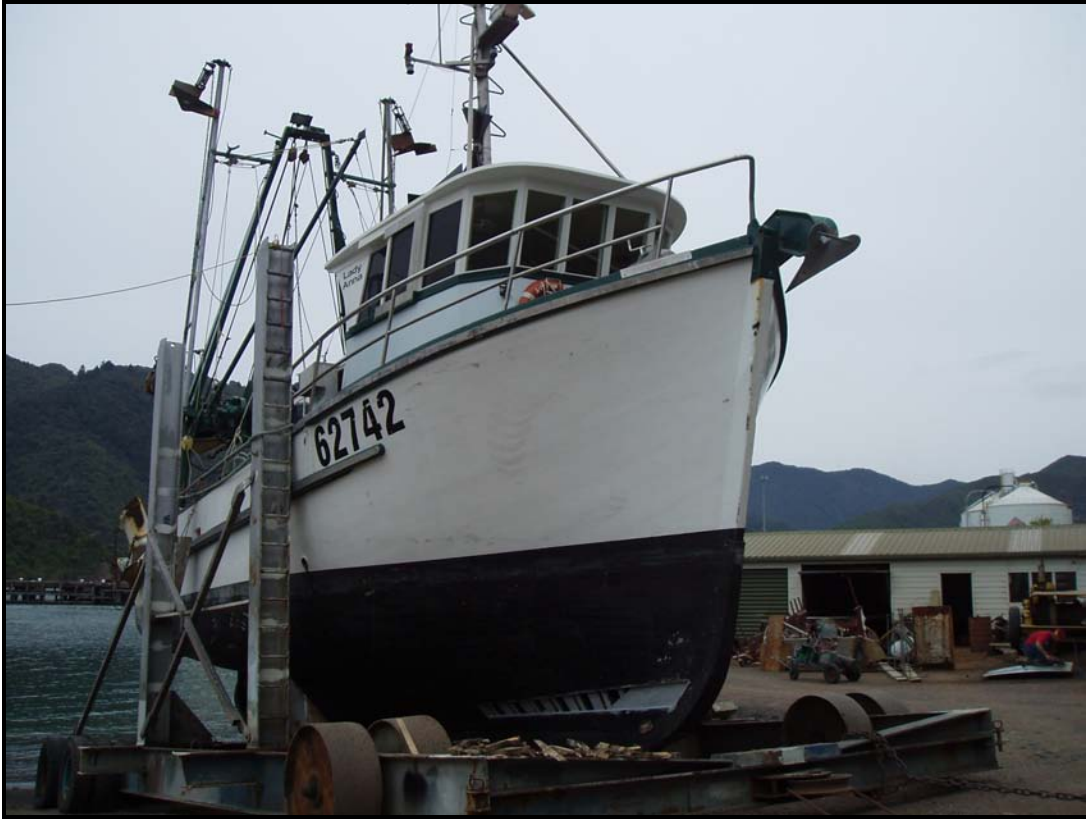
Photograph 1  
*Lady Anna*

On collision, the stabiliser arms of both vessels made contact with each other causing damage to both vessels.

At 0220 hours, as Deckhand 2 and the Skipper returned to the wheelhouse, the two vessels collided. The stabiliser arm of **Torea II** struck a handrail forward of the wheelhouse and afterwards their own stabiliser arm. The two Skippers yelled at each other across the gap between the two vessels. They then hauled their respective trawl nets and returned to port for repairs.

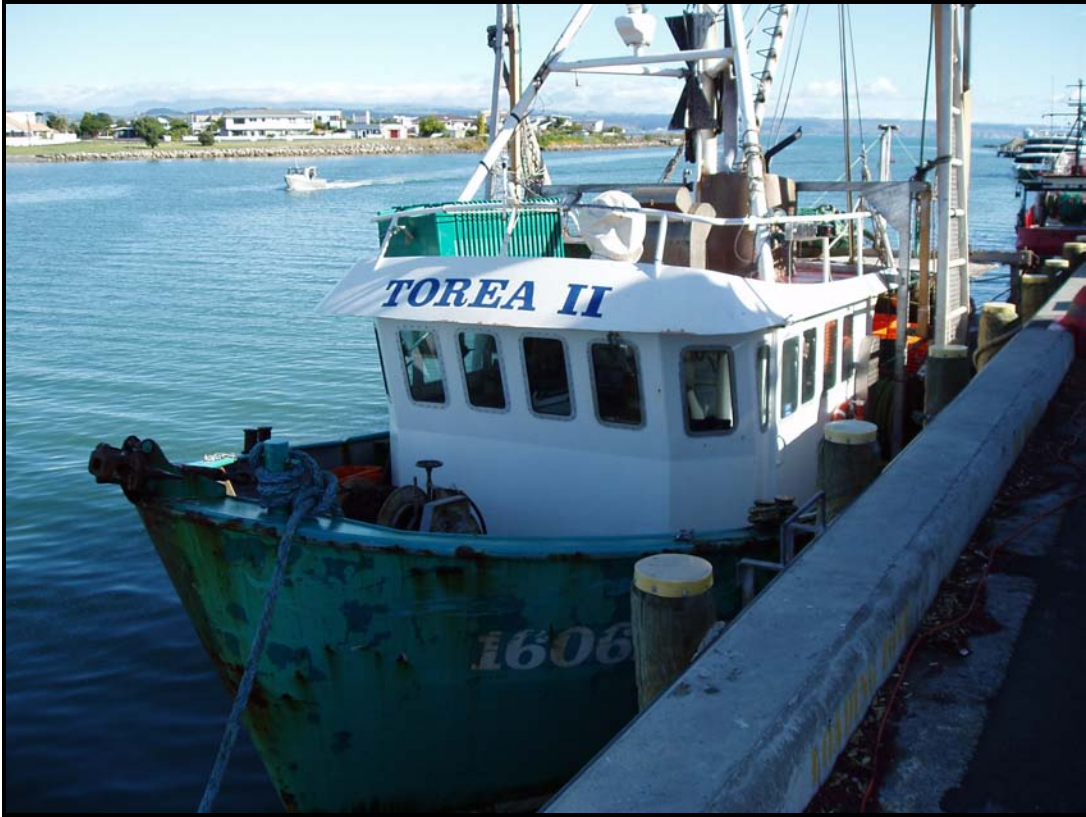
Photograph 2  
*Torea II*

As the Skipper was climbing out of the engine room into the wheelhouse, he heard the low level watch alarm sounding. The low level alarm activates automatically if the alarm has not been reset, after a period of 14 minutes. He had reached the top of the ladder leading from the engine room, when the collision occurred. The Skipper immediately took the engine out of gear and ran out on deck. He looked up and saw the stabiliser arm belonging to *Lady Anna* striking the aerial 'A' frame on the monkey island of *Torea II*. The arm damaged the VHF, SSB and cell phone aerials. The stabiliser arm of *Torea II* struck the handrail of *Lady Anna* and then their stabiliser arm. The speed of each vessel on impact was about three knots.

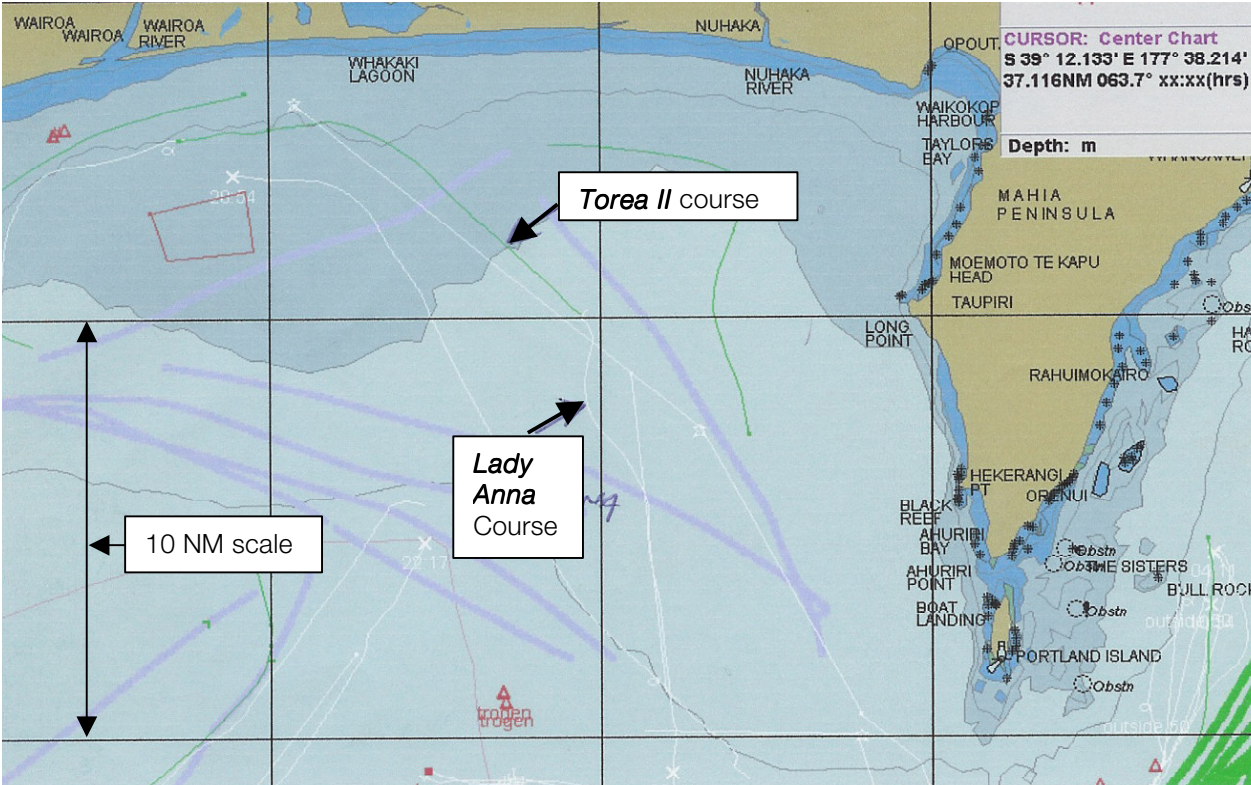
Up to the time of that Deckhand 2 first altered course to port, **Lady Anna** would have been showing her red sidelight (See *Figure 1*). Accordingly, if the Skipper of **Torea II** did see a green sidelight, it must have been after the Deckhand altered course to port at which time, **Lady Anna** would have been under 5 miles distant and not 6 NM as he has stated (See *Figure 2*). By leaving the bridge unattended, the Skipper breached **Maritime Rules Part 31.16 – Watchkeeping Standards and 22.5 - Look out**.

Figure 1  
Figure 1 above is the combined electronic plotting chart from both vessels. The track of *Torea II* is displayed in green and the track of *Lady Anna* in white. The scale of the grid is 10 NM in this instance.

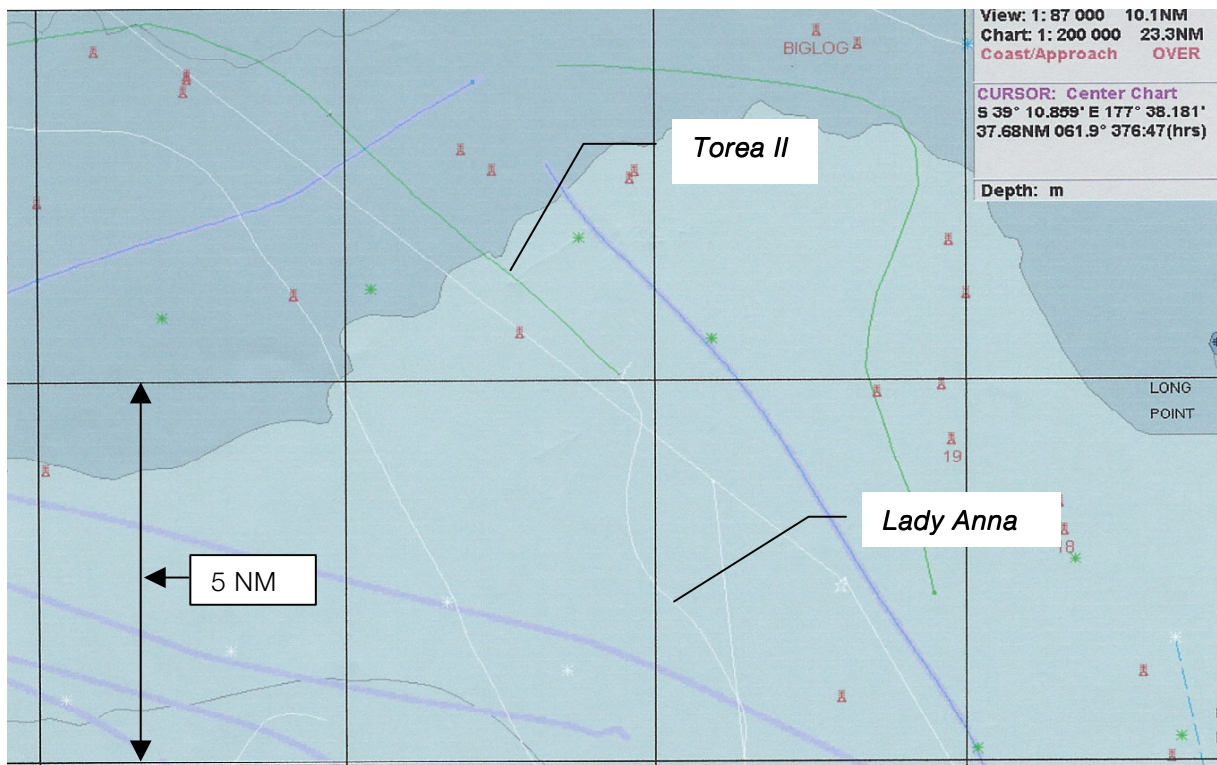
**Figure 2**

Instead, Deckhand 2 altered course to port when the two vessels were less than 5 NM apart. Reference to *Figure 2* shows that when the two vessels had closed to a distance of about 2½ NM, Deckhand 2 altered course to starboard. By reference to *Figure 3*, it can be seen that he altered course to port again when the two vessels were under 1 NM apart. This had the effect of bringing the two vessels into a head on or nearly head situation that subsequently resulted in the collision occurring.

Figure 2 above chart is displayed on a 5 NM scale. This shows **Toreia II** holding an almost constant straight course. The course of **Lady Anna** shows that she altered course to port approximately 5 NM before the collision point. Deckhand 2 states he put 20° of port helm on the automatic pilot. The pilot would then bring the helm back to 0°. After a time, Deckhand 2 would re-apply another 20° of port helm. This is illustrated in the white course above.

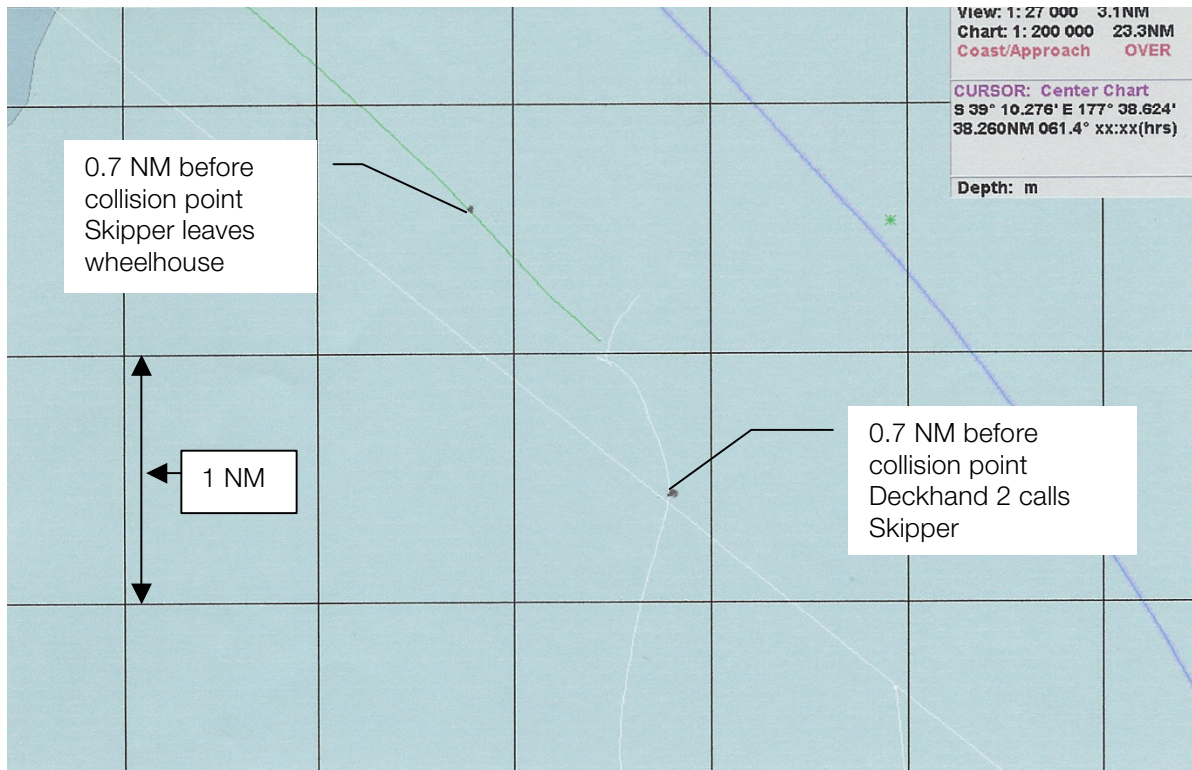
**Figure 3**

Figure 3 above is displayed at a scale of 1 NM. The points marked on each track line are at 0.7 NM before the collision point. *Torea II* continued on a straight course. The track of *Lady Anna* shows an alteration to port shortly after Deckhand 2 would have returned to the wheelhouse after waking the Skipper.
