Class B Non Serious Harm Accident Report

# **Lady Marie**

# **Injury**

## **REPORT NO: 96 323**

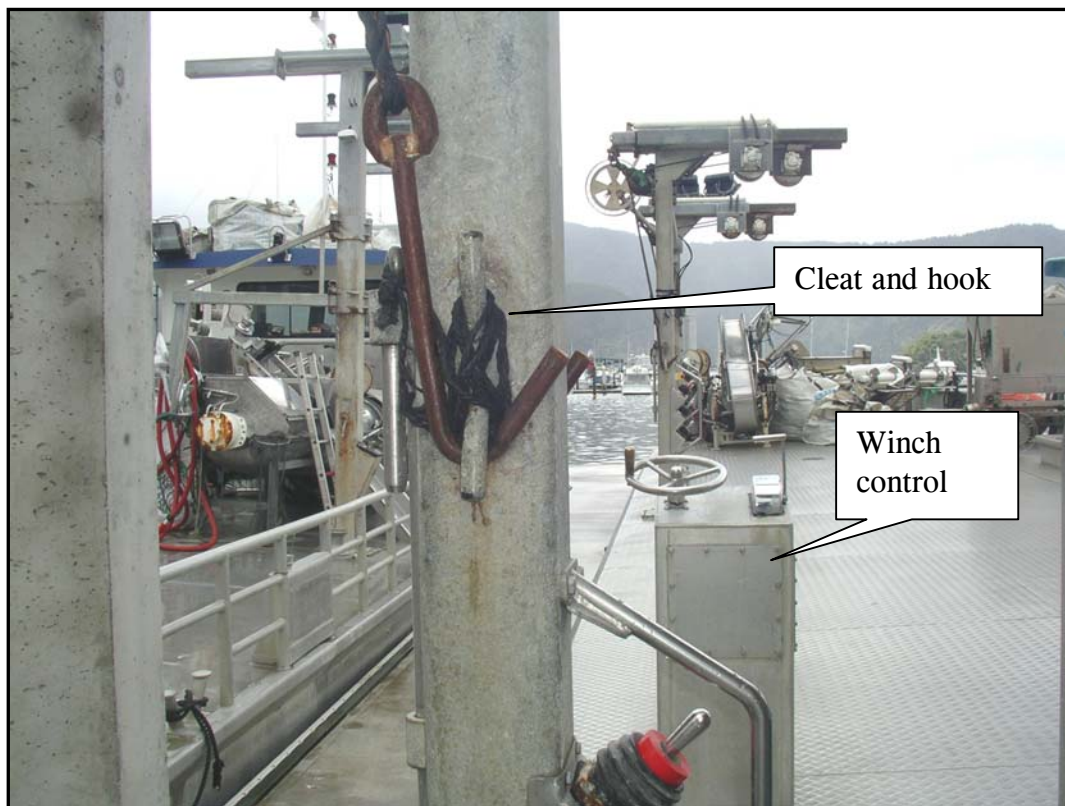
Deckhand One placed the hook from the aft gantry over the rail on the wharf, put the rope around the gantry cleat using his left hand and reached out with his right hand to take the slack up using the winch. This would secure the vessel against the wharf.

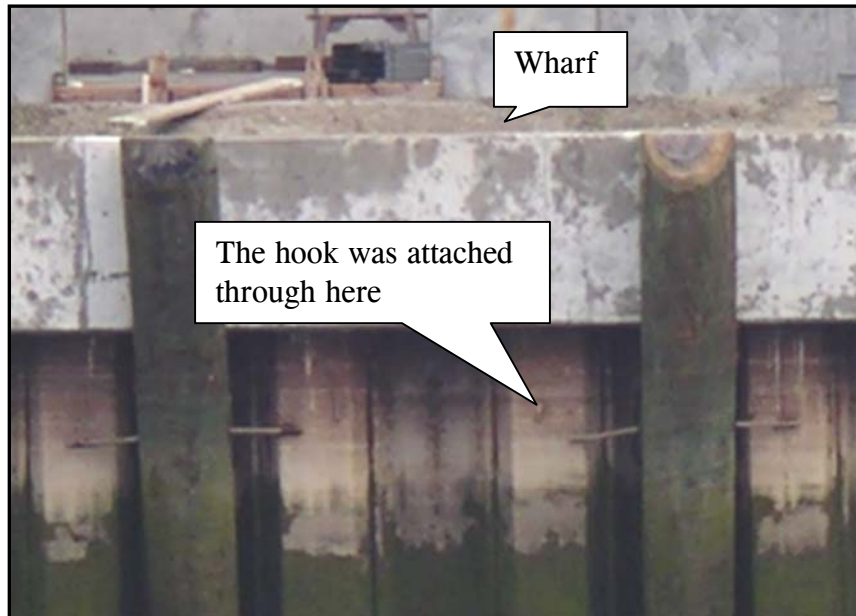
At the same time as he activated the winch to take up the slack, a gust of wind hit the vessel and moved it away from the wharf. Deckhand One had not removed his fingers from the vicinity of the cleat and they got caught between the line and the cleat as the wind pushed the vessel away from the wharf and the winch took up the slack. He cried out and then pulled his fingers clear of the cleat.

*Photo showing where Deckhand One was holding the line before the accident  
(note: at the time Deckhand One was holding the line with his left hand)*
