Incident Report
Close Quarters
MOL Wellington & Chips
7 September 2005
Class C

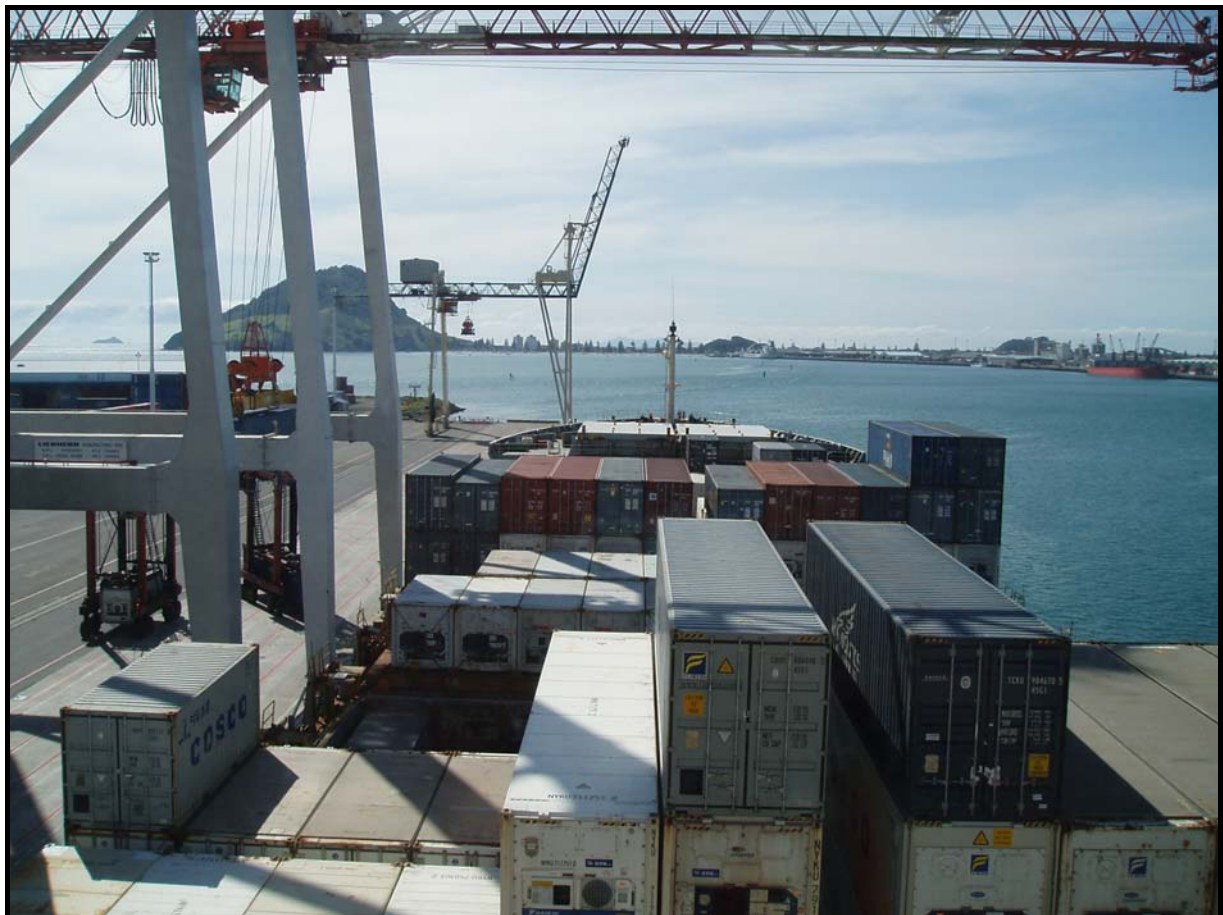
Photograph 2

The Able Seaman was steering until the Second officer changed the steering mode to autopilot, after which he stood by the helm to monitor the course and to keep a lookout. Both Second Officer and Able Seaman stated that they did not see any small boats near their ship. From the bridge of **MOL Wellington** there was clear visibility on both sides and of the sea beyond about 300 m ahead of the ship (See *Photograph 2*).

View from the wheelhouse of **MOL Wellington**

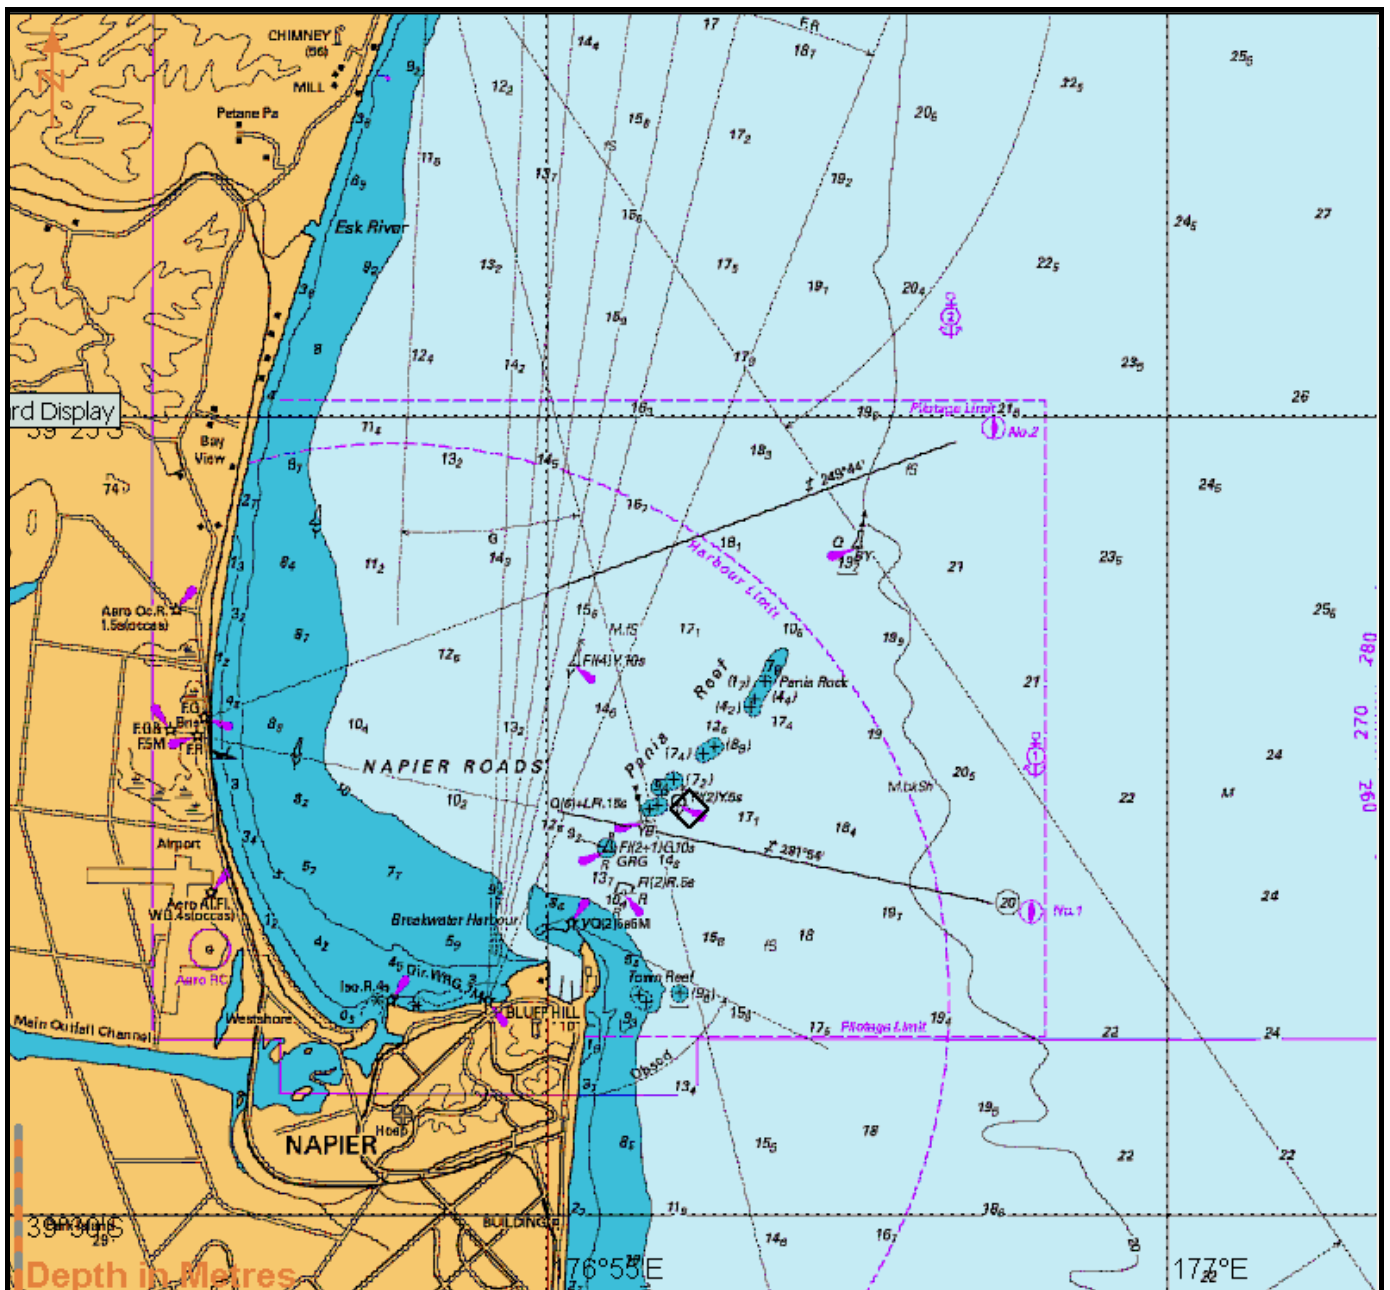
Figure 1
Chart Extract – Approaches to Napier

At 1500 hours, *MOL Wellington* was in a position with the north cardinal buoy (39° 25'.8 S 176° 57'.6 E) bearing 072°(T), distant 1.3 miles (See *Figure 1 – Chart Extract*). The engine order full away was given and the vessel's speed began to increase from 12 knots to 19 knots, a process that would take about an hour.
