Accident Report
Gas Inhalation
Marlborough River Queen
9 June 2007
Class B

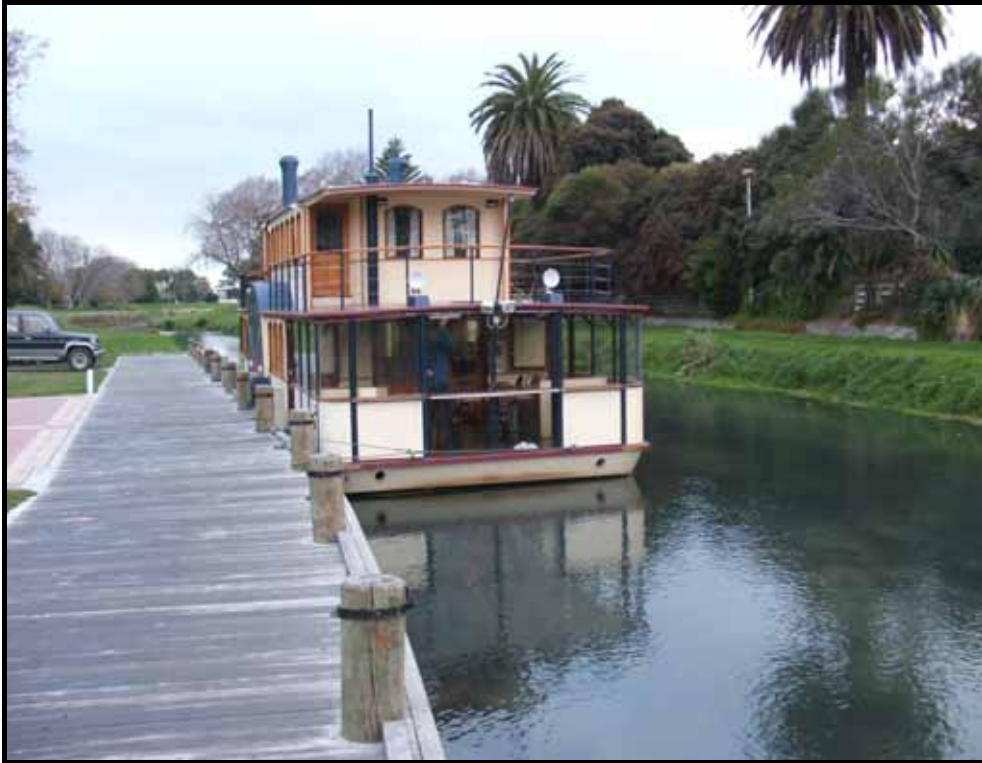
Both outboard engines are mounted on a false transom and are completely enclosed with a non structural wall on three sides. The aft wall has a pipe passing through it for passive venting only.

Both engines have external fresh air ducting but did not have any means of forced extraction of the exhaust gases to the outside atmosphere.

Figure 2
Vessel alongside berth, note two passive vent holes in the stern.

1. On 11 June 2007 the Owners were issued with a Prohibition Notice requiring the operation to cease until the following were complied with.
 - Install powered extraction fans in each of the engine housing units
 - Install fresh air ducts to vent the aft deck area.
 - Install a gas detector in the galley/bar area.
 - Seal the under seat access hatches to the fuel tank storage area.
2. The above was complied with on 14 June 2007.
3. It is recommended that a guidance notice to be sent out to all Safe Ship Management Companies and Maritime New Zealand Safety Inspectors to highlight the need to check this issue in any other vessels of a similar configuration (*See Appendix 1 – Guidance Notice*). *This recommendation is in progress.*

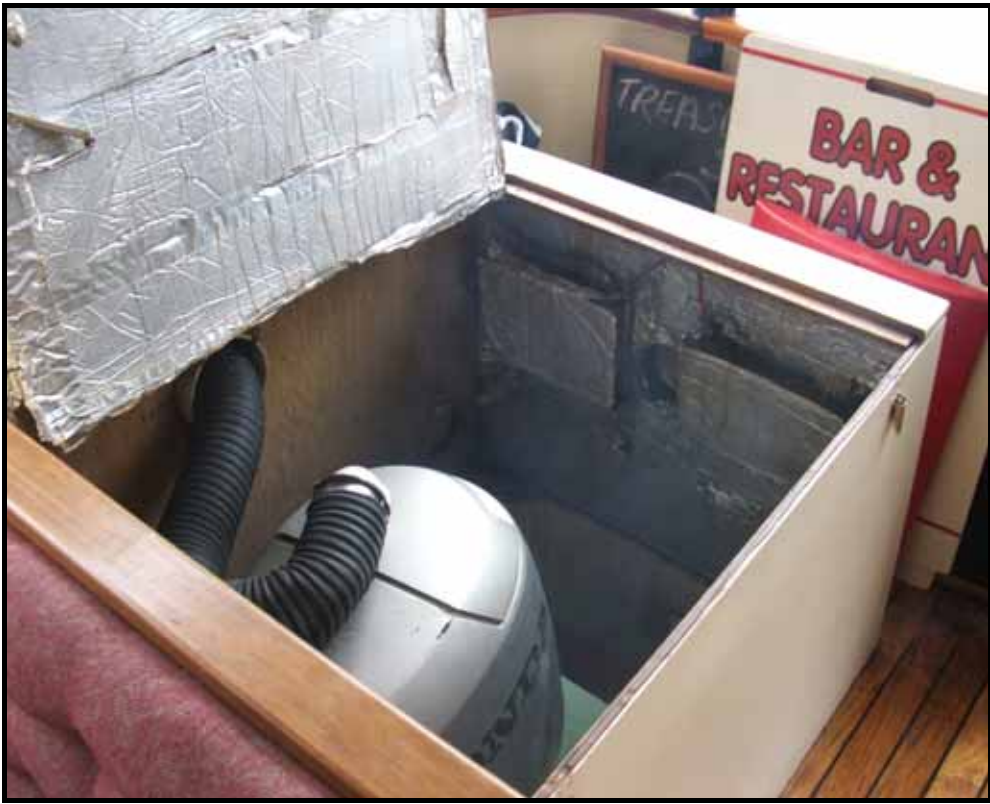
Earlier in the evening the starboard engine had shut down. When the crew member checked it he found that the fresh air ducting to the engine had vibrated off. Suspicions were not raised at this time as to why the engine had stopped.

Figure 3
Starboard engine configuration.

The vessel was tested using a calibrated gas detector. It was found that the two outboard engines were feeding exhaust gases into the passenger space at low speeds.
