Accident Report

Matakana

Capsize

Totaranui Beach, Abel Tasman National
Park on 1 September 2004

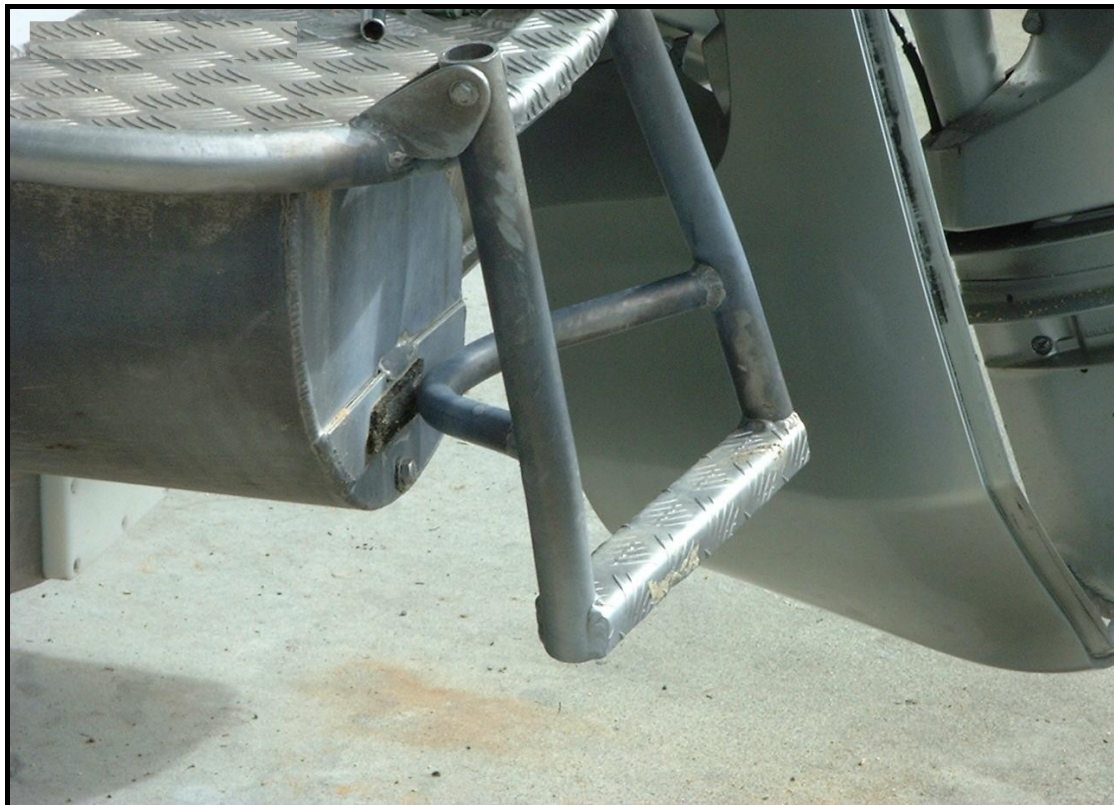
PHOTO 2 – DAMAGED BOARDING LADDER

- 1.18** Shortly after this a third wave struck the bow lifting it and lowering the stern where the port quarter boarding ladder struck the seabed. The vessel then started to capsize, turning over through an arc of 90° in a fore and aft direction and ending up resting on the radar stand, on the bottom, about 8-10 metres from the shore.

In reply to the above, the Skipper stated that as the boat rolled over to rest on the radar arch, the motor was never fully submerged. Further, that the stern of the vessel was lying on the beach and not 8-10 metres as stated above. To have been 8-10 metres offshore would have meant the vessel was floating in about 3 metres of water at the height of tide at the time of the incident. For the vessel to roll onto its side would require the pontoon to be grounded. It was at this time that the boarding ladder was damaged.

In commenting on the draft report, Passenger 1 stated that “Based purely on mechanics and the design of the craft, if this was the case; because of the length of the boarding ladder when compared to the depth of the engine or the hull at the stern of the vessel, the angle the bow would have to be lifted or the stern lowered for this to occur would have to be almost vertical.”

2.6.3 After the Skipper had anchored the vessel using the bow anchor he started to embark the passengers. During this process a number of large waves acted upon the bow of the vessel. The wind also acted on the port quarter, essentially pushing the stern to starboard. This presented the starboard bow to the incoming waves. As the bow rose the port quarter lowered which in turn dug the boarding ladder into the seabed enabling the wave to turn the vessel over (*See Photographs 2, 3 & 4 – Damaged Vessel*).

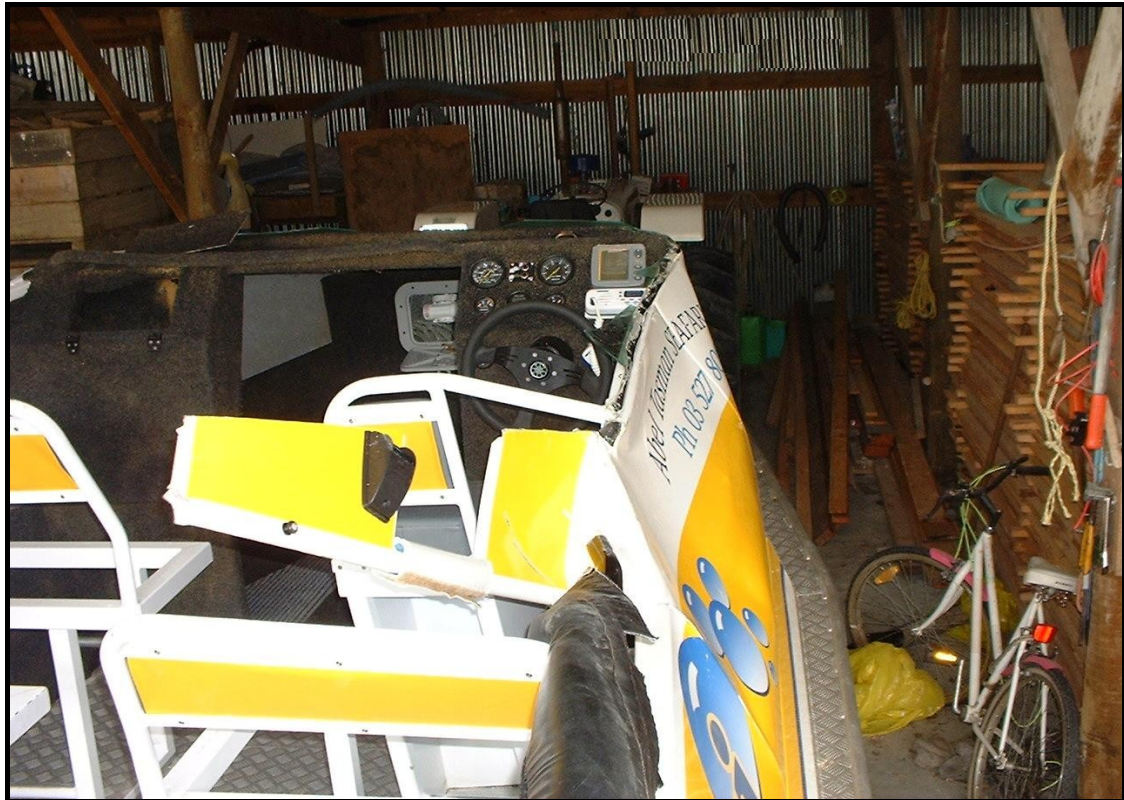
PHOTO 3 – DAMAGED VESSEL

In commenting on the draft report, Passenger 1 stated that whilst accepting some damage was caused by the salvage of the vessel, it was quite obvious, in his opinion, from the photographic evidence that the majority of the damage was occasioned during the accident. He questioned whether the damage had been blamed on the salvage excavation in an effort to minimise or cover up the forces that impacted on the vessel during the accident (See Appendix 2 – Photos 2 - Photographs of damaged vessel taken some time after the capsizing).

In reply to the above, the company stated that the water damage to the vessel and the damage to the window screen and radar arch was caused directly as a result of the accident. The damage to the port and starboard pontoons was sustained during the salvage of the vessel. The company stated that this was confirmed by staff and the digger driver who were present during the course

of the salvage and is supported by the attached photographic evidence to the report. Appendix 2, photograph 1, starboard side backs up this evidence as no damage can be seen pre-salvage. Photographs 3 and 4 show the post salvage damage to the vessel.

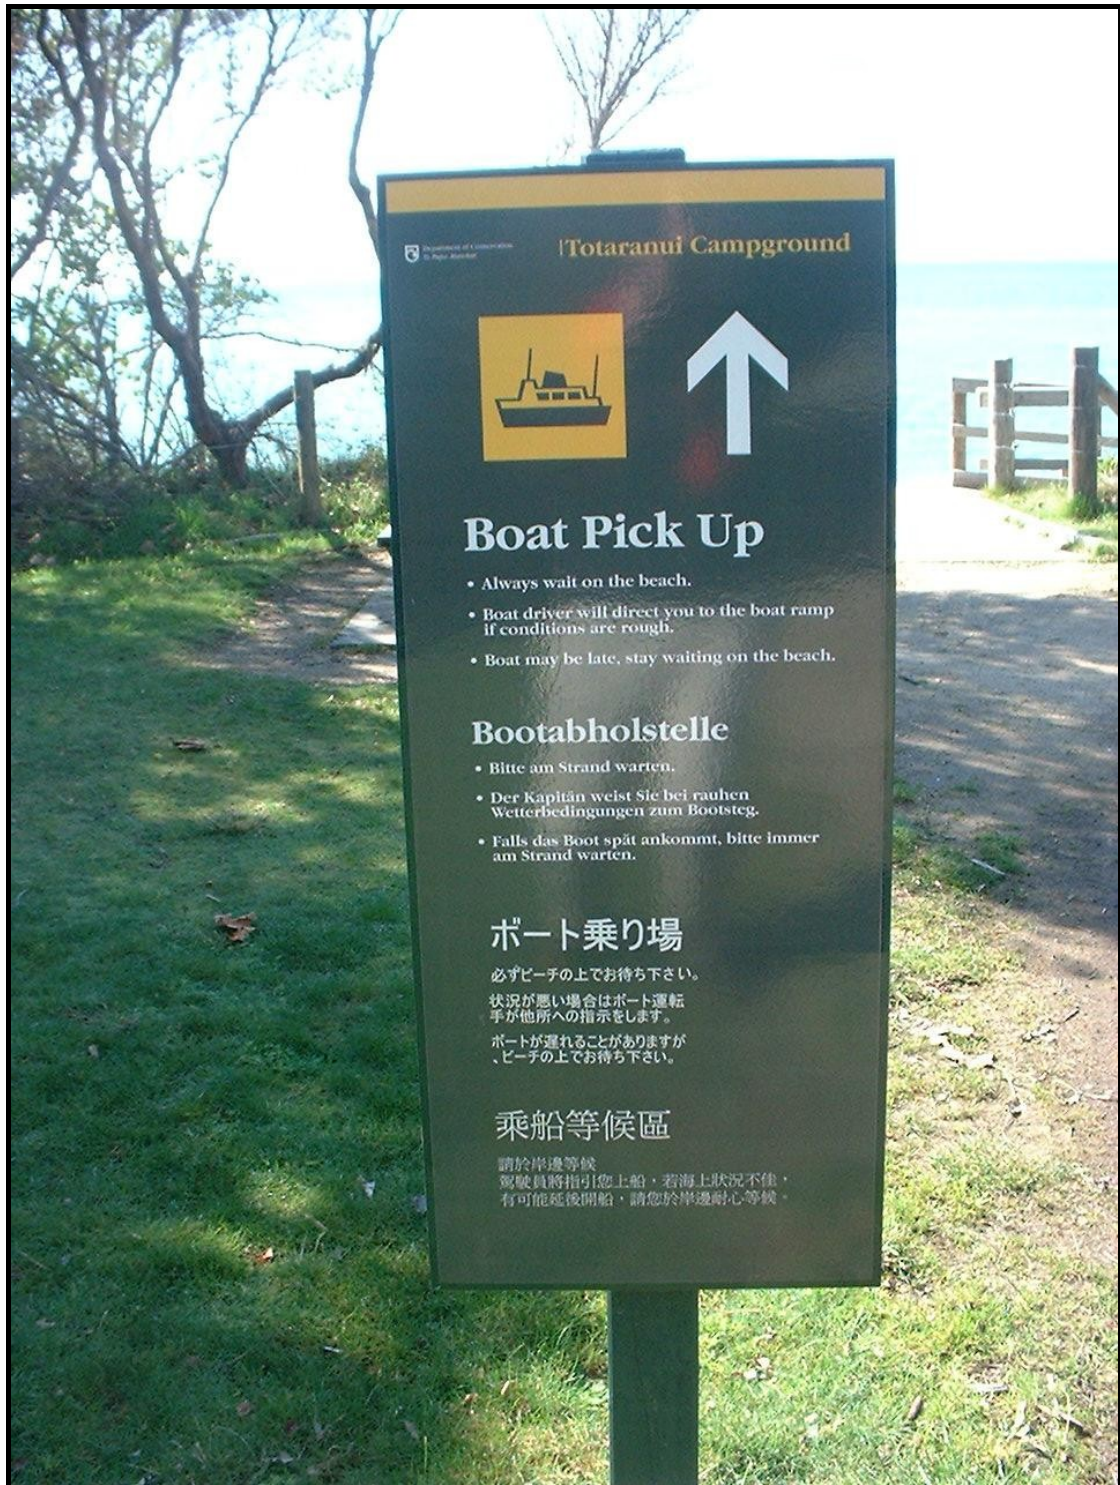
PHOTO 5 – SIGN

- 3.2** The Skipper was complacent when deciding his pick-up point. There is a boat loading sign ashore at the Information Centre, which directs passengers onto the beach for pick-up. This sign states that the Skipper may direct them up the beach (northern end) for safer embarkation (*See Photograph 5-Photograph of sign*). The company's Training Manual could have made it clearer that in swell conditions/heavy weather, landings should not be attempted except at the northern end of the beach, where some lee would have been afforded to the vessel.

- 5.1.3** The Skipper should have indicated to the passengers on the beach to move further up the beach nearer the ramp, where there was some lee from the swell conditions. The sign at the Information Centre informed passengers that they could be asked to move by the Skipper if the weather conditions were poor.

- 5.2.5** It is recommended that Aqua Taxis amend their Training Manual to reflect the fact that during periods of heavy weather and on the basis that a landing can still be safely executed, these should be restricted to the northern end of the beach at Totaranui and not also to the Information Centre as is currently stated.
