Class B Accident Report

# Melilla 201

# Man Overboard

## **REPORT NO: 04 3607**

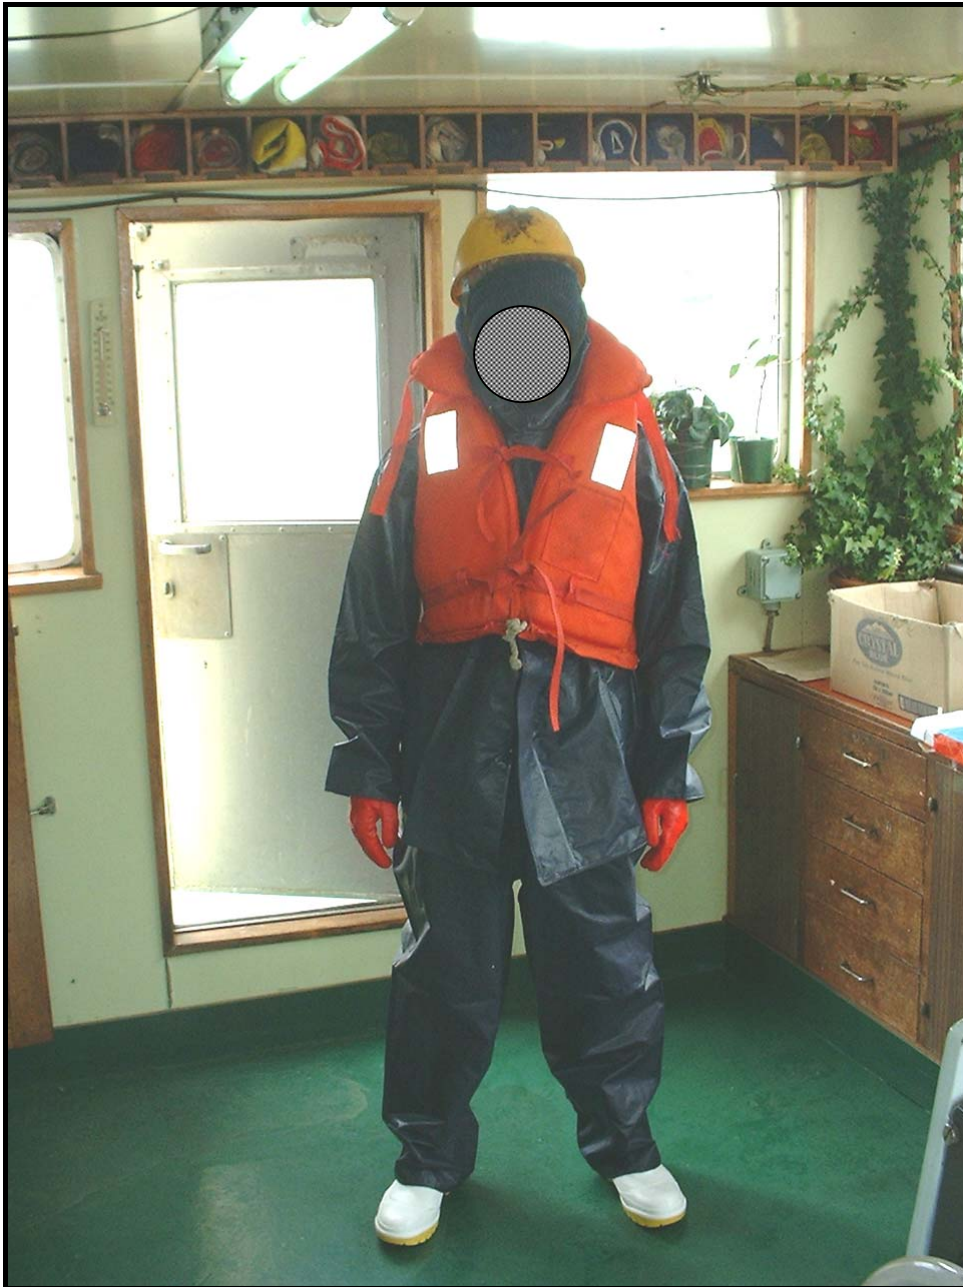
**DECK GEAR AS WORN BY DECKHAND 1.**

When comparable New Zealand deep-sea fishing vessels operate in a similar area, the deck crew wear a lifejacket with a head support and a salt water activated lifejacket light. When on deck in very poor weather deck crew also are attached to a retractable safety line.

The Owners provide retractable safety lines for all deck crew when working on deck in rough weather.

The Owners provide salt water activating lifejacket lights for all deck crew lifejackets.
