Accident Report

Foundering & Loss of life

Mi Jay

Report Issued on 4 June 2008

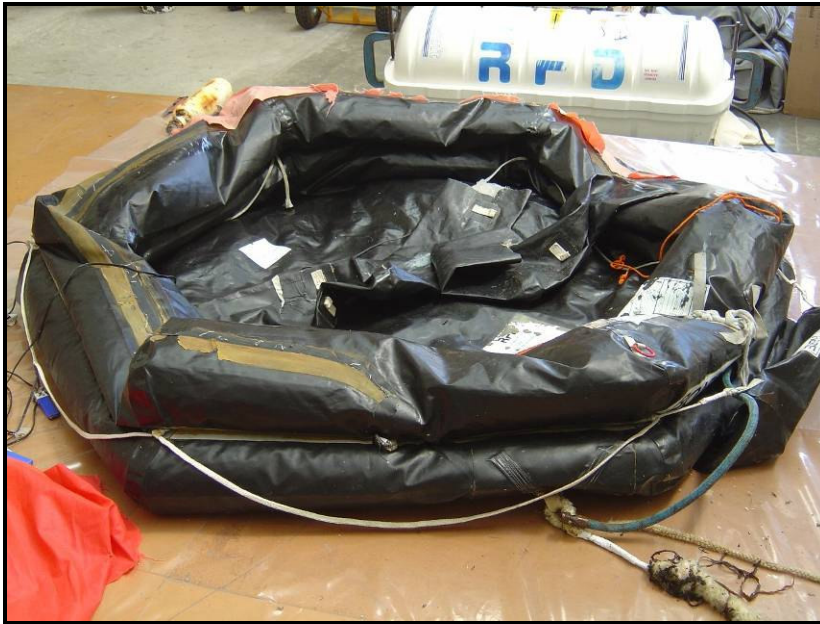
RFD Report Photograph 1

On inspection, both buoyancy chambers were found to be partially inflated with no sign of damage to either (Photo 1). The firing head was in the fully activated position, with the cylinder valve open, and subsequent weight checks proved the cylinder to be empty. This showed that the liferaft had been deployed and had inflated successfully on deployment. The subsequent loss of gas from the buoyancy chambers would be due to two main factors. Firstly, the arch tube had been severed relatively cleanly almost in its centre, (Photo 2) allowing gas to escape from the arch and then from the top buoyancy chamber via the non return transfer valve. Secondly the lower buoyancy top-up valve plug had become detached from its retaining cord and was lying in the bottom of the raft. This may have allowed gas to leak back through the top-up valve allowing the lower chamber to deflate gradually. (This process would have been very slow and adds weight to the liferaft having been afloat for some considerable time.) In addition to these two factors neither of the relief valves had been plugged, and the plugs were not in the raft, though they were recorded as present in the equipment pack at the raft's last survey (Appendix 1). All external life lines were intact, but the internal line had been severed in two places. Both lighting batteries were still attached to the raft body.

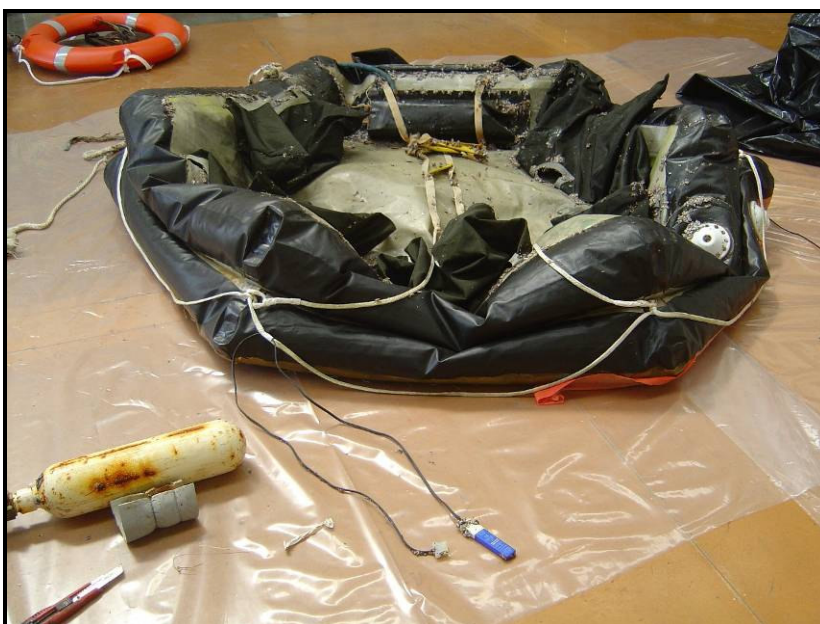
RFD Report Photograph 3

The floor of the raft was intact, with the exception of two holes which had been intentionally made to allow the raft to drain before being lifted on board when found. All the water ballast pockets and righting ladder were intact.(Photo 3)

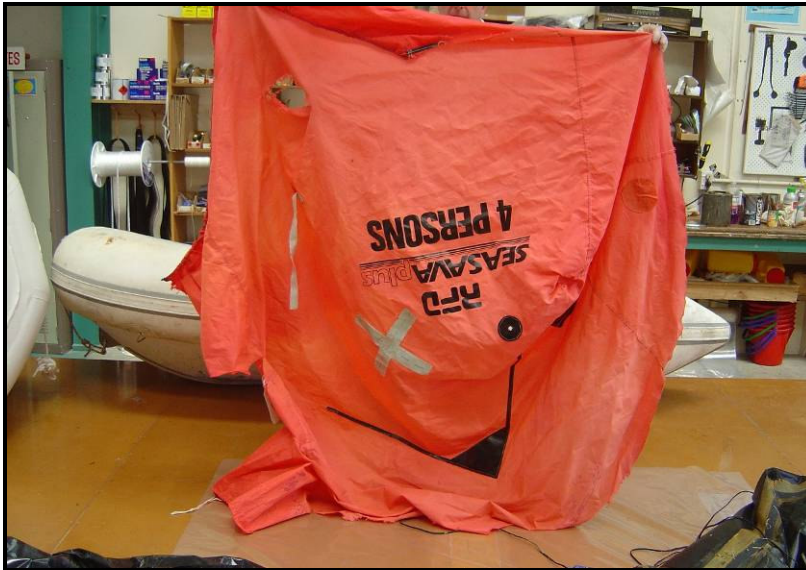
RFD Report Photograph 4

The canopy had been removed from the raft completely (Photo 4). The material appeared to have been cut initially for approximately half the canopy circumference, and then subsequently torn from the raft. This assumption was reached due to the canopy material still attached to the raft on one half, the other half had pulled off cleanly with the glued strip still in place on the canopy (Photo 5). The wires for the lights had been severed and both lights were missing.

- 7. The liferaft had been successfully deployed and had stayed afloat for some considerable time despite being severely damaged. It appears that the canopy had been deliberately removed and the arch tube severed by a relatively sharp object. The damage to the arch tube would have resulted in a large loss of gas from the upper buoyancy chamber, reducing the rafts freeboard, and reducing the amount of shelter offered by the buoyancy tubes. The rigidity of the raft would also have been compromised. The canopy is designed to provide a fully enclosed, sheltered environment in which survivors can shelter. Removal of the canopy would leave the rafts occupants open to the elements with all the associated risks. It also removes the main means of collecting rain water for drinking, as well as a large measure of security for both occupants and equipment.*

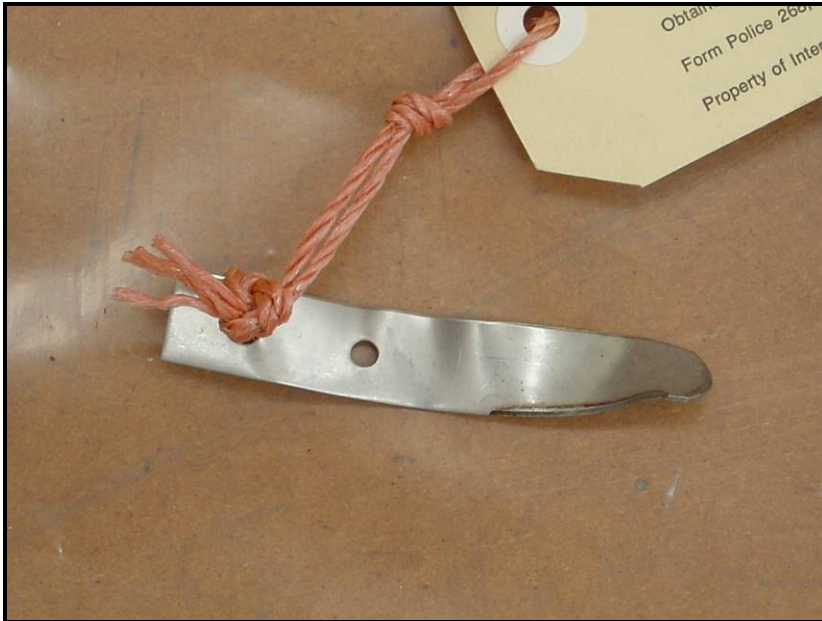
RFD Report Photograph 6

The blade of the safety knife would normally be riveted to the handle, but in this case, only the blade of the safety knife remained, the handle and retaining lanyard were missing. This and the shape of the blade led me to believe that the knife had been used extensively. (Photo 6)

- 9. The safety knife blade had become detached from the handle. As mentioned earlier, due to the appearance of the blade, I can only speculate that the knife had been used extensively and had broken due to the application of excessive cutting force. This suggests that the knife may have been used to cut the arch tube as well as the canopy.*

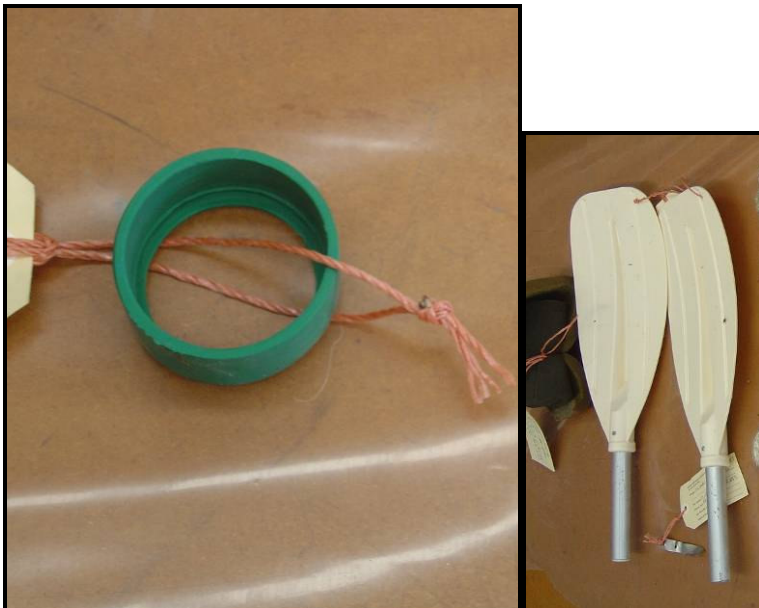
RFD Report Photograph 7

The only items remaining from the equipment pack were the lens retaining ring from the torch (Photo 7), and the two paddles (Photo 8). There was no evidence of any other equipment or the emergency equipment bag itself.

- 10. Most of the emergency equipment was missing. The equipment bag is tied securely to the raft during survey, and should remain so even when the liferaft is used, with equipment being removed from the bag, and then (if necessary) replaced and the bag re-tied. If this was not done, and with the liferaft canopy removed, the contents of the emergency pack would have quickly been lost overboard, especially in a rough sea. The presence of the torch lens retaining ring indicates that the occupants opened the emergency pack at some point.*
