Accident Report

Grounding

Milford Mariner

18 September 2005

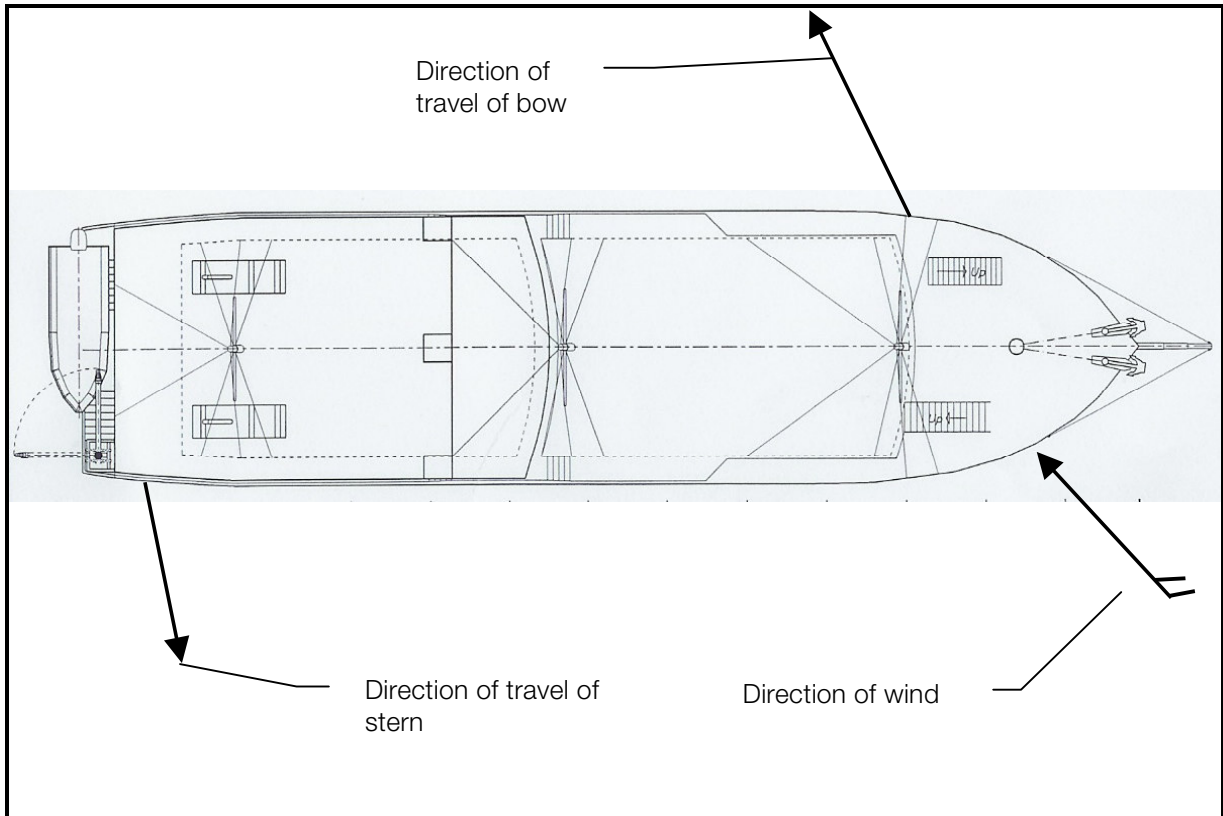
If the main engines stalled because astern was engaged while the vessel was travelling at about 8 to 10 knots, then the stern of the vessel would tend to weather cock and the bow would fall away to port due to windage at the time acting on the starboard bow. The combination of both the above would allow, if unchecked, a sheer to port.

Figure 2
 Diagram of approximate movement of vessel after both main engines stall.

The above illustrates the effect the wind had on the stern when the main engines stalled. The wind was acting on the starboard side of the vessel; this caused the port bow to move to port as speed fell away after the stall.

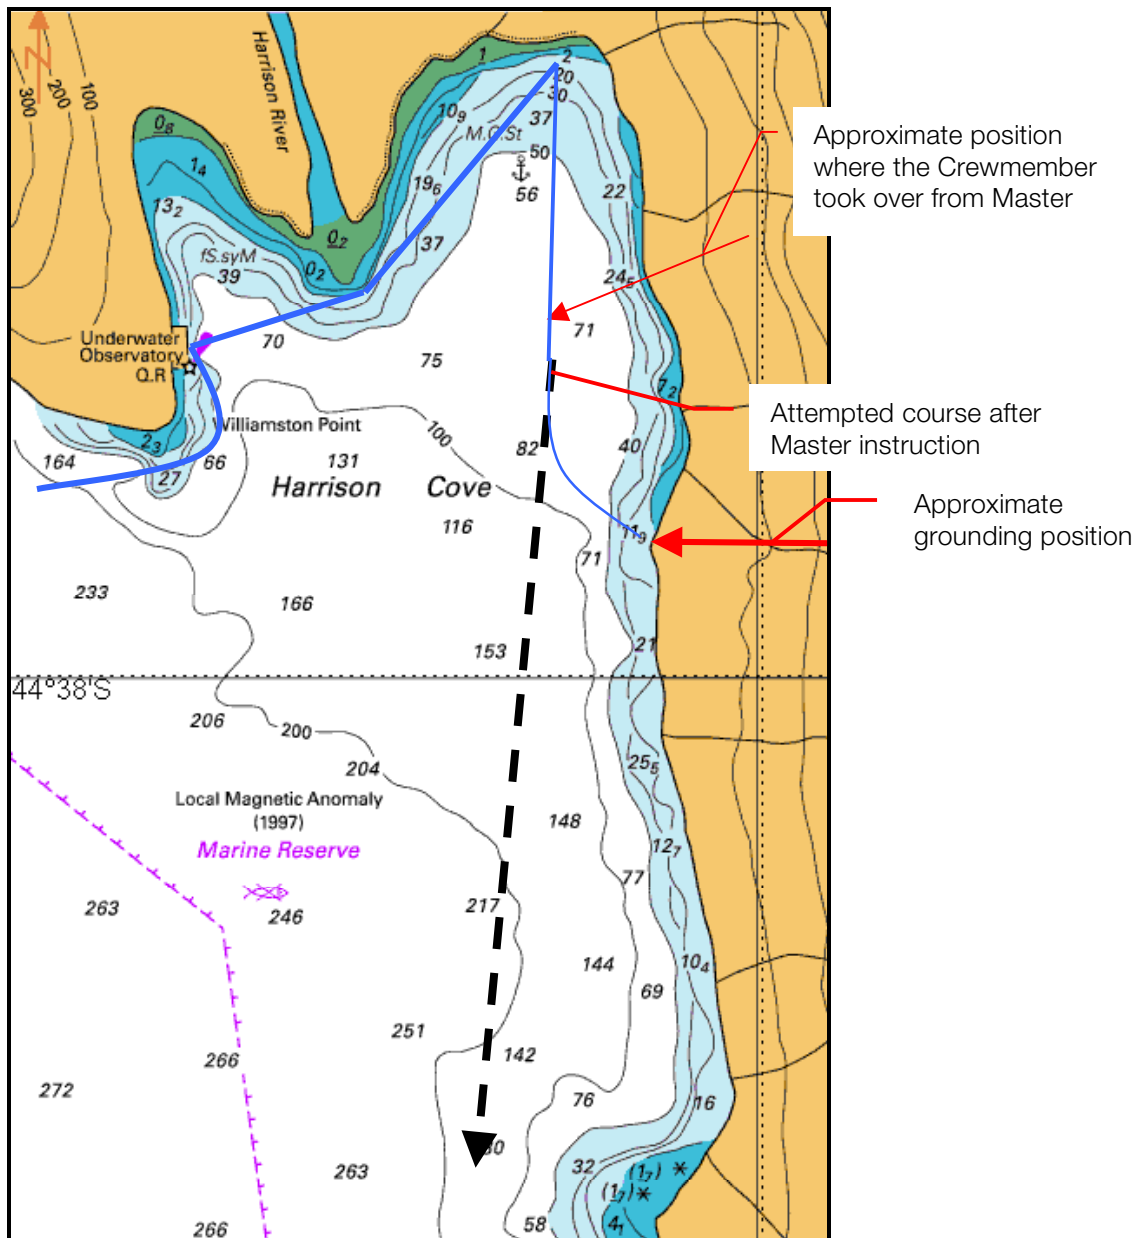
Figure 4
Harrison Cove

The vessel reared up on a rock and then settled onto an even keel (*See Figure 4*). As this was happening the Master shut down the main engines and restarted them using the centre console. He then engaged idle ahead to hold the vessel in place while the vessel and passengers were checked.

The vessel was approximately 150 to 200 metres off the shore when making passage back towards Fresh Water Basin.

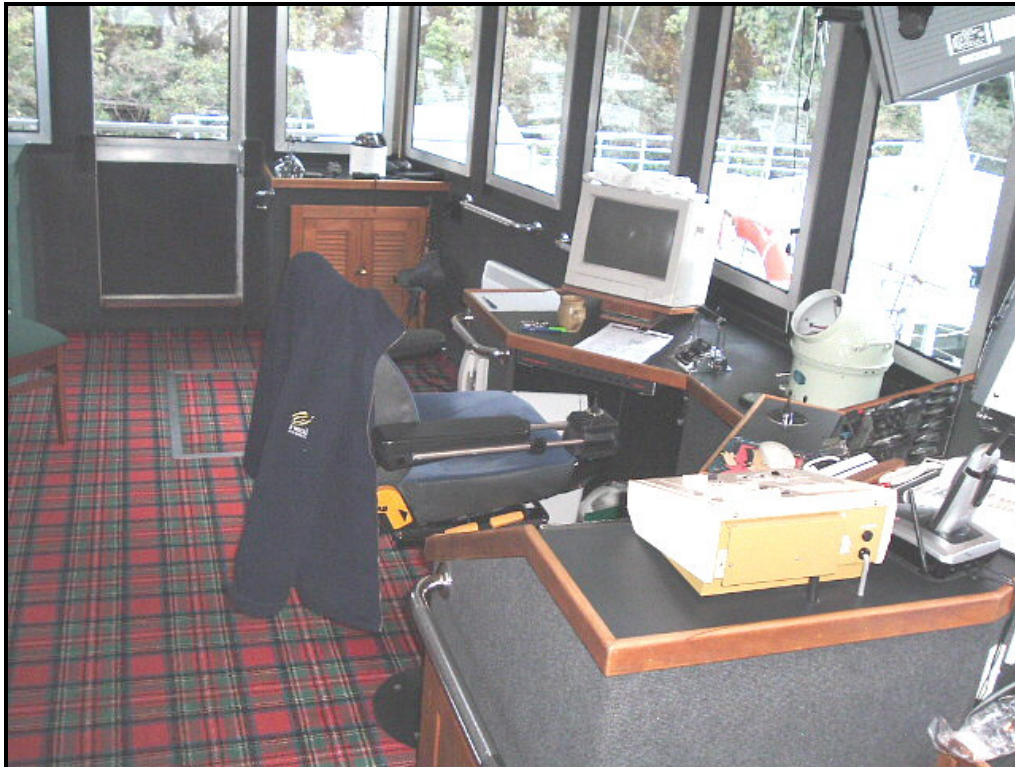
Photograph 2

The view looking from the centre console towards the port control

The wheelhouse has three helm stations. The main console in the centre has the engine gauges and start keys. The starboard station has a helm and a power commander that operates the throttle/gearbox levers. The port station has a helm, a power commander and two 'hot start' buttons. These buttons can be used to bypass the four-stage start-up procedure if the engines have stalled when conning the vessel from the port station.

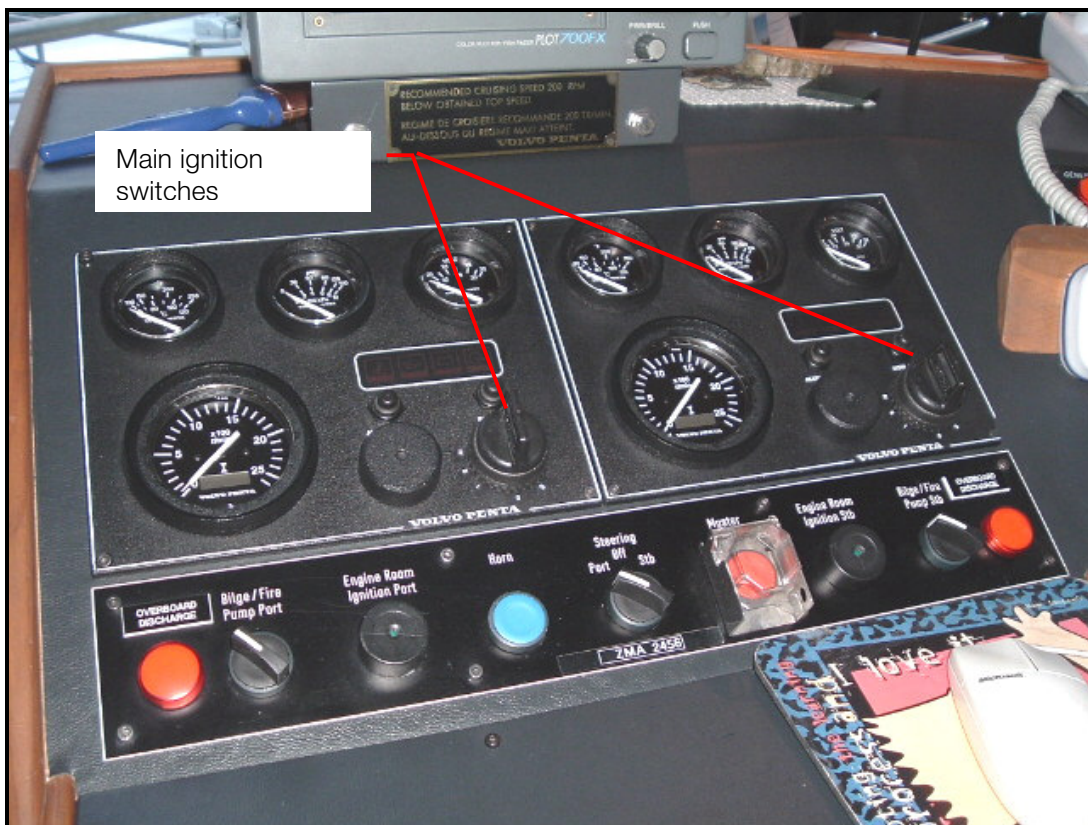
Photograph 3
Centre console engine control panel

Starting the main engines from the centre helm station essentially requires four stages:

- Turn ignition switches to the ON position
- Make sure throttle/gearbox levers are in neutral position
- Depress the button on the power commander unit
- Turn ignition key against the spring resistance to engage starter motor on main engine.

The above four steps must be completed for both port and starboard main engines. The power commander button needs only to be pushed once for both main engines.

If this procedure is not completed in this order then the main engines will not start.

- The start-up procedure requires a number of steps to be followed precisely in order for the main engines to start. In a stressful situation, like that one that the Chef and Master found themselves in as the vessel drifted towards the beach, the start-up can and was overly complicated. Fiordland Travel has amended the stall procedures but they stop short of trying to simplify the system.

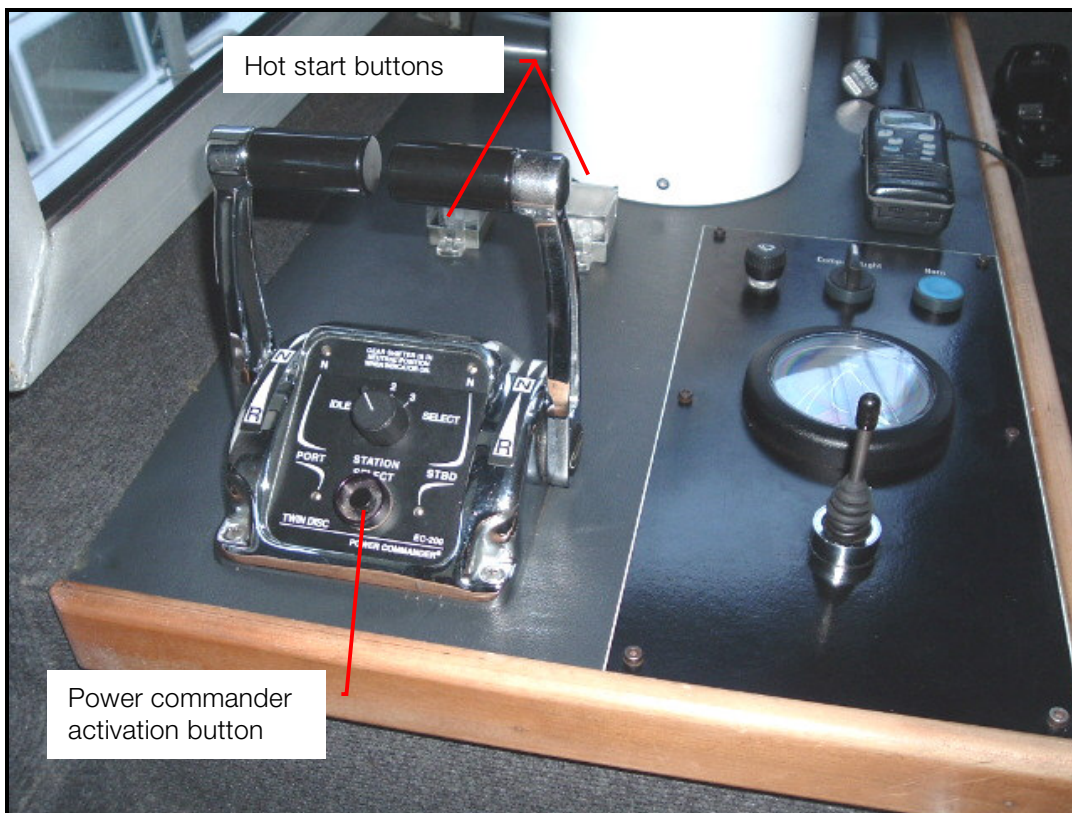
Photograph 4
Port helm control station

When conning the vessel from the port station and the main engines stall they can be restarted using the following 4 stages:

- The main console ignition switches must be in the ON position
- Make sure throttle/ gearbox levers are in neutral position
- Push the hot start buttons to start engines
- Depress power commander button to activate lever controls.

If the main console ignition switches are not in the ON position then the power commanders will not be operational.

The 'hot start' procedure allows the main engines to be restarted quickly when conning from the port station without needing to go back to the centre console. If the engine did stall when conning from the port station then the main ignition switches would already be in the ON position.

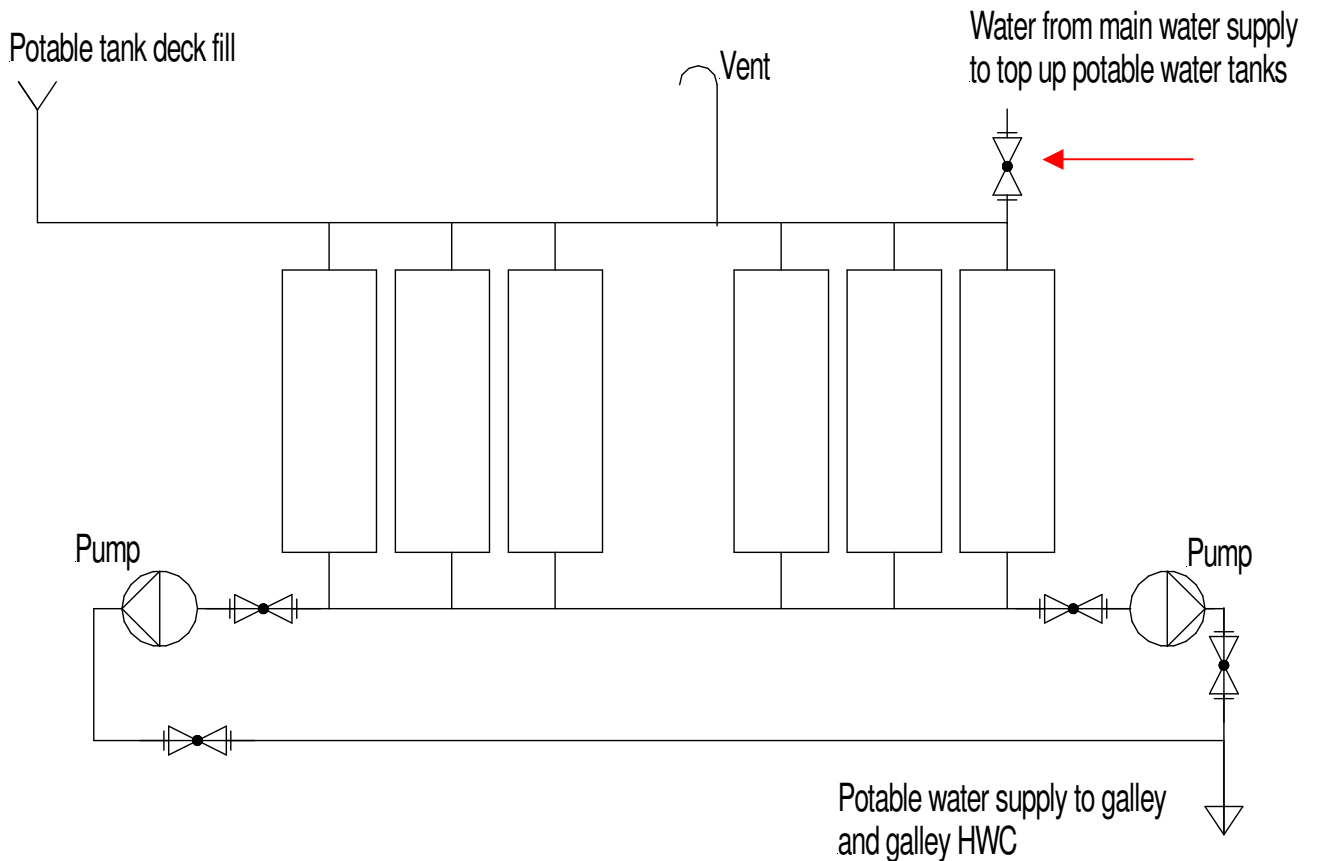
Figure 5

The above diagram illustrates the potable water system onboard *Milford Mariner*.

The red arrow indicates the valve that the Master went to turn. This was approximately 70 paces from the wheelhouse. He was transferring fresh water from the double bottom tanks to the six potable water tanks in the tank room. The valve was being adjusted so that the water would be transferred into all the tanks at an even rate, rather than one filling up at a time. The gauge on the potable tanks had failed sometime ago; this gauge could be monitored on a wheelhouse display. The Master wanted to transfer the water to the tanks so that after berthing he could simply fill the double bottom tanks using the shore supply. Both members of the crew who were in the wheelhouse could have adjusted this valve rather than the Master.

- The gauge that monitors the potable water tank level had failed some time ago. The tanks then had to be monitored manually. The Company had initiated steps to correct the problem after the issue was raised.

- Fiordland Travel's General Manager of Maintenance has recommended that they remove the separate potable water system and that they revert to the original double bottom water tanks.

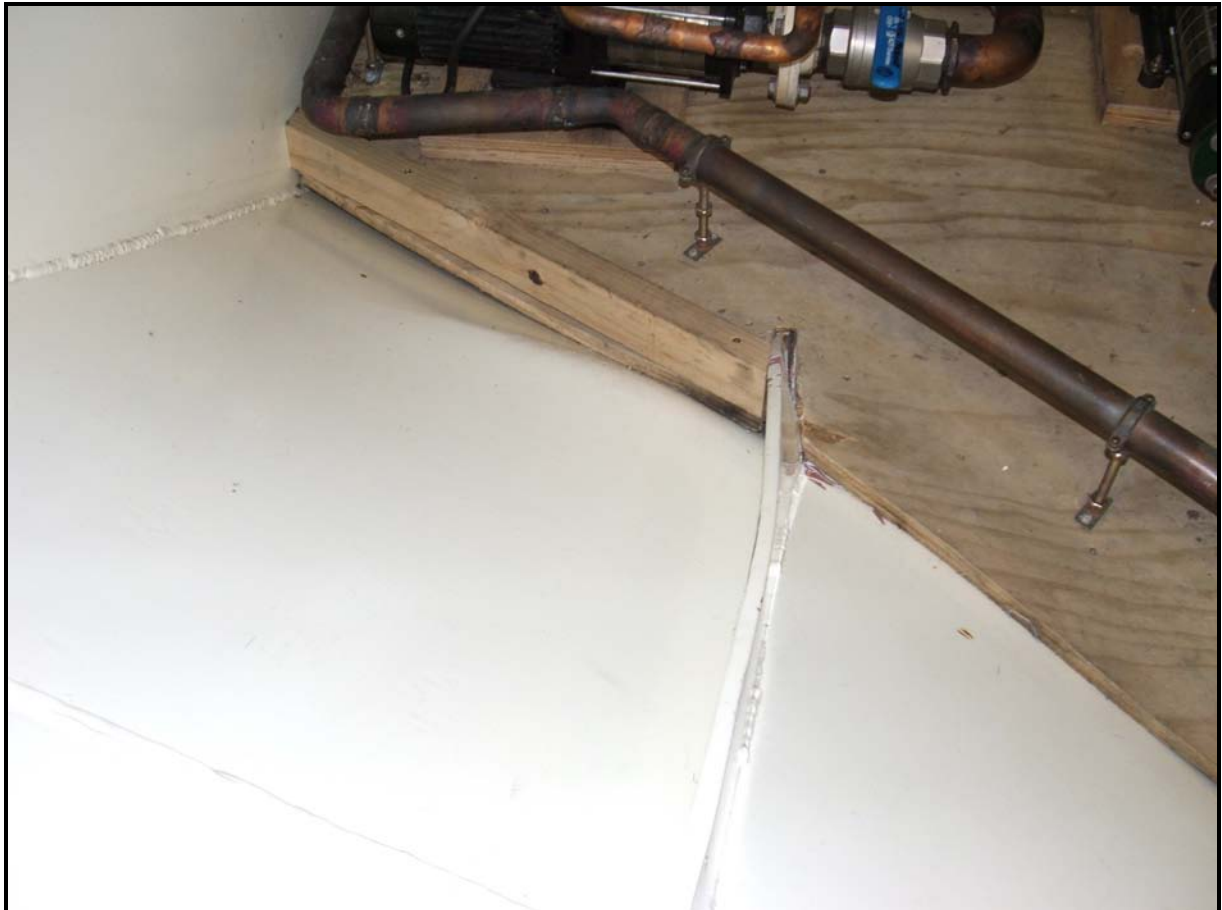
The vessel sustained damage to two areas of contact below the water line on the port side. Both were aft of the forward watertight bulkhead between frames 10 and 11. They were located mid-way between the keel and the first chine. The worst effected area was 1 metre below the chine in frame 10 which was deformed approximately 100mm inwards and had caused the frame to lay over about 60 degrees from the hull plating.

The diver reported significant gouges and scraping over the area of impact.

Photograph 5
Impact area at frame 10

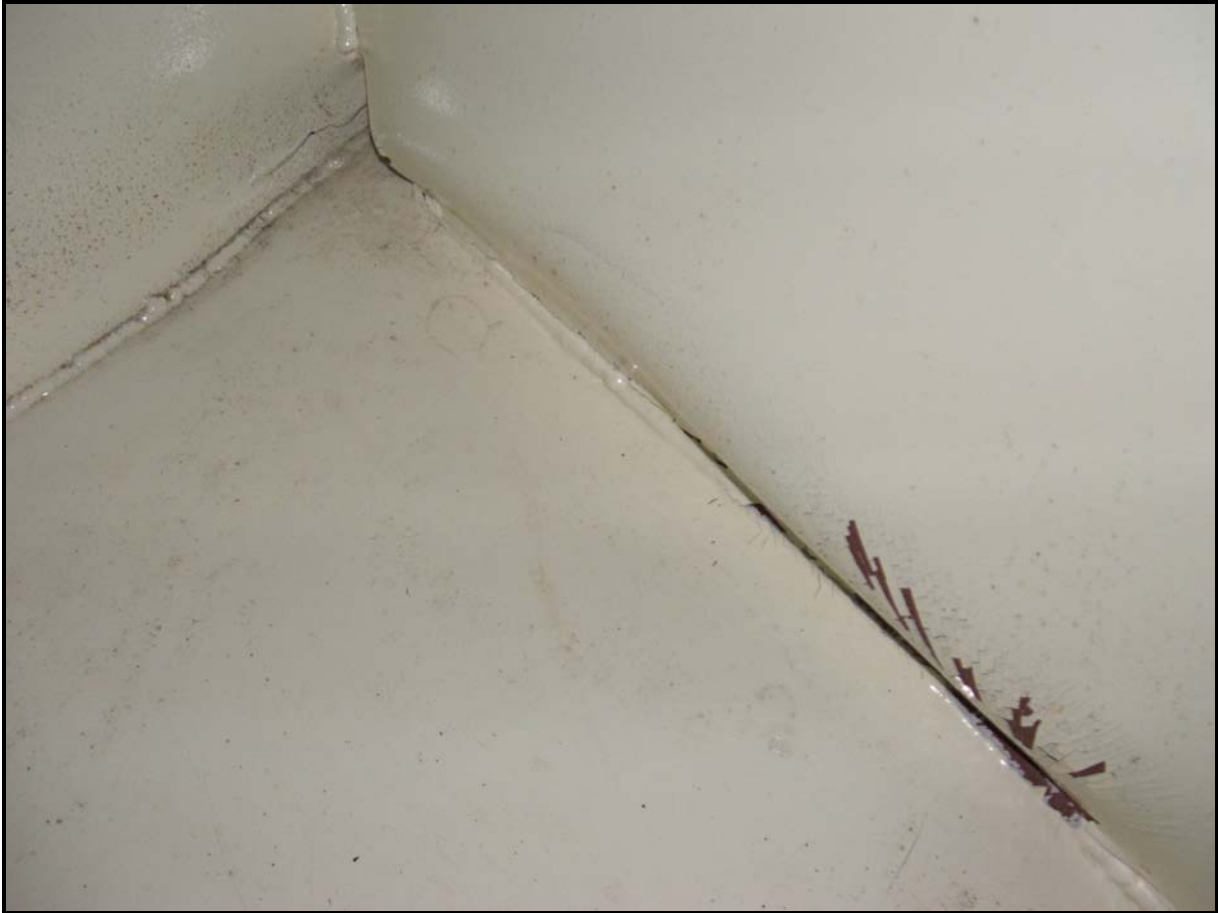
Photograph 6
Damage to frame 11
