# Accident Report

Loss of Control of Vessel

*Milford Sovereign*

30 September 2005 & 20 November 2005

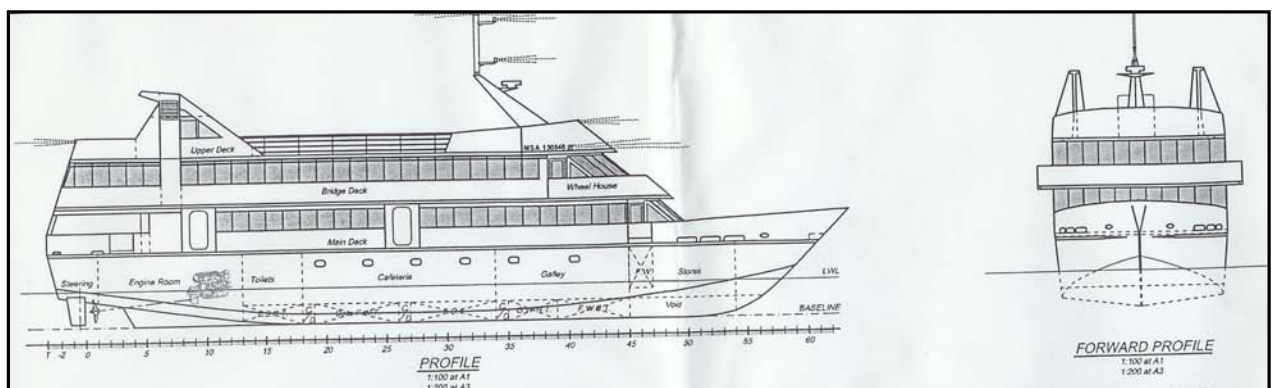
**Figure 1**  
Profile plan of **Milford Sovereign**

Unlike **Milford Sovereign**, **Milford Monarch** was built with a 100mm keel bar.

*It is our recommendation that a vertical fin bar be fixed to the flat keel bar on Milford Sovereign. This bar to be the same depth as the structural keel bar on Milford Monarch but being non structural should be of a minimum thickness and attached with sufficient welding for its purpose as a "spoiler" to break up the lateral flow of water under the hull. This will achieve as near as practicable, low speed handling characteristics similar to those of Milford Monarch.*

The vessel has been fitted with a keel bar and inclining tests have been carried out.

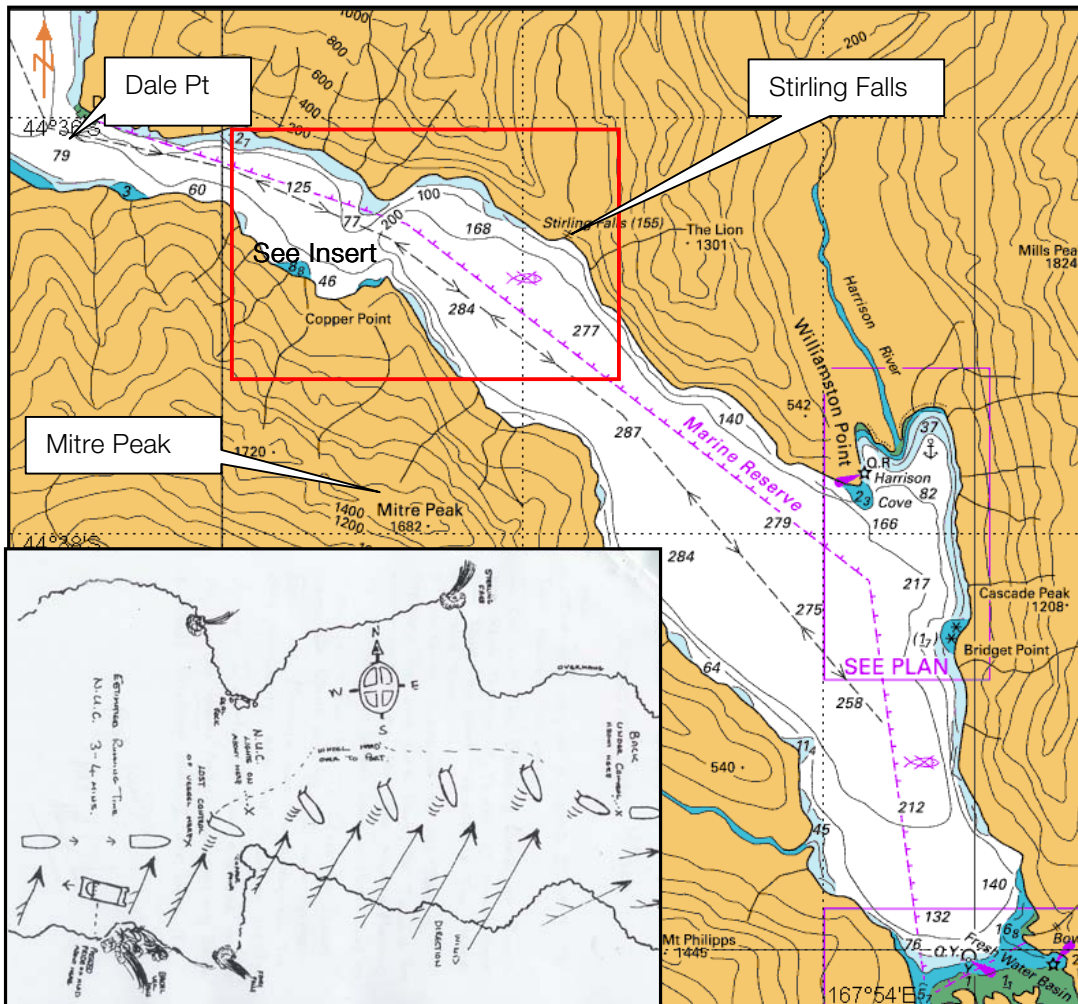
**Figure 2**  
Milford Sound – Chart extract from Land Information New Zealand (LINZ) Chart 7622  
Insert – Diagram drawn by the Skipper of **Milford Sovereign** at the time of the incident.  
*The diagram does not necessarily accurately reflect the actual times and distances as portrayed above.*

As the wind was “gusty” the Skipper found that the strongest winds were bouncing off the southern side of the Sound (Peak) and blowing across to Stirling Falls (See Figure 2). Because of this the Skipper favoured the southern side of the fiord as he headed back to Freshwater Basin.

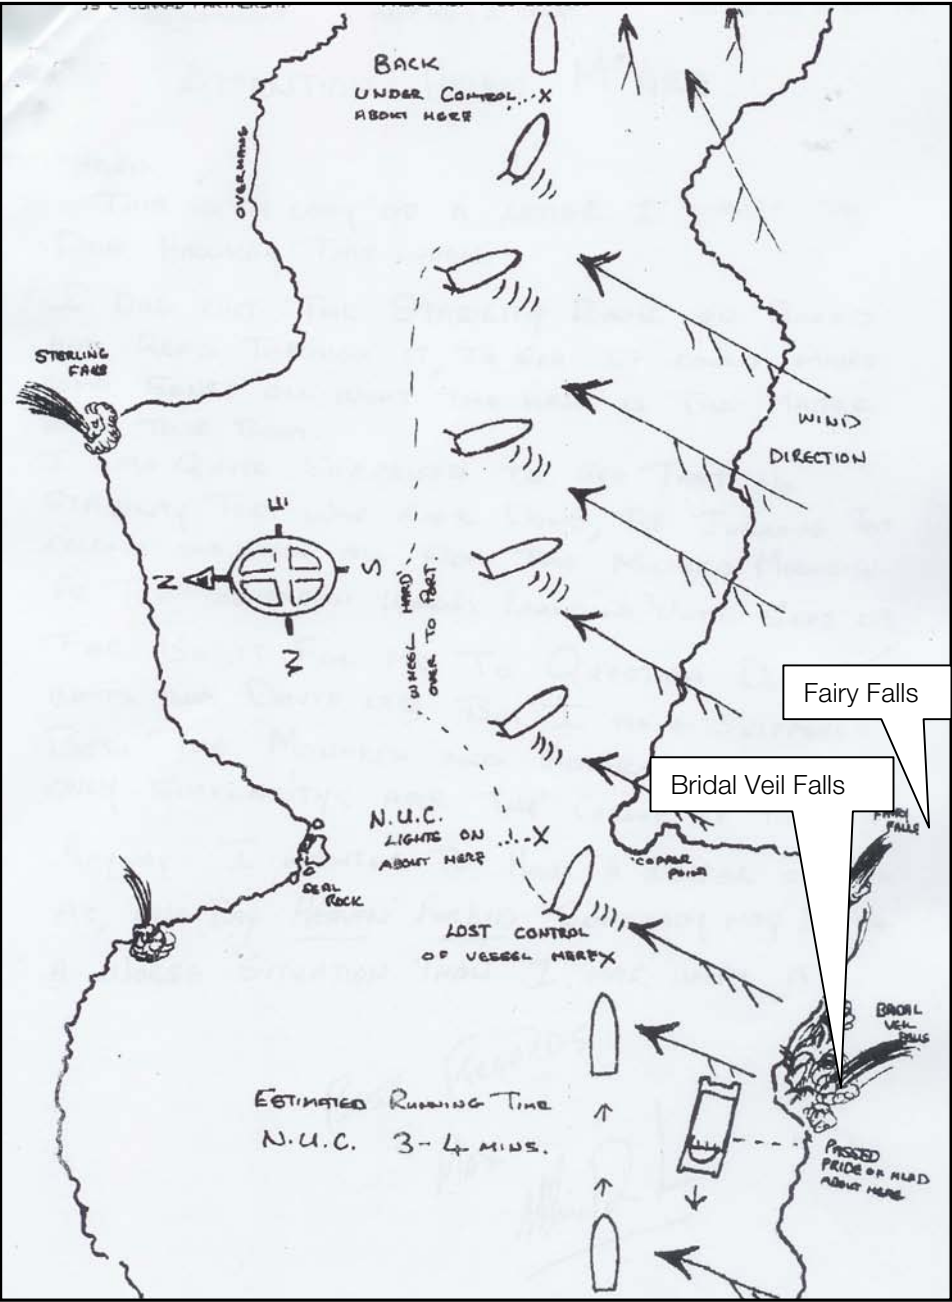
**Figure 3**  
Diagram of the incident drawn by the Skipper of *Milford Sovereign* at the time of the incident.

As the vessel passed abeam Fairy Falls *Milford Sovereign* was struck on the starboard quarter by a large gust of wind measuring 65 knots on the vessel's anemometer. The vessel heeled over approximately 18-20 degrees to port. When this happened the Skipper found that he had no control over the vessel. The Skipper had the helm hard over to port and the propulsion at full ahead equating to a speed of about 11½ knots. Notwithstanding this action, the vessel did not respond and continued to drive down the Sound under the influence of the wind (See Figure 3).

**Milford Sovereign** was “Not Under Command” (NUC - unable to manoeuvre due to exceptional circumstances) for about 3-4 minutes as it ‘skidded across’ the water heeling to port and slowly turning to starboard. The Skipper exhibited the NUC lights to indicate to other vessels that he had no control of the vessel and could not manoeuvre in accordance with the Maritime Rule for preventing collision.

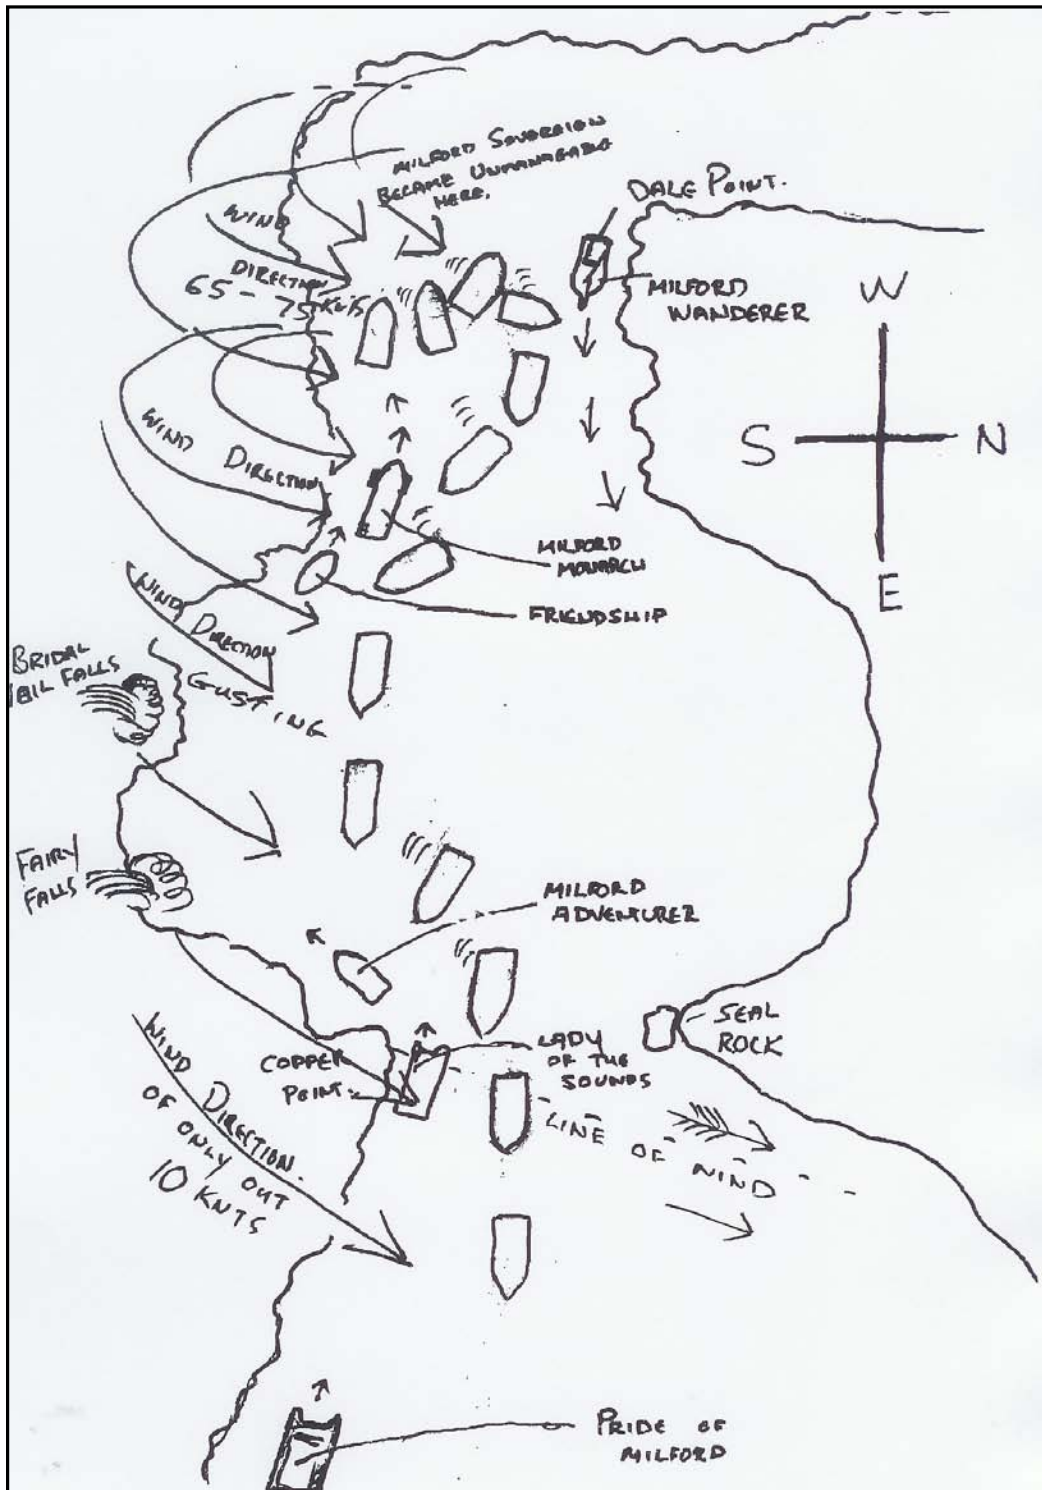
Figure 5  
 Diagram drawn by the Skipper of *Milford Sovereign* at the time of the incident.  
 The diagram does not necessarily accurately reflect the actual times and distances as portrayed above.

At 1300 hours, **Milford Sovereign** departed for the afternoon cruise. When they reached Cooper Point the wind increased to 45-55 knots from the north. As the vessel proceeded past Copper Point towards the heads at Dale Point, they were struck by a gust of 70 knots on the forward port side. The vessel heeled over to starboard and the bow swung to starboard, allowing the wind to strike the port side of the vessel (See *Insert on Figure 4*).

At the above time, **Milford Wanderer** was entering the Sound from seaward and was directly opposite **Milford Sovereign** on the northern side of the fiord (See *Figures 4 & 5*). The Skipper of **Milford Sovereign** was concerned that his vessel would be blown into the path of the **Milford Wanderer**, but was able to regain control of the vessel before this occurred. The Skipper then headed down the Sound towards Freshwater Basin.
