Class B Accident Report

NZL41

Injury to Passenger

Auckland 27 November 2004

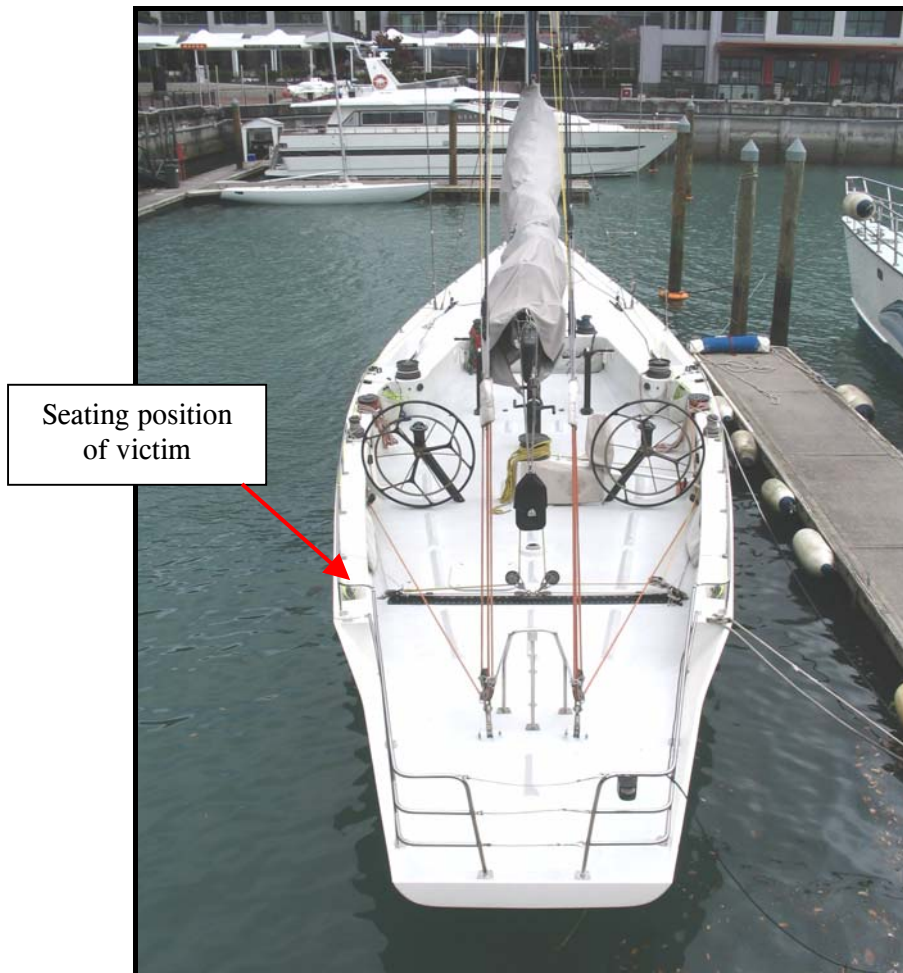
The vessel eventually turned around and commenced tacking back towards the harbour bridge. At approximately 1530 hours, whilst on a port tack approximately 300 metres south of Stanley Point, the vessel tacked to starboard. The victims' husband stumbled over a deck stiffener and fell. The victim, who was sitting on the port side of the vessel, attempted to move across to the starboard side but had nothing substantial to hold on to. In moving, she held onto the mainsheet line. At that moment, the mainsheet moved along the traveller. The passenger's right hand entered the mainsheet block thumb first. This resulted in the right thumb being amputated and other injuries to her right hand.

The passenger instinctively grabbed hold of the mainsheet to steady herself whilst moving from the port side to the starboard side of the vessel during a tack. At that instant, the mainsheet moved along the traveller causing the mainsheet, which the passenger was holding, to run through the block. The passenger suffered major injuries to her hand as a result.

At the time of the accident, the mainsheet block was uncovered, with nothing to prevent a person's hand being caught in it.
