Accident Report

Pacific Way

26 November 2005

Pacific Way – Injury

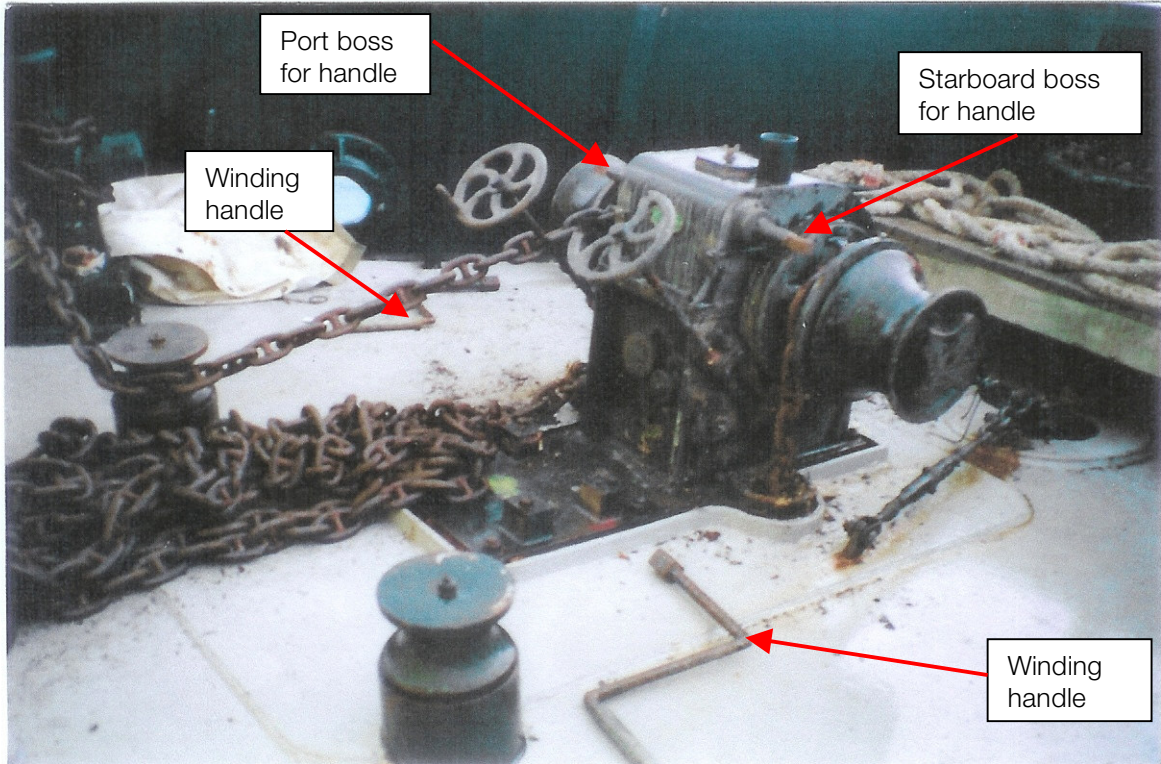
Photograph 2
Windlass viewed from Starboard Quarter

After one shackle had been heaved on deck, **Pacific Way** lifted on a two metre swell wave bringing considerable weight onto the cable. This caused the anchor to suddenly run out and the winding handles to counter-rotate. The starboard handle stuck a crewmember on the left wrist.

The windlass was manually driven by means of winding handles. There was no ratchet in place to prevent the cable running out when weight came on.

1. It is recommended that the owners of ***Pacific Way*** install an alternative (mechanical, hydraulic or electrical) means of operating the windlass as soon as possible. Also, as the anchoring equipment is used infrequently, it is recommended that a planned maintenance regime be implemented for the windlass.
2. It is recommended that the owners of ***Pacific Way*** immediately ensure that crew training records be kept up to date and all relevant paperwork onboard ***Pacific Way*** is brought up to the required standard.
3. It is recommended that the owners of ***Pacific Way*** immediately issue written procedures to the Masters of their vessels reaffirming the need to inform Maritime New Zealand directly of any accident, incident or mishap involving serious harm, as soon as practicable.
