Safety Investigation
Paihia High-Speed Passenger
Boats
27 June 2009

Maritime New Zealand

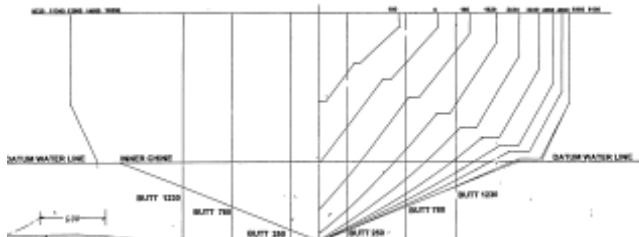
Figure 1 Bow section of **Excitor**

11. This vessel is a moderate to deep V mono hull with a single chine. This type of hull is designed for high-speed. In moderate or larger sea conditions this could result in the vessel appearing to handle the larger waves easily, but as a result the vertical motion of the bow would be pronounced which can lead to rapid deceleration when passengers are seated in the most forward areas.

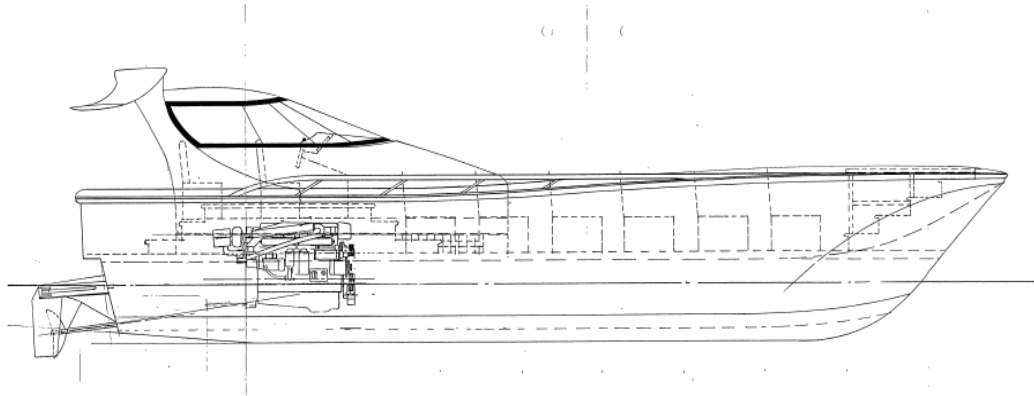
Figure 2 Mack Attack

13. This vessel is a catamaran design. Vessels of this type of design are likely to operate in similar conditions as the mono-hull up to a point. The maximum point is reached earlier and a reduction in speed and/or course is likely to be needed earlier for comfort and safety of those on board the catamaran.

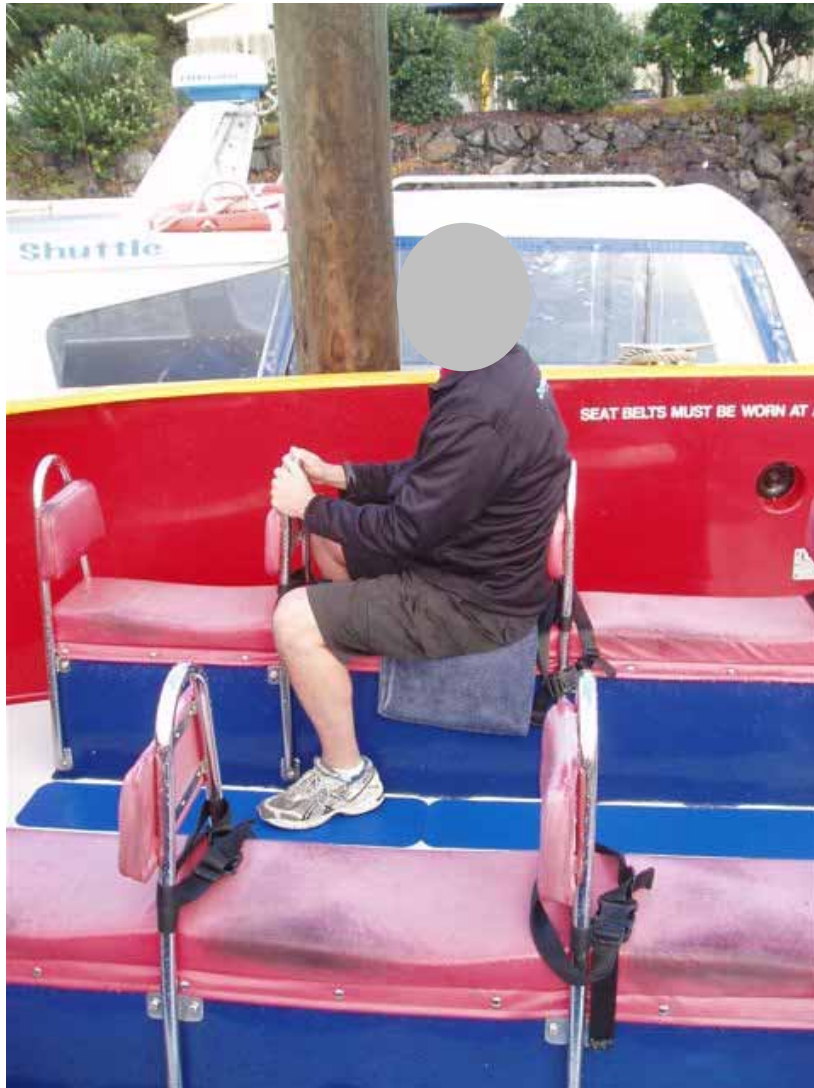
48. ***Excitor*** has a number of different seating designs. The vessel has a number of 'extreme' seats that are situated at the most forward part of the passenger area. These are a 'jockey' style where passengers need to sit astride the seat and grip the seat pod between their legs and use their knees to absorb the shocks, in a similar manner to a jockey riding a horse.

Figure 19 Extreme seats on *Excitor*

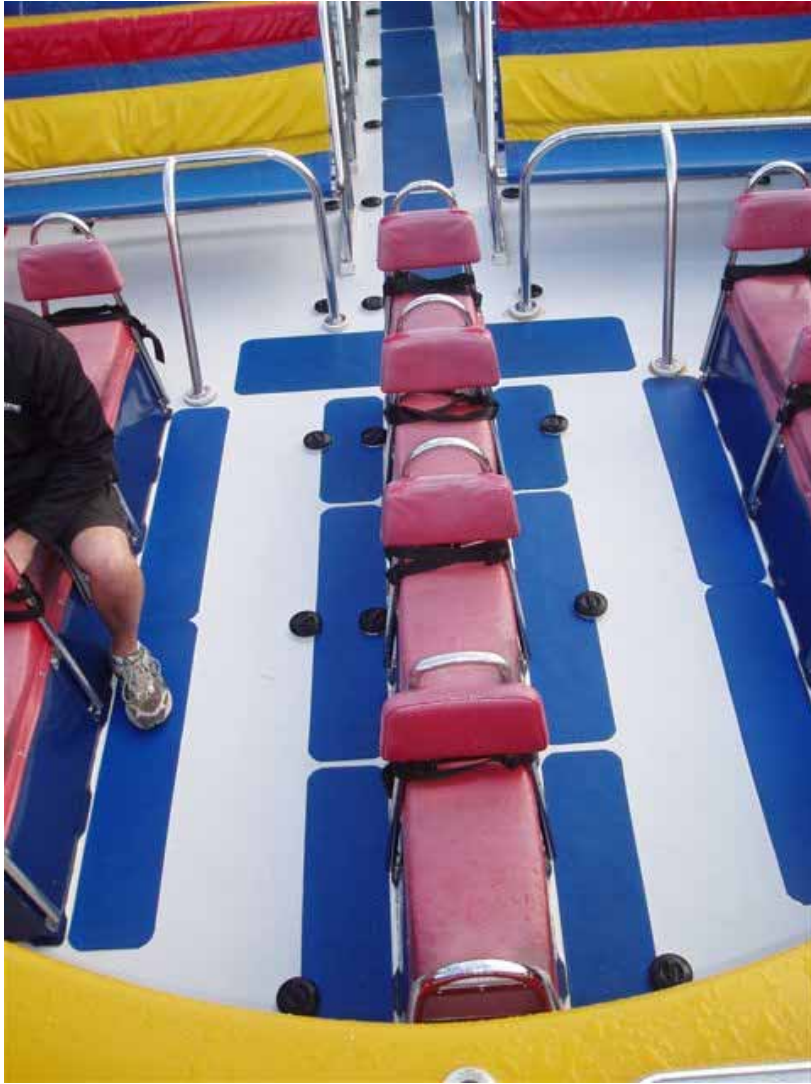
Figure 20 Extreme seats as seen from the front of the boat

50. The seat cushion padding of this type of seat is 70mm thick with the lumbar padding being 40mm thick. Note the narrow hand rail available to passengers seated here; this could contribute to a lack of lateral support where a wide hand grip is seen as best practise.
51. Other designs on board **Excitor** are a bench seat type. There are slight variations in design and padding but all are essentially very similar. They do, however allow for wide hand placement.

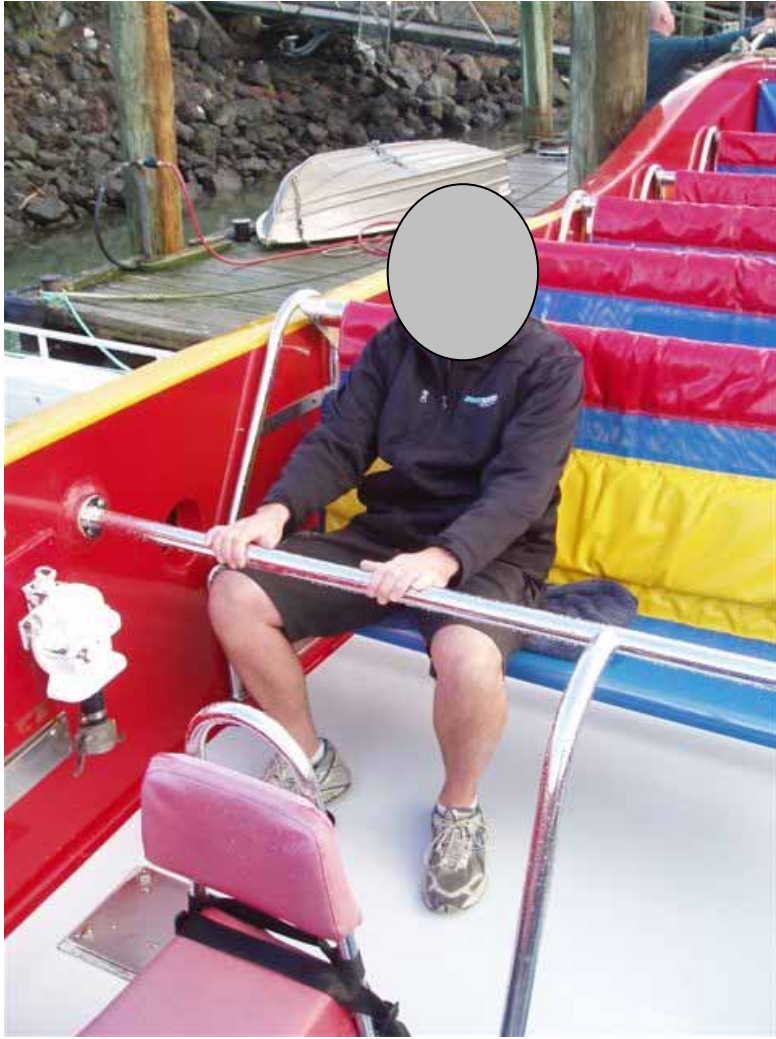
Figure 21 Bench seat on *Excitor*

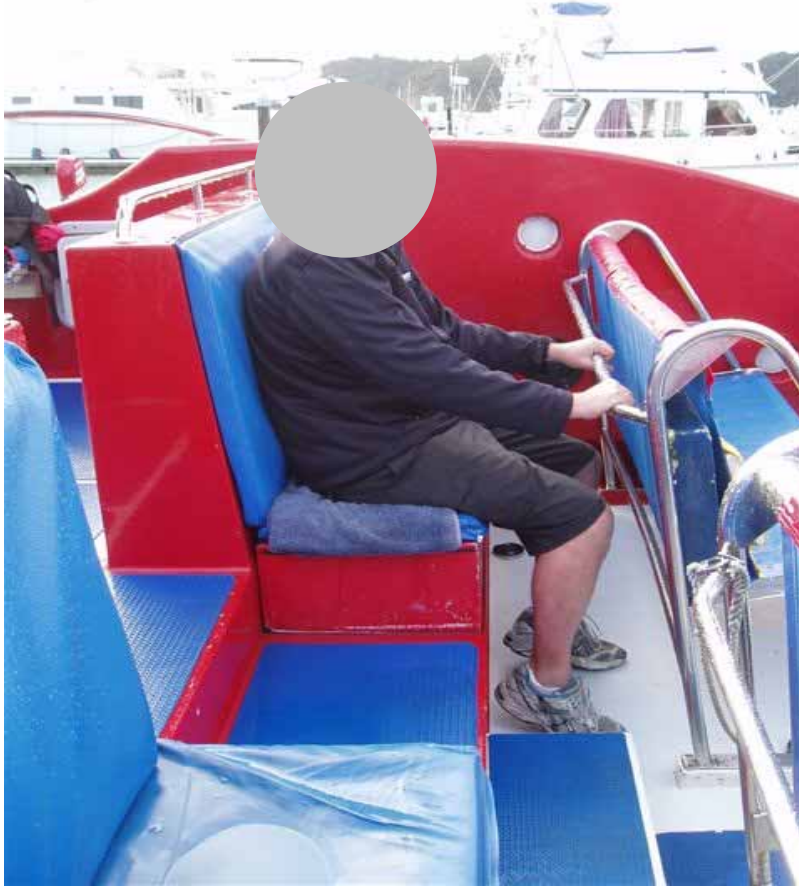
Figure 22 Alternative bench seat on *Excitor* showing that low forearm angle which allows for greater lumbar instability compared to a higher forearm angle

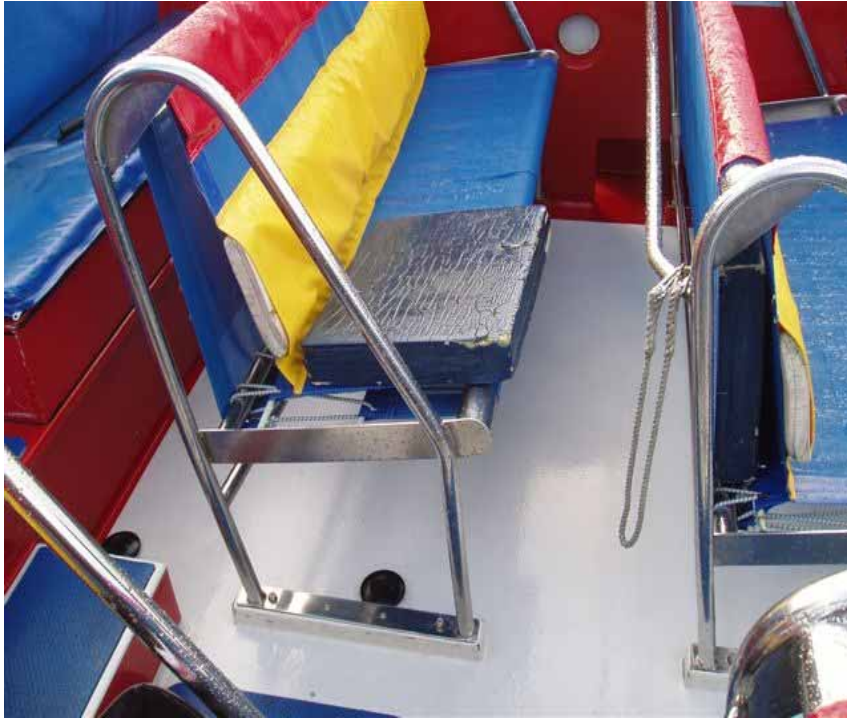
Figure 23 Bench seat on *Excitor*

52. Figures 23 and 24 show the different styles of bench seats currently used on board *Excitor*. Figure 24 shows the moveable seat cushion used for short people and children.
53. Bench seats offer little opportunity for passengers to use their legs to absorb shocks while underway. They are, however, simple to use and are generally better suited for high-speed vessel trips on smoother water.

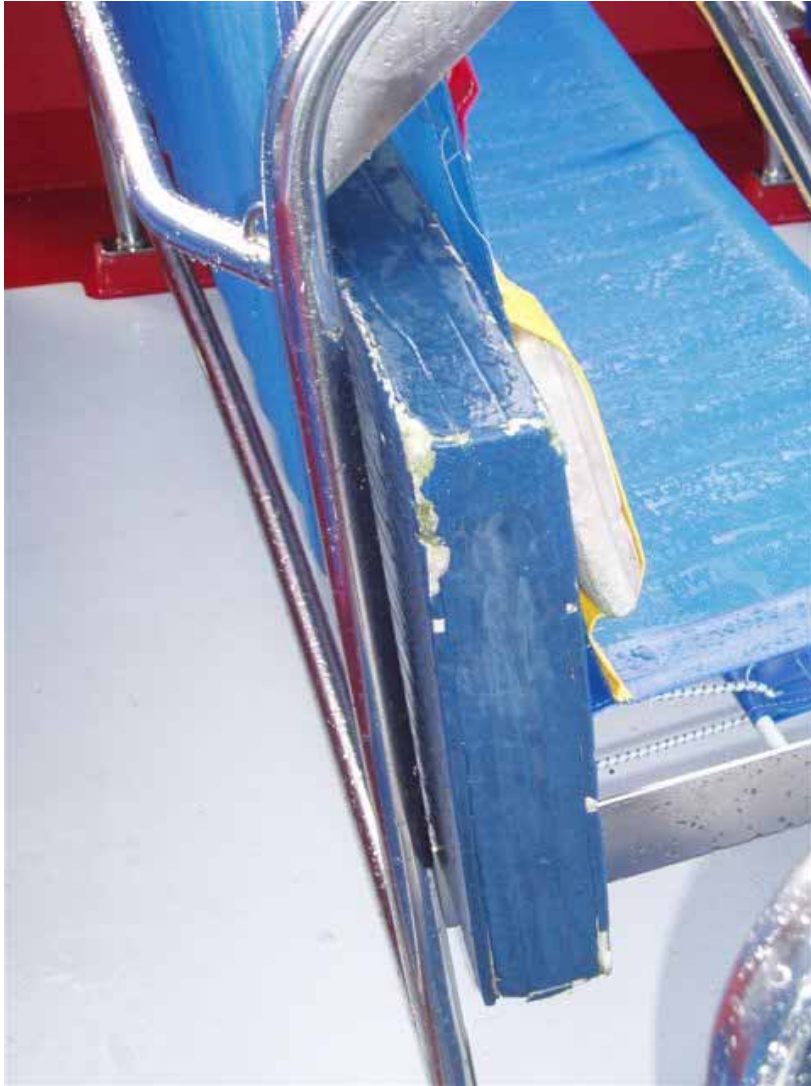
Figure 24 Showing wear on padding in its stored position.

54. The condition of the seat cushions is an important part of the overall operation of the seat. Figure 25 shows that the cushion cover has been allowed to degrade. This will allow water ingress to the cushion, as well as allowing the foam material to protrude which can further accelerate degradation.

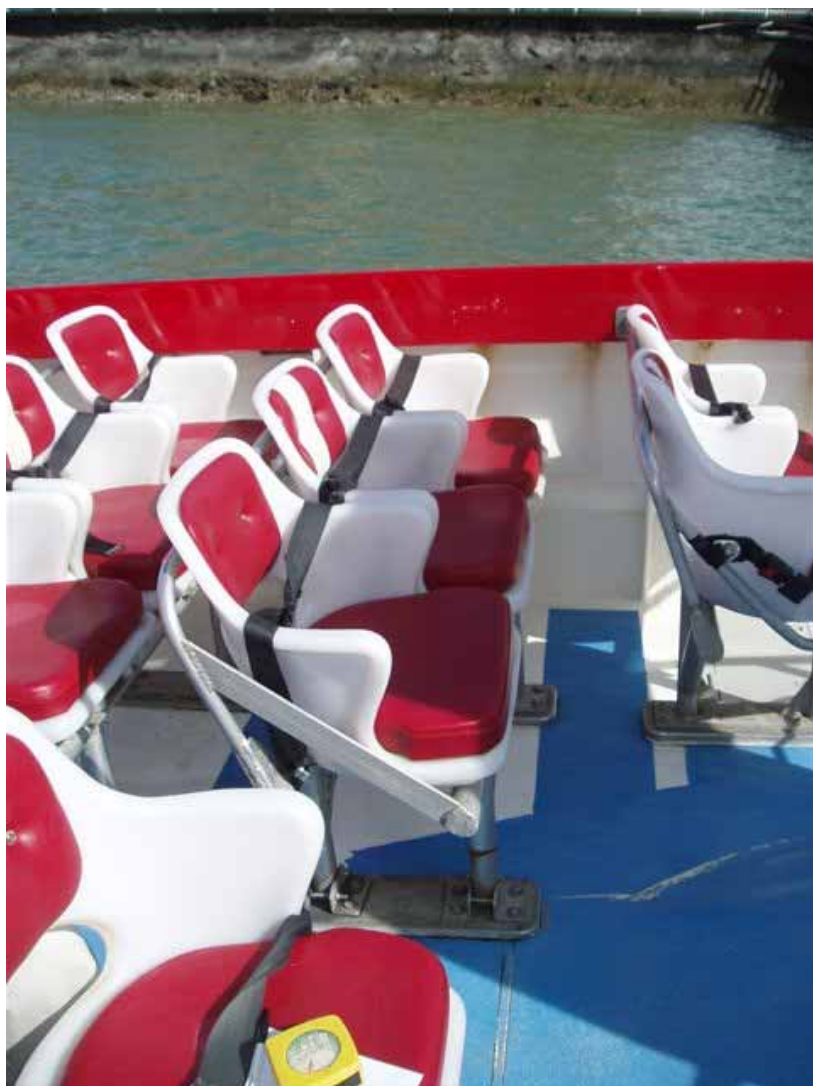
Figure 25 Bucket style seating of *Mack Attack*. The seat padding is 60mm thick and the lumbar padding is 20mm thick

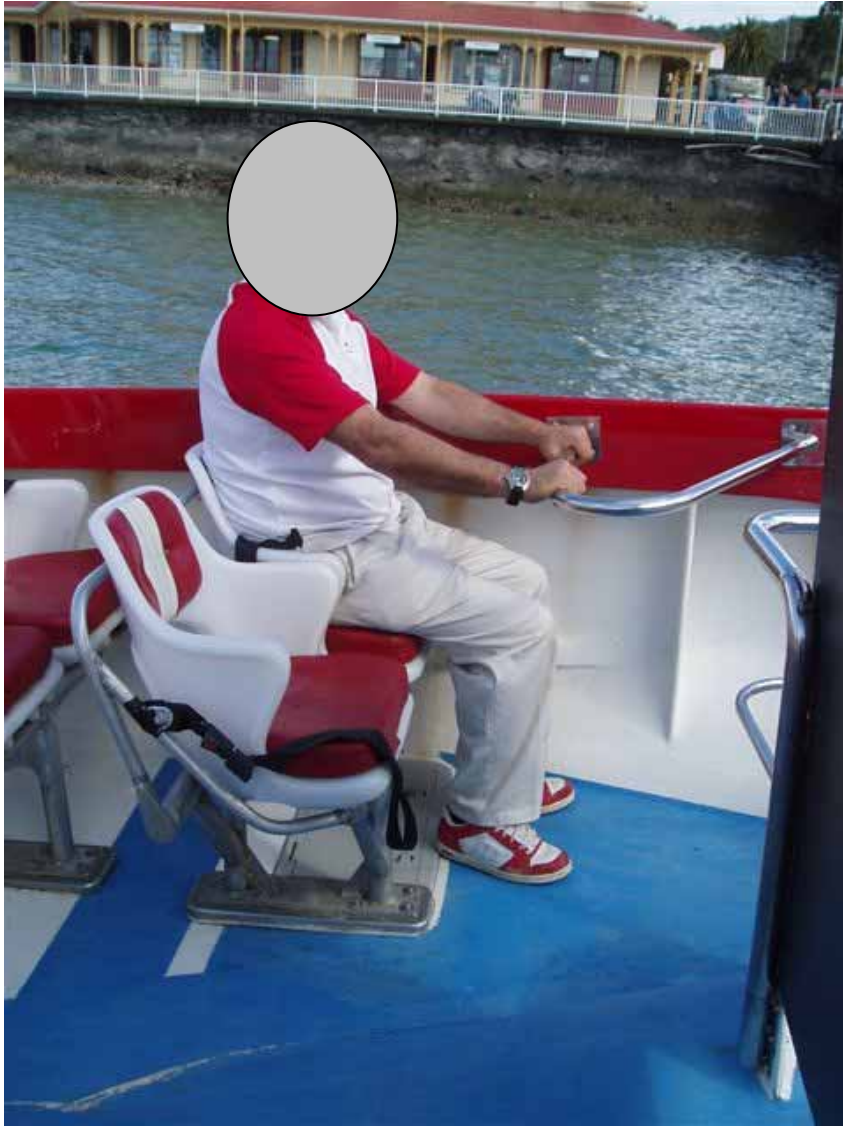
Figure 26 Front seats of *Mack Attack*

57. This vessel has four seats at the extreme forward end of the passenger deck. These are shown in Figure 27 above. Note that the inside passenger has no readily available hand rail for their use. This reduces the ability of the passenger to support themselves during periods of vertical movement.

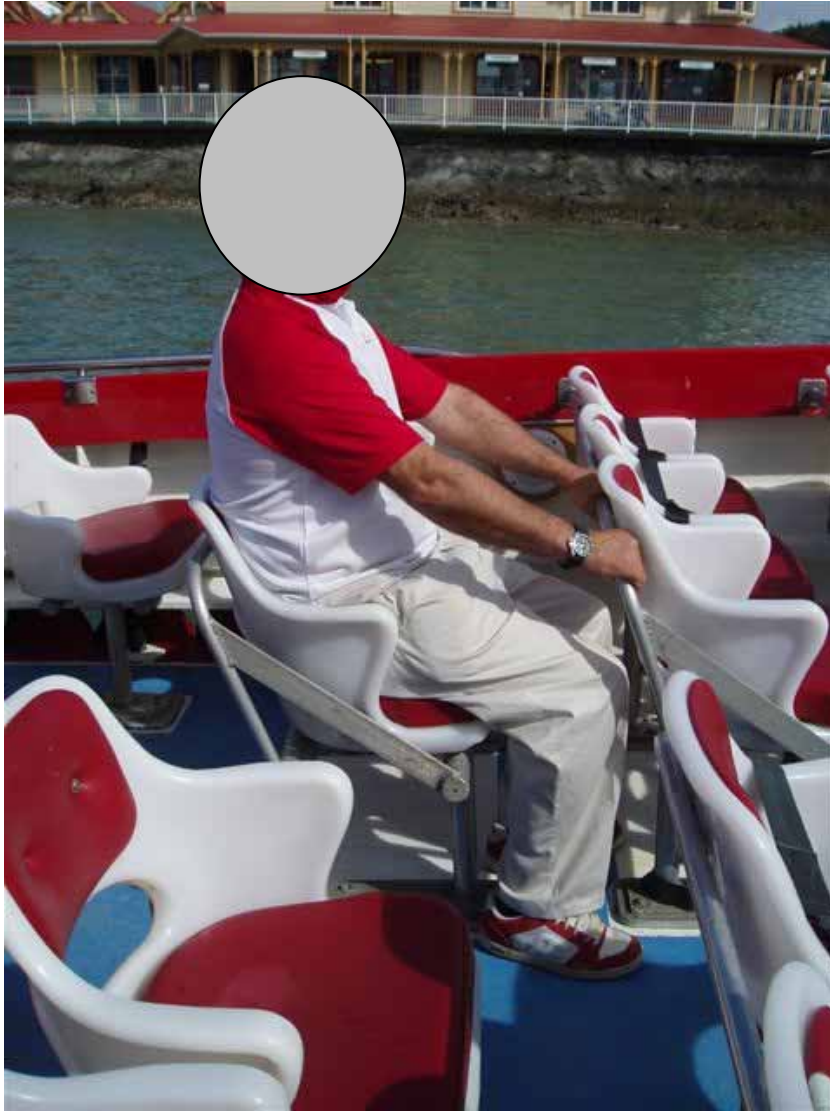
Figure 27 Hand position on *Mack Attack*

58. Figure 28 shows poor positioning of passenger hands with regard to the forearm angle. This low angle does not allow the passenger to set a solid stance when riding over waves. The angle is further reduced when the passenger lifts off their seat when the vessel drops away. It does, however, appear to provide support for the hands to be wide enough for better posture.
59. In summary, both vessels have a one size fits all seating arrangement. Seating styles do differ and with passenger placement the risk of injury could be reduced when body type, strength and experience are taken into account.
