Class B Accident Report

# **Paihia Duck**

## **Collision**

**REPORT No: 04 3632**

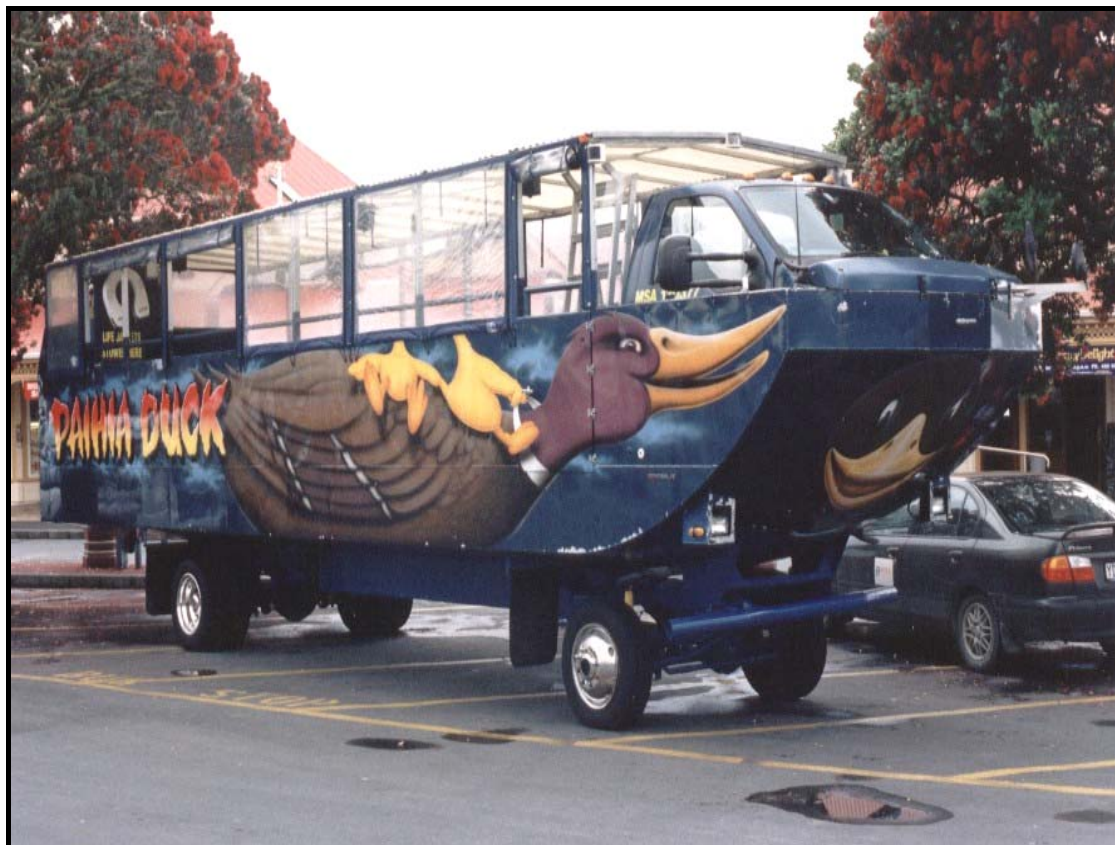
When entering the water via a boat ramp at Okiato in the Bay of Islands, the amphibious craft *Paihia Duck* sustained damage to its left front wheel and rim and broke the ‘centre bolts’ which moved the rear axle out of its alignment.

1. The boat ramp at Okiato, to be reassessed fully by the owner/operator and the Skipper for its suitability by *Paihia Duck*.
2. The findings of this reassessment should be included in the Safe Ship Management Manual/Operations Manual and be part of future training requirements.
3. It is recommended that the local Maritime Safety Inspector conduct a Flag State Inspection of this operation, including the suitability of the vehicle used, having regard to passenger safety.
