Accident Report  
*Para 1 & Lightning One*  
Collision on Lake Wakatipu  
on 14 July 2004

REPORT NO.: 04 3511

VESSEL NAME: *PARA 1 & LIGHTNING ONE*

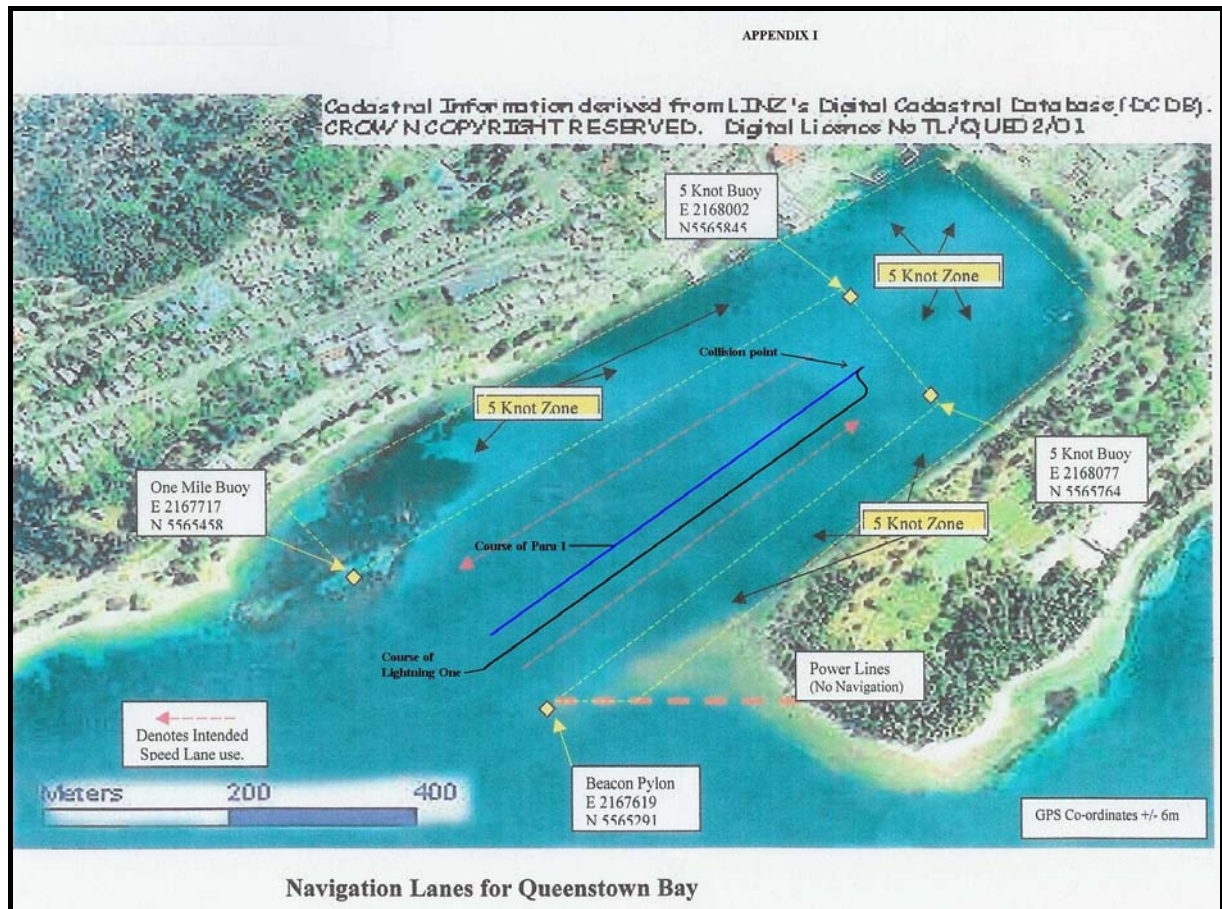
# Appendix I

- 1.5 Both vessels departed at the same time but upon arrival in Queenstown Bay, **Para 1** was ahead and to port of **Lightning One**.
- 1.6 **Para 1** slowed at the 5-knot marker and slowly proceeded to enter the 5-knot zone. The Skipper of **Lightning One** made a turn to port and crossed the wake of **Para 1** and then turned to starboard to straighten up the vessel. Immediately after returning to a straight course, he saw **Para 1** ahead. He put both main engines full astern, at which point, both engines stalled (See Appendix I – chart of Queenstown Bay).

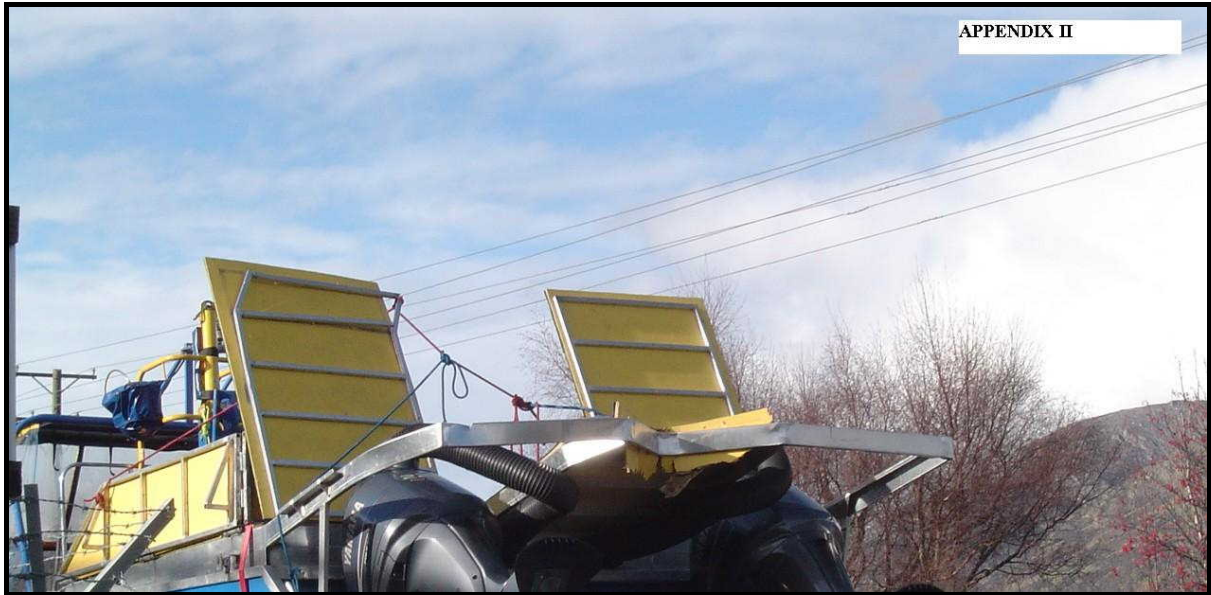
Appendix II & II(a)

- 1.9 Both vessels were assessed for damage. **Lightning One** was removed from the water for engine repairs as was **Para 1** for repairs to the aluminium launch platform at the stern of the vessel (See Appendix II – Damage to **Para 1** and IIA - Damage to **Lightning One**).

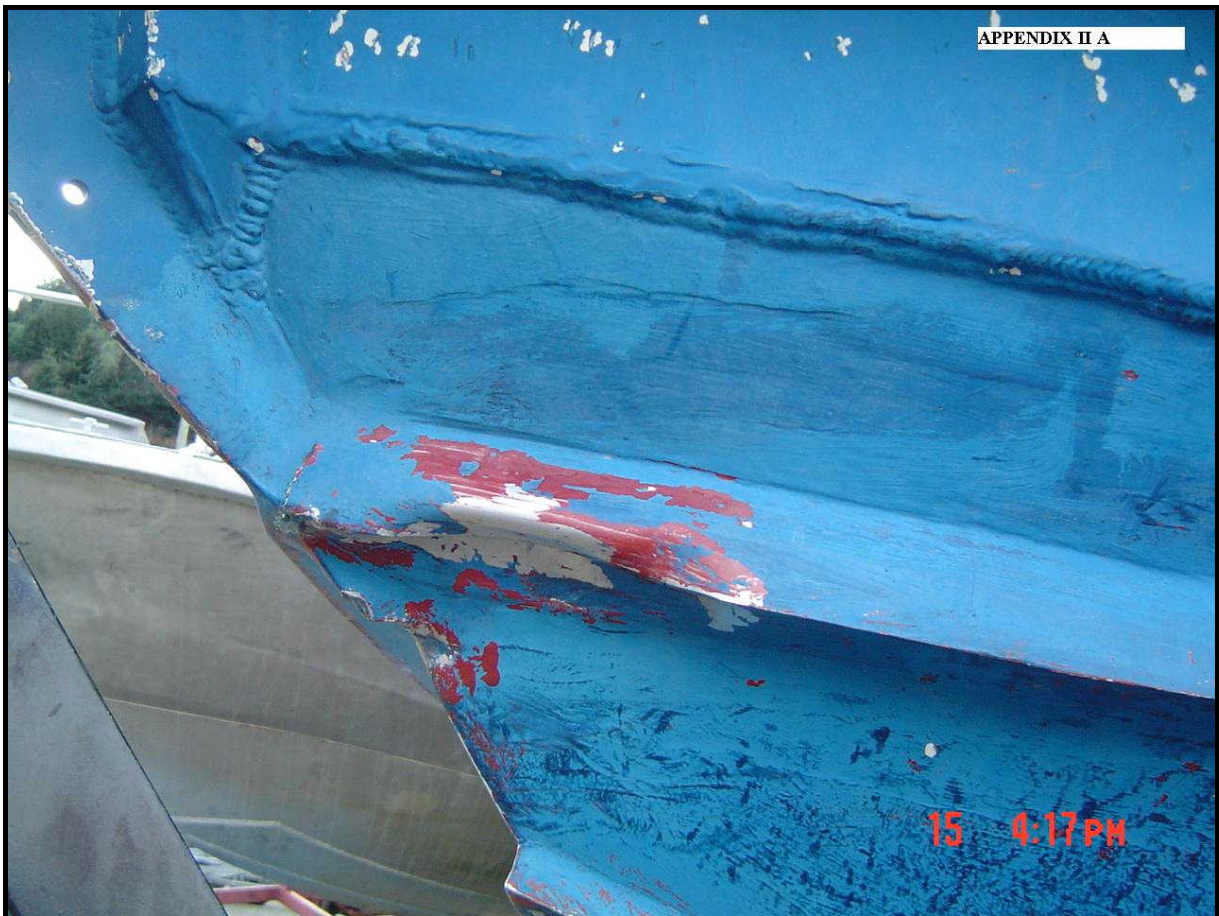
- 1.7 At 1720 hours, the bow of **Lightning One** struck the stern of **Para 1** damaging both vessels. Passengers on both vessels were checked for injuries with none found.

- 2.3.1 When the Skipper of **Lightning 1** put both engines full astern the vessel was still travelling ahead at about 15 knots. The throttles were in the process of being returned to the idle position but were still at about ¼ revolutions.
- 2.3.2 Both engines stalled when they were put full astern. One engine could be restarted after the collision and the other could not due to a bent conrod.
