Summary Report

Serious Harm Injury

Patea Explorer

21 September 2006

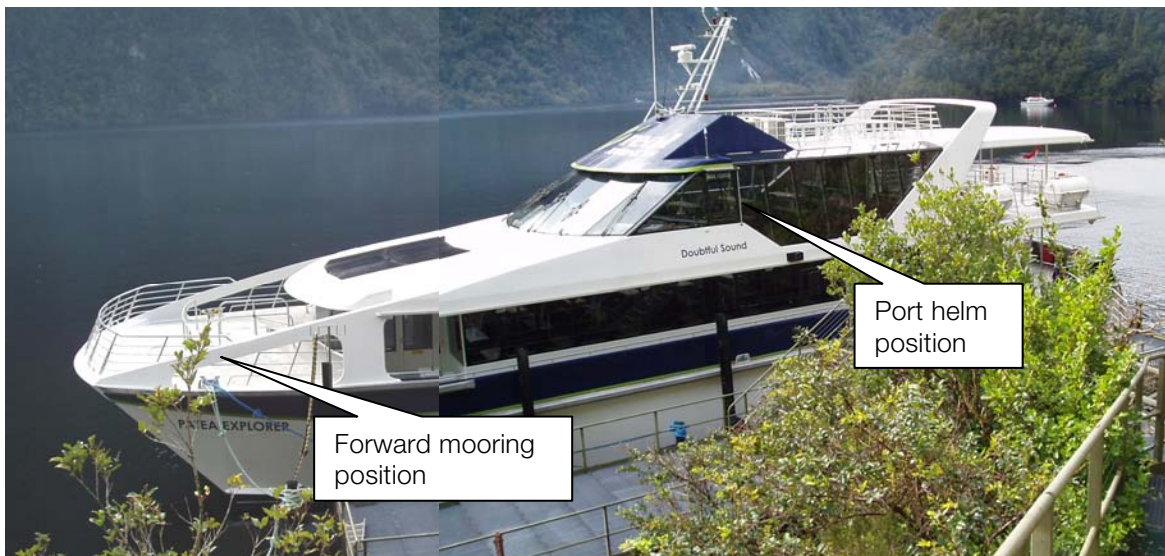
Photograph 1
Patea Explorer

At about 0845, the school children and their teachers boarded the vessel. At 0900, the crew made preparations to leave the wharf. The Skipper was on the bridge at the port helm position (See *Photograph 1*) whilst Crew 1 and Crew 2 were at the stern, readying the lines.

The Skipper could see that Crew 1 was at the bow (See *Photograph 1*) and ready to let go the forward lines but he could not see all that was happening in this area due to his position at the port helm station on the bridge (See *Photograph 2*). As such, he could not see the bits where the forward lines were attached to the vessel or what Crew 1 was doing with them.

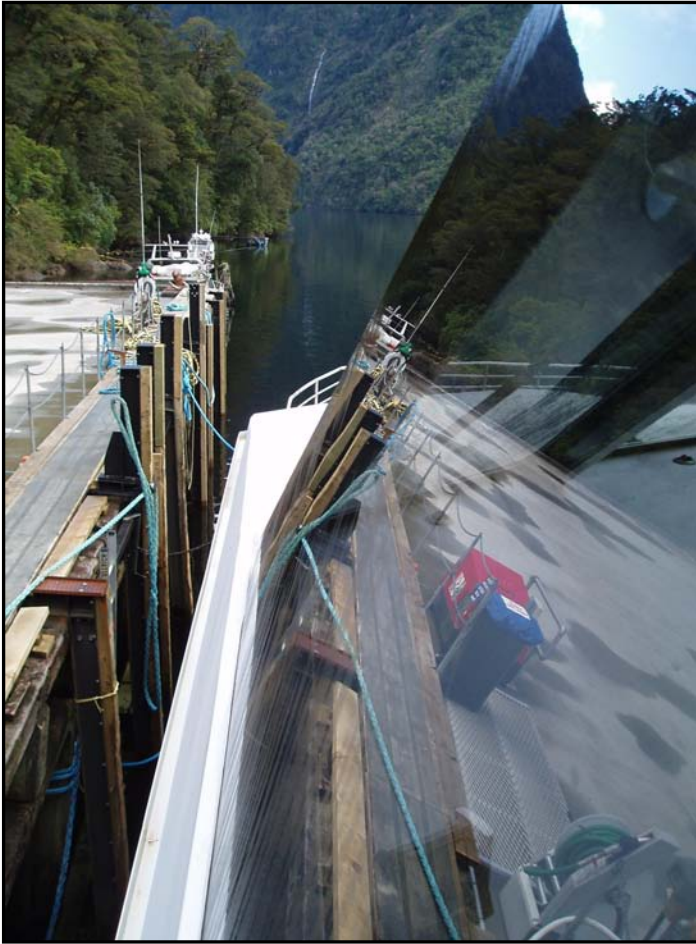
Photograph 2

View from port helm position on the bridge (leaning out the window)

The Skipper has limited vision of the port waist and bow mooring area from both the port and starboard helm positions on the bridge.

1. Employ a second fulltime crewmember on *Patea Explorer*.
2. Establish radio communications between the bridge and bow.
3. Ensure Skippers have positive control of the vessel and crew at all times while mooring and unmooring.

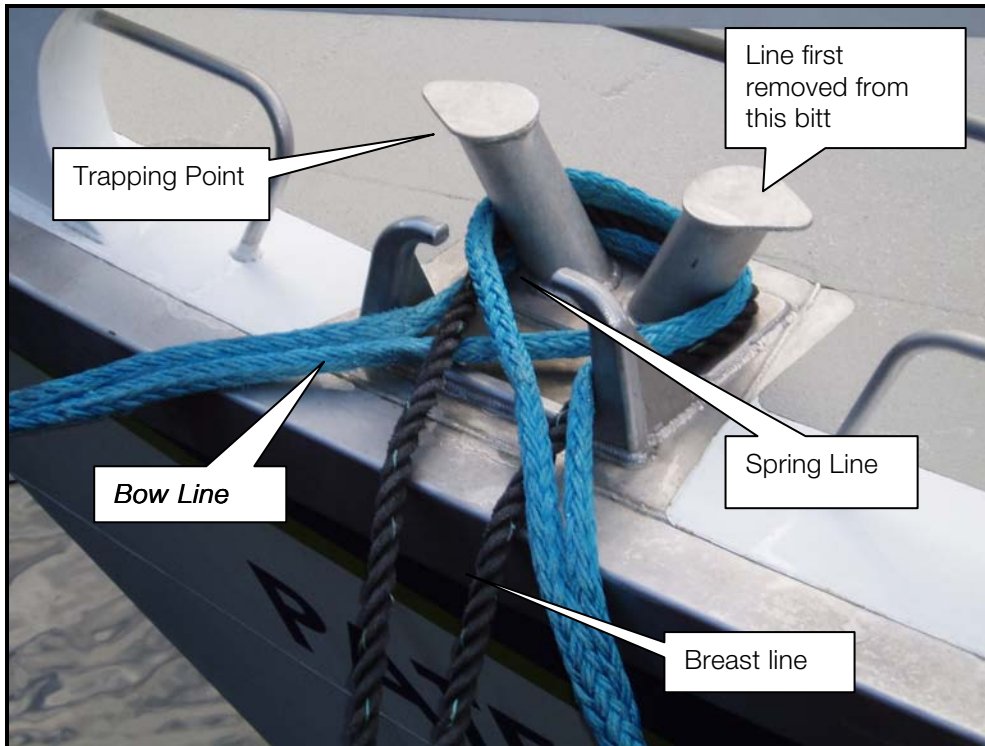
Photograph 3
Mooring lines and bollards

The eyes of three mooring lines at the bow namely, the bow line, forward breast line and forward spring line were secured over the set of bitts located on the port side of the bow section (See *Photograph 3*).

The eye of the forward spring line, which overlaid the eyes of the bow and breast lines, was the first to be removed by Crew 1. Using her left hand, she removed the eye of the spring line from the after bitt first. When she was about to remove the eye from the forward bitt, there was a gust of wind and the line tightened suddenly. Crew 1 did not have time to drop the line or move her hand before she found her left fingers trapped between the forward bitt and the forward spring.

The shore end of the mooring lines, all of which have a fixed length, are left permanently secured to bollards on the wharf. The eye of each mooring line, is placed over bitts on the vessel, as shown in *Photograph 3*. When the mooring lines have been let go, they are looped over retaining hooks attached to the wharf (See *Photograph 4*).

Real Journeys are currently reassessing the mooring arrangements of *Patea Explorer*. They have approached Incat Crowther in Australia, the builders of the vessel, to prepare drawings for the modification of the mooring bits at the stern and the fitment of a single Samson post at the bow on the outside of the coaming about a metre above the deck to allow easier and safer mooring/unmooring.
