Incident Report
Close Quarters
Pegasus II & Distraction
26 April 2006
Class B

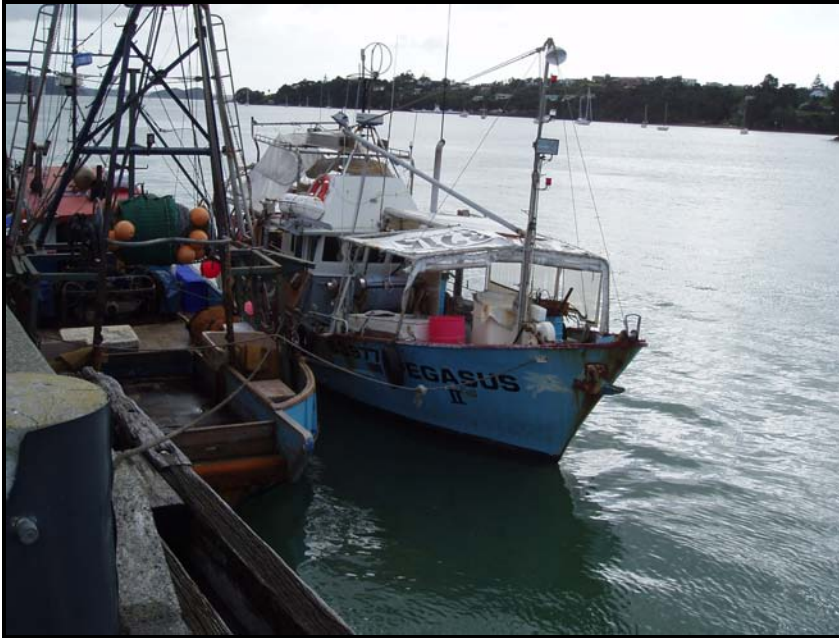
Photograph 1
Pegasus II

Pegasus II (See Photograph 1 – ***Pegasus II***) is a 15.46 metre commercial fishing vessel with a gross tonnage of 40. She is owned by Squid Enterprises Ltd of Gisborne. The vessel held a valid Safe Ship Management (SSM) certificate at the time of the incident.

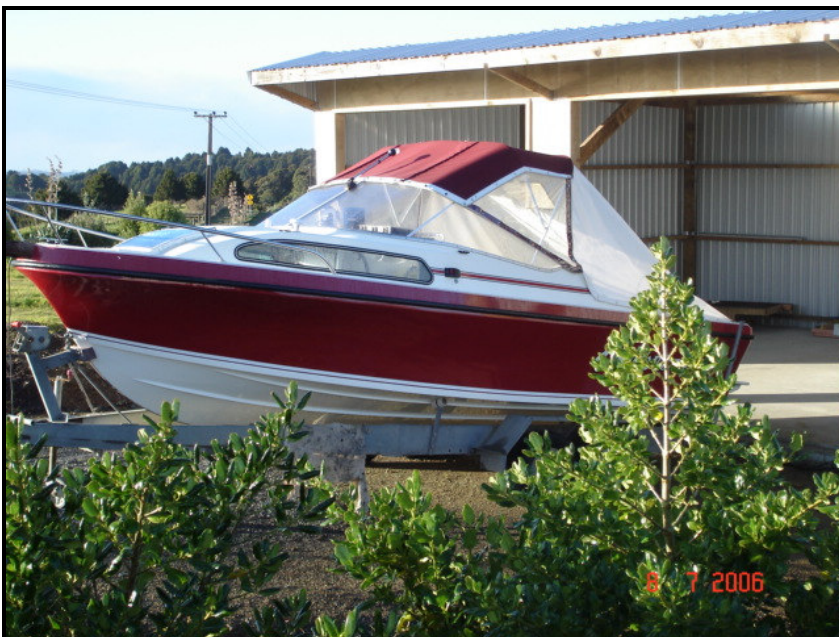
Photograph 2
Distraction

Distraction (See Photograph 2 – ***Distraction***) is a fibreglass 6 metre recreational vessel.

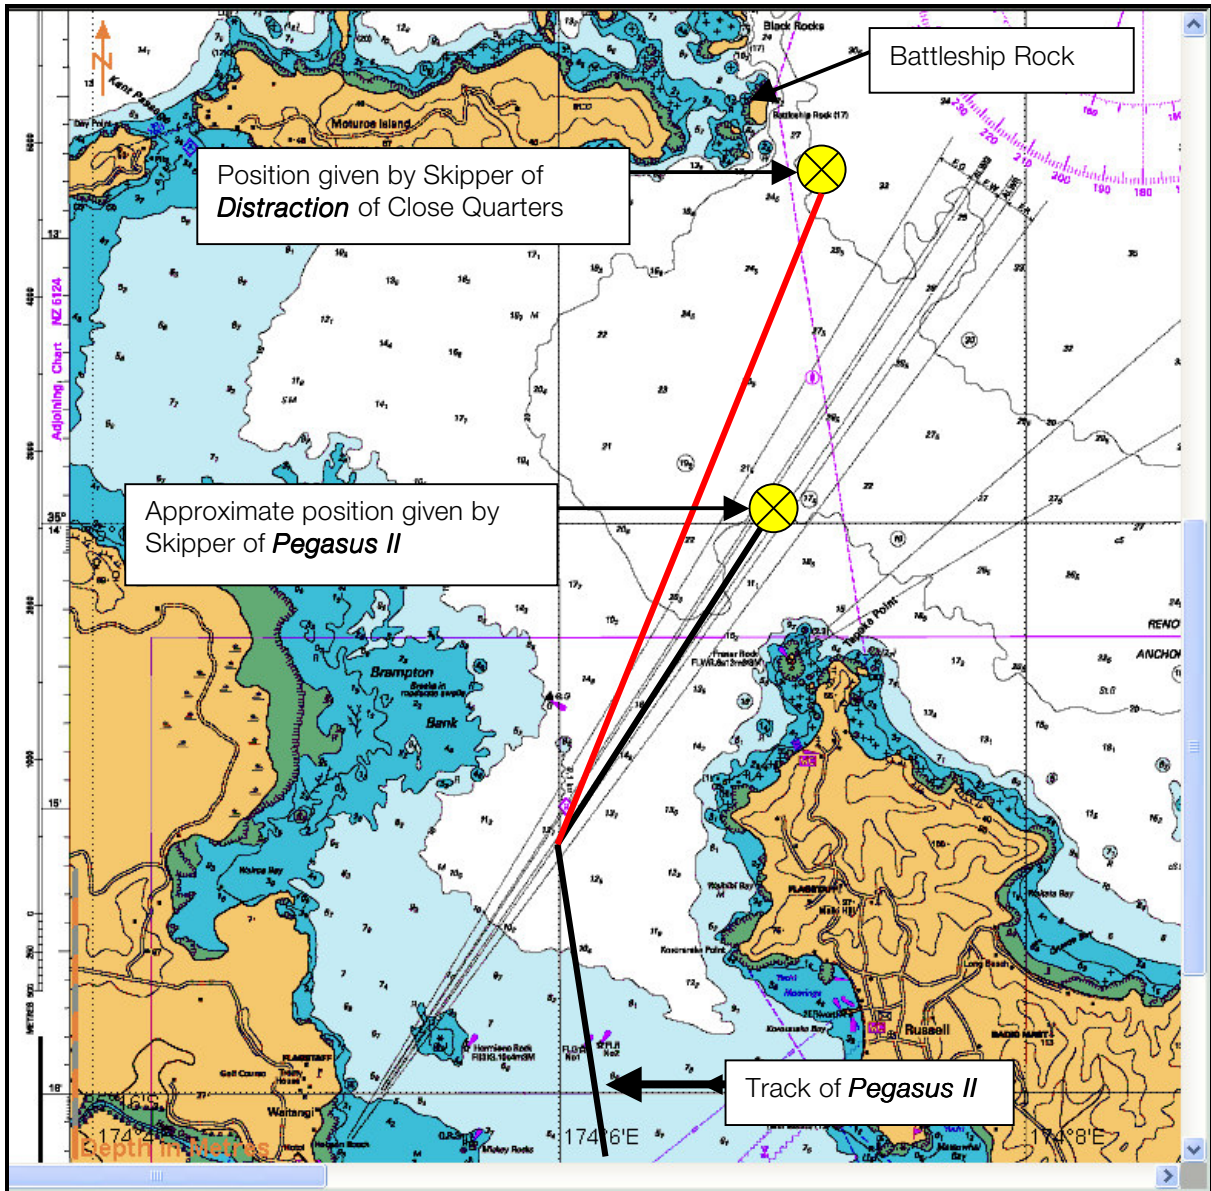
On 24 April 2006 at approximately 1445 hours New Zealand Standard Time (NZST), the recreational vessel *Distraction* was at anchor, fishing in the Bay of Islands. At the same time the fishing vessel *Pegasus II* was outbound from Opuia. The Skipper of *Pegasus II* left his vessel on auto pilot to do maintenance on deck. He failed to observe that his vessel was on a collision course with *Distraction*. *Pegasus II* passed over *Distraction's* anchor warp after the Skipper of *Distraction* took evasive action (See Figure 1 - NZ Chart 5125 showing stated positions and courses).

The Skipper had anchored *Distraction* approximately 0.5 miles south east of Battleship Rock (See *Figure 1*) for fishing. He observed *Pegasus 2* on a course from the south west heading directly towards his vessel. He could see someone on the foredeck bent over doing what looked like maintenance. As *Pegasus II* closed on *Distraction* the Skipper determined collision was imminent and ordered his crew to haul in the anchor. At that stage it became apparent to him that there was no time to haul in the anchor and he ordered the crewman to release the anchor warp. He immediately went hard in reverse to avoid *Pegasus 2* colliding with his vessel. As *Pegasus II* passed within three to five metres of his vessel he observed the Skipper running to his wheelhouse. *Pegasus II* then circled back to *Distraction* whereupon the Skipper alleged that *Distraction* was anchored in a shipping channel and was not permitted to anchor according to his "almanac".

Figure 1
 NZ Chart 5125 showing stated positions and courses.

There is considerable doubt as to whether the incident took place in the sector light area or off to the west as stated by the Skipper of *Distraction*.

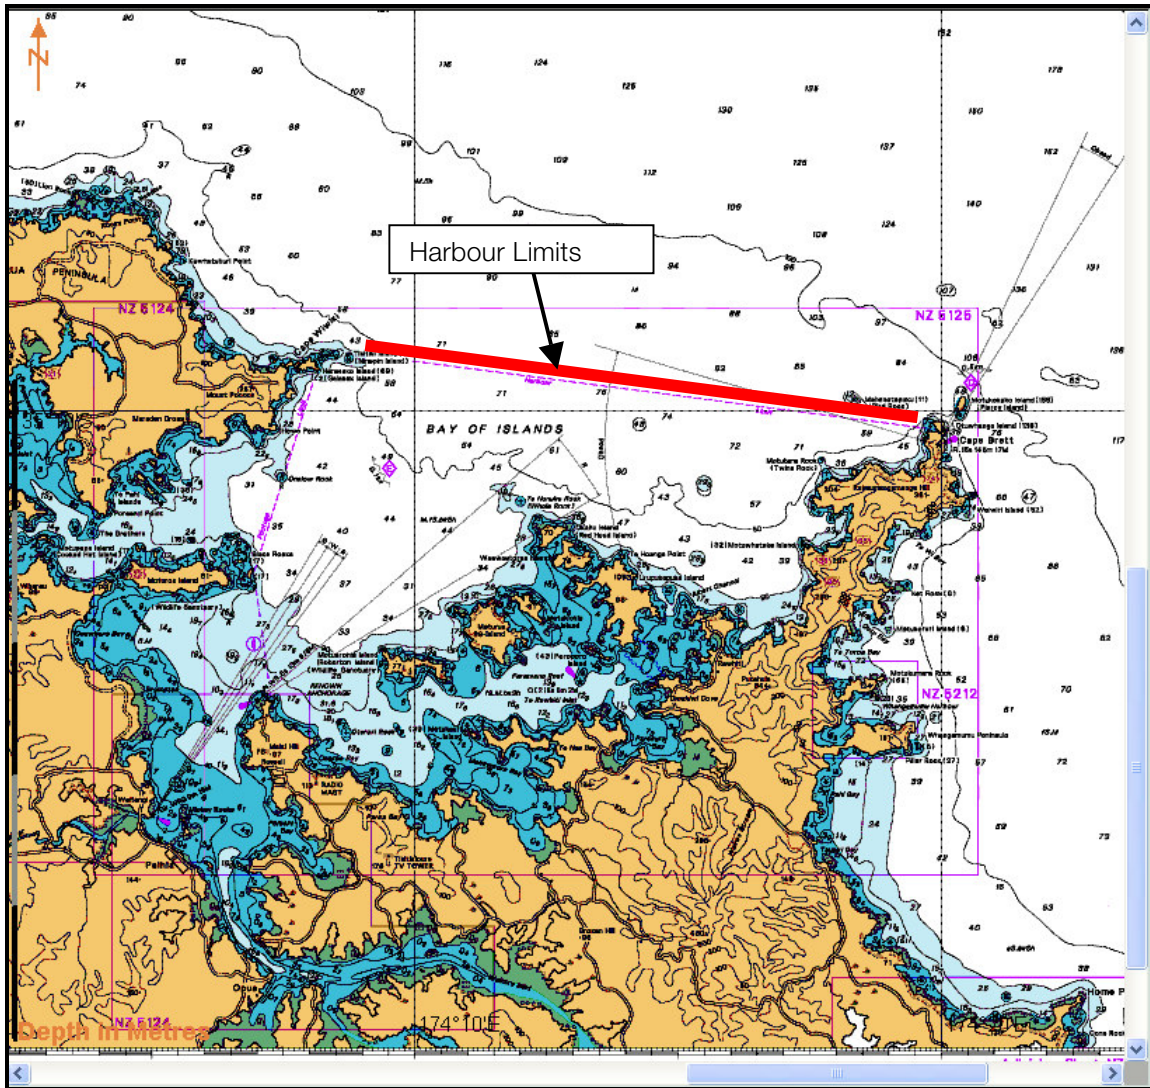
Figure 2
 NZ Chart 5125 showing Harbour Limits.

The positions given by both skippers fall well within Harbour limits. Harbour Limits lie inside a line from Harakeke Island to Tikitiki (Ninepin) Island to Cape Brett (See *Figure 2*).
