Accident Report

Predator

Capsize & Fatality

REPORT NO.: 05 1166

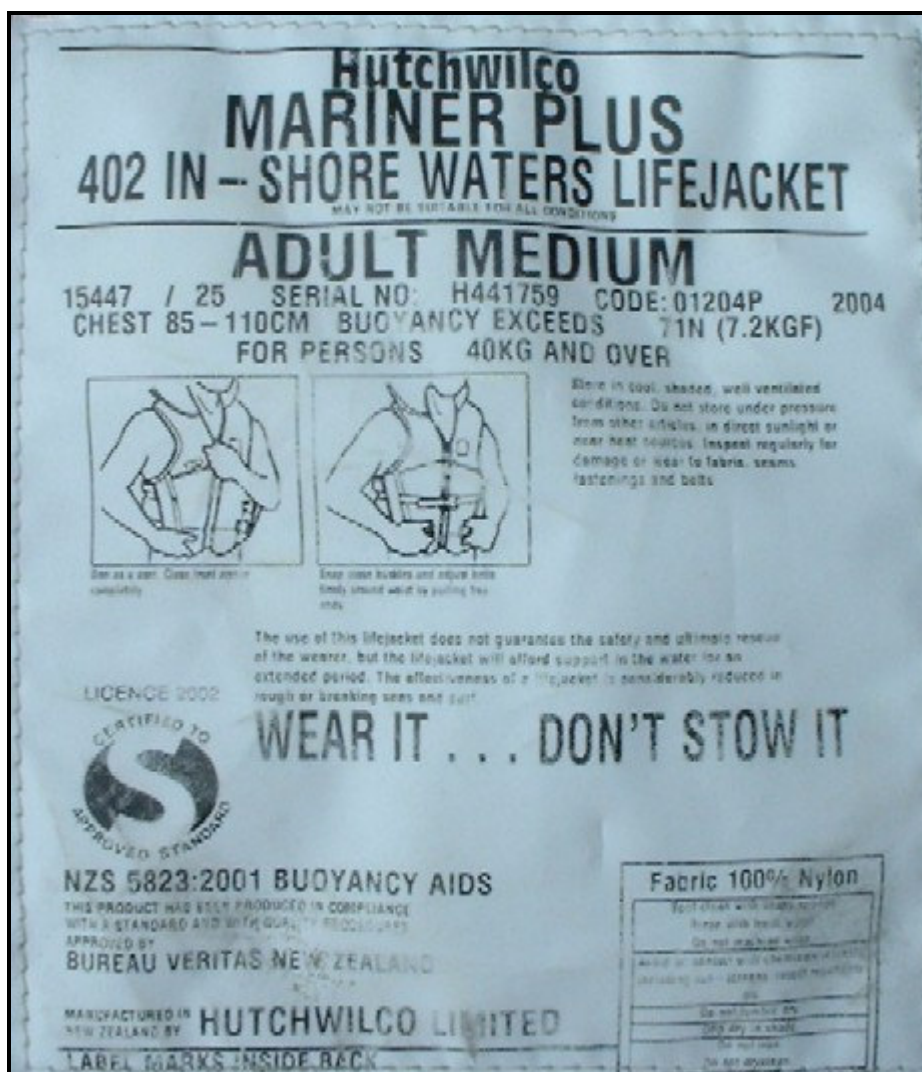
Photograph 2

The Owner asked if all the boys had done up their lifejacket but did not check this for himself. Steven was seen to have zipped his lifejacket up but had not secured the two securing clips. This jacket was seen shortly after the capsizing floating away. Without the two clips secured and pulled tight, the lifejacket would have floated clear of the wearer.

Label of the Lifejacket that Steven was wearing before capsizing

3. That the Business Development & Communications Division of Maritime New Zealand continue to promote by all possible means, the wearing and proper securing of lifejackets for recreational boat users.

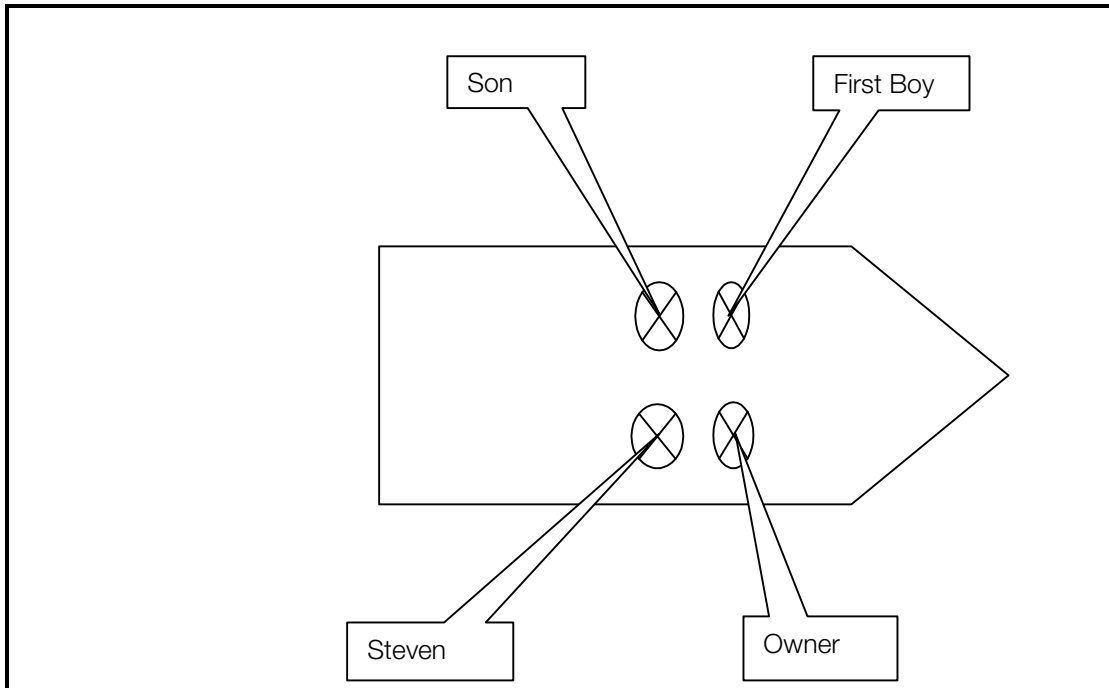
Figure 2
Plan of vessel before capsized

The Owner was standing on a pedestal at the helm station on the starboard side of the vessel. The first boy was seated on the port side, and Steven was standing behind the helm station seat on the starboard side. The Owner’s son was standing behind the port side seat.

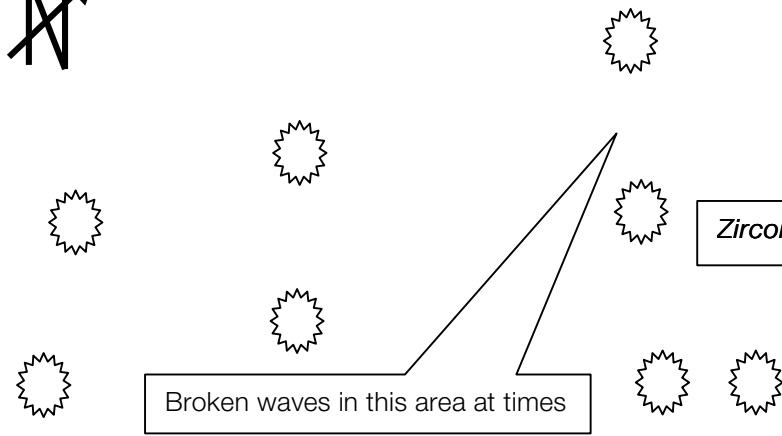
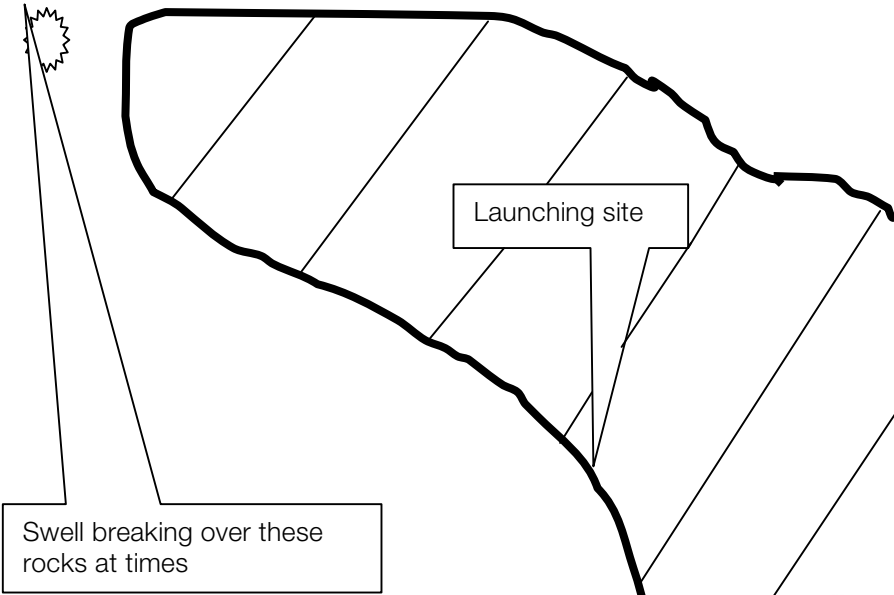
Figure 3
Sketch of Maraetai Bay

Approximate *Predator* track and capsize position

Broken waves in this area at times

Swell breaking over these rocks at times

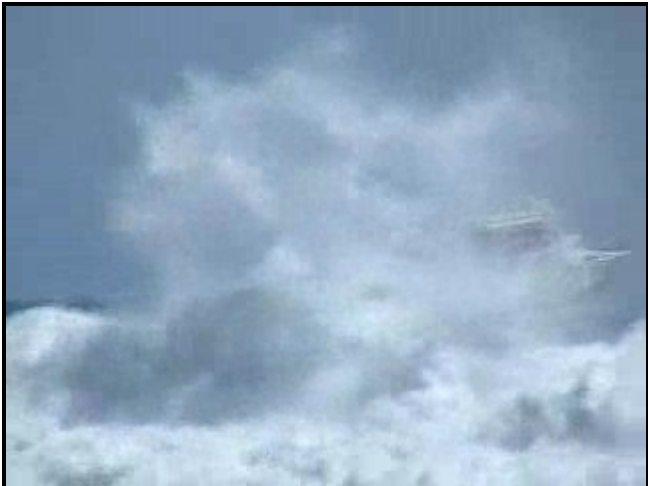
Photograph 4a
Predator emerging from wave

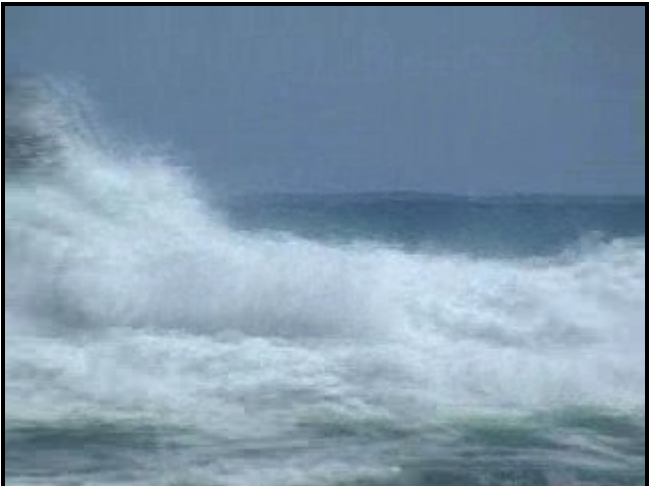
Photograph 4b
Predator is partially rolled over backwards

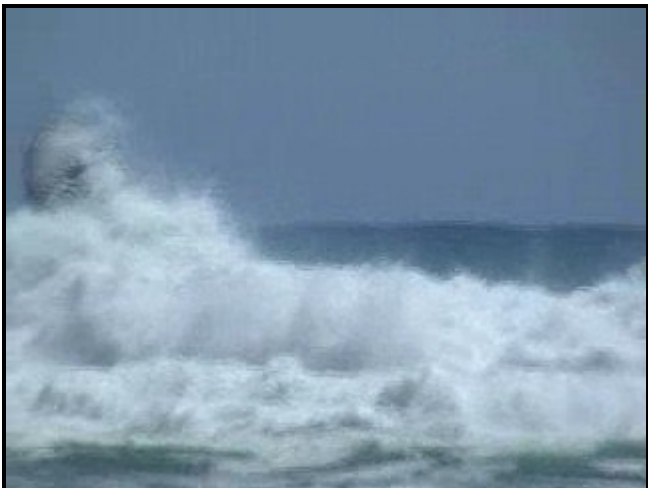
Photograph 4c
Predator falling over to upturned position

- **Predator** was designed with its reserve buoyancy situated in the floors below the water line, with the result that, in conjunction with a heavy outboard motor at the stern, it adopted a "bow up" attitude following the capsize.

2. That Maritime New Zealand, in conjunction with the Marine Industries Association and the boat building industry continue to explore the feasibility of the ways in which level floatation can be achieved for vessels up to 8 metres in length.

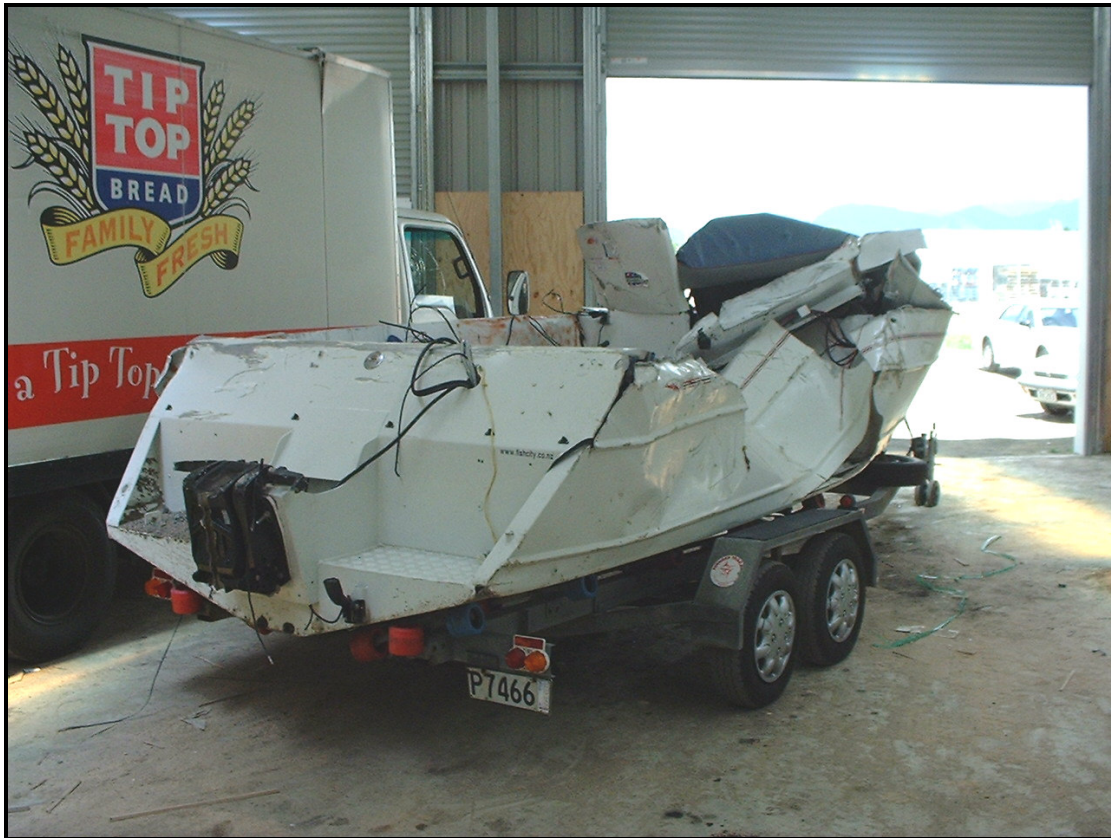
Predator sustained severe damage due to the fact that after it capsized, it drifted over a number of rocks and reefs before reaching the shore. It is difficult to determine what damage the vessel sustained as a result of capsizing. However, the hull of the vessel was apparently intact when the survivors exited the upturned vessel.

Photograph 5
Predator after recovery
