Incident Report
Close Quarters
*Morning Haruka & Otakou
& Purbeck*
9 August 2005
Class B

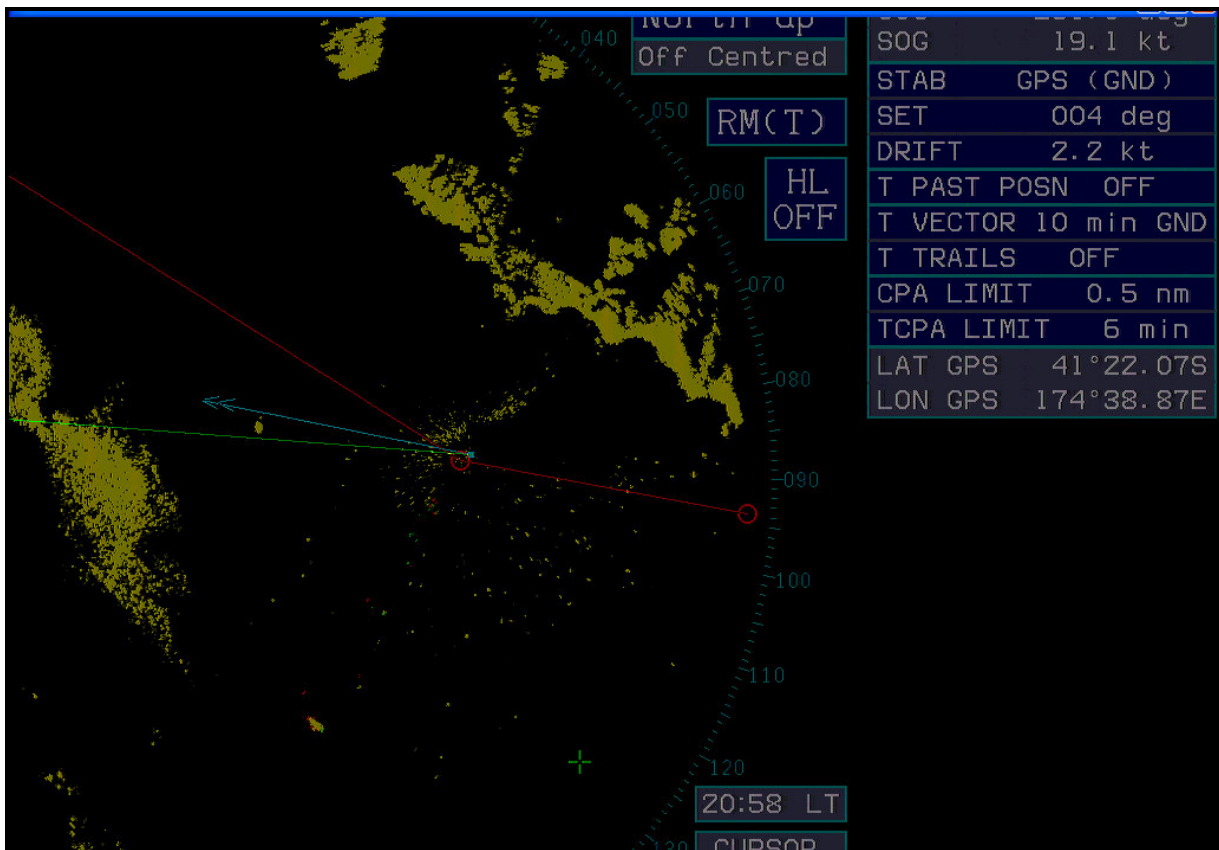
Figure 2
Part of Radar Image at 2058

- 2058 *Purbeck* alters course for Tory Channel Entrance at way point 2.0 miles south west of Tongue Point. Figure 2 shows part of *Purbeck's* radar image at this time. She has a speed over the ground of 19.3 knots. Alarms are set for a CPA of another vessel of 0.5 miles and a time to closest point of approach (TCPA) of 6 minutes. The return from *Morning Haruka* is masked by the returns from the band of rain ahead of *Purbeck*. The red line shown on the screen is *Purbeck's* planned track. The red circles on the red line are the alter course way points. The blue dot marks *Purbeck's* position and the blue line extending from it shows the course over the ground. The green line indicates the course being steered.

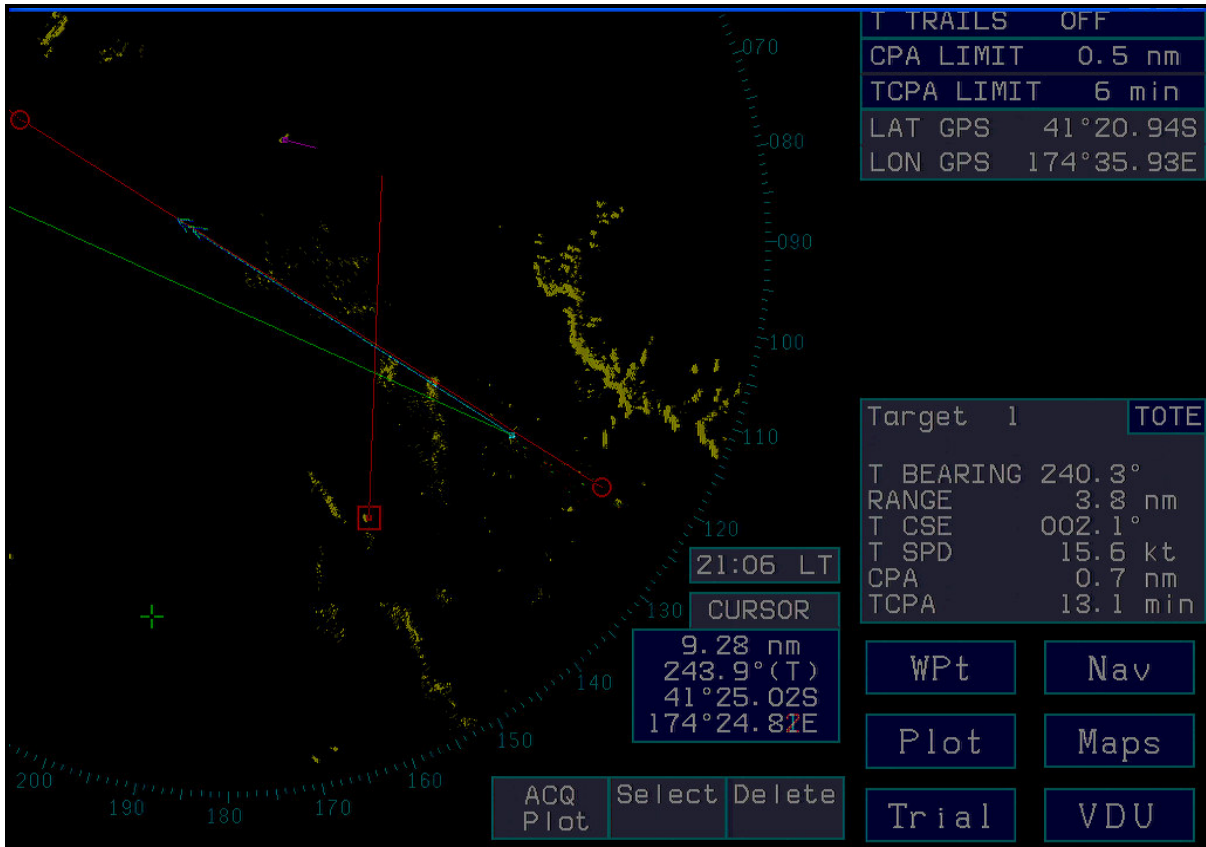
Figure 3
Part of Radar Image at 2106

2106 Information available from the ARPA acquisition indicated a CPA of 0.7 miles and a TCPA of 13.1 minutes at 2119. (See Figure 3 - Part of Radar Image at 2106). **Morning Haruka** has **Purbeck** 59° on her starboard bow. **Purbeck** has **Morning Haruka** 54° on her port bow at a distance of 3.8 miles.

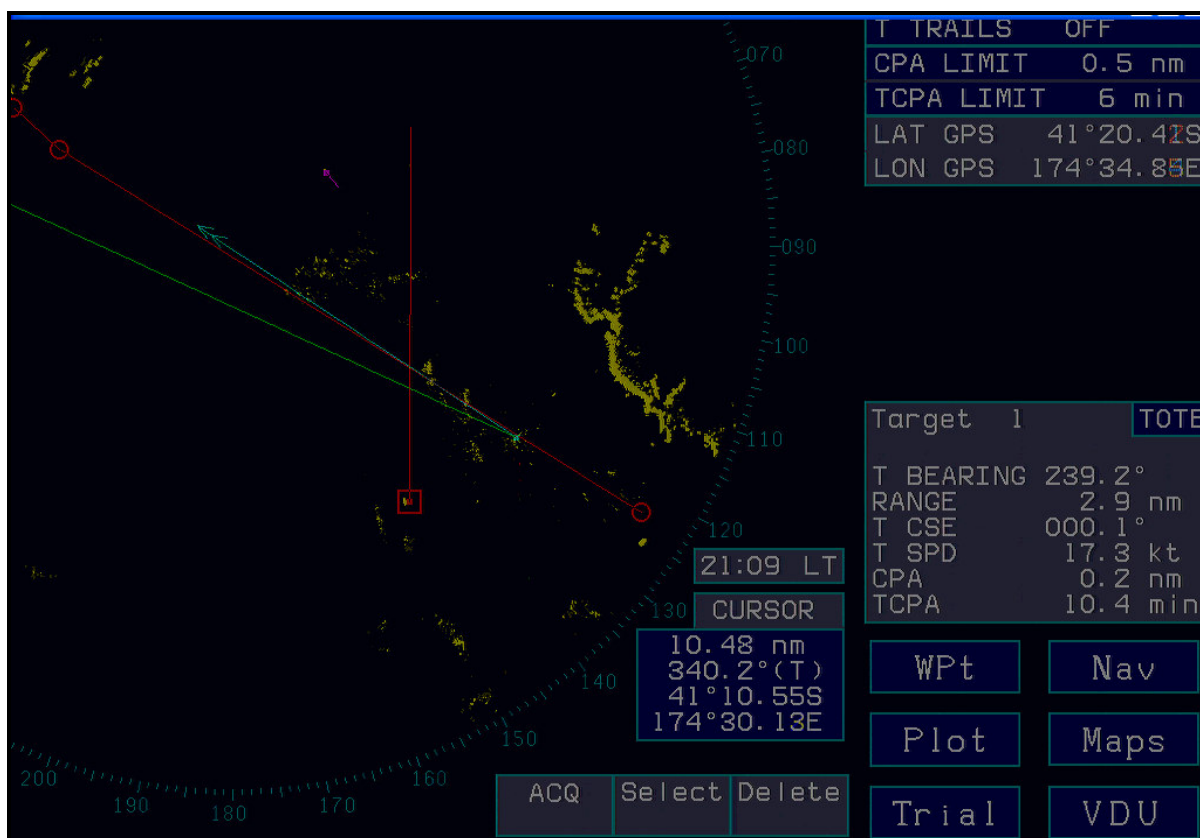
Figure 4
Part of Radar Image at 2109

2109 The accuracy of the radar plot increased with time and the CPA of *Morning Haruka* had reduced to 0.2 miles and the TCPA to 10.4 minutes at 2119. (See Figure 4 - Part of Radar Image at 2109). The distance between the two vessels at this time was 2.9 miles. At this time the following radio communication took place on VHF Channel 16:

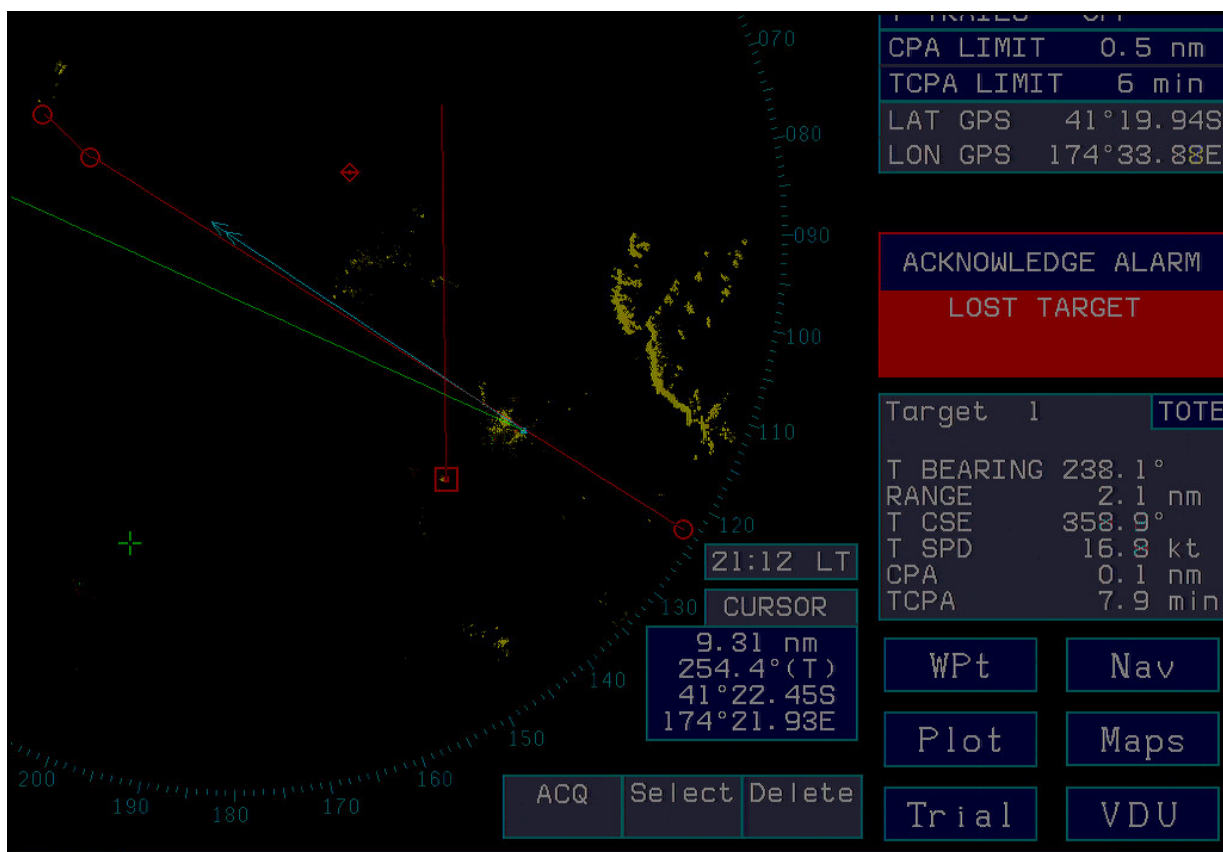
Figure 5
Part of Radar Image at 2112

2112 **Morning Haruka** had not altered course and the CPA had reduced to 0.1 miles. TCPA was 7.9 minutes at 2120. (See Figure 5 - Part of Radar Image at 2112). The following radio communications took place:

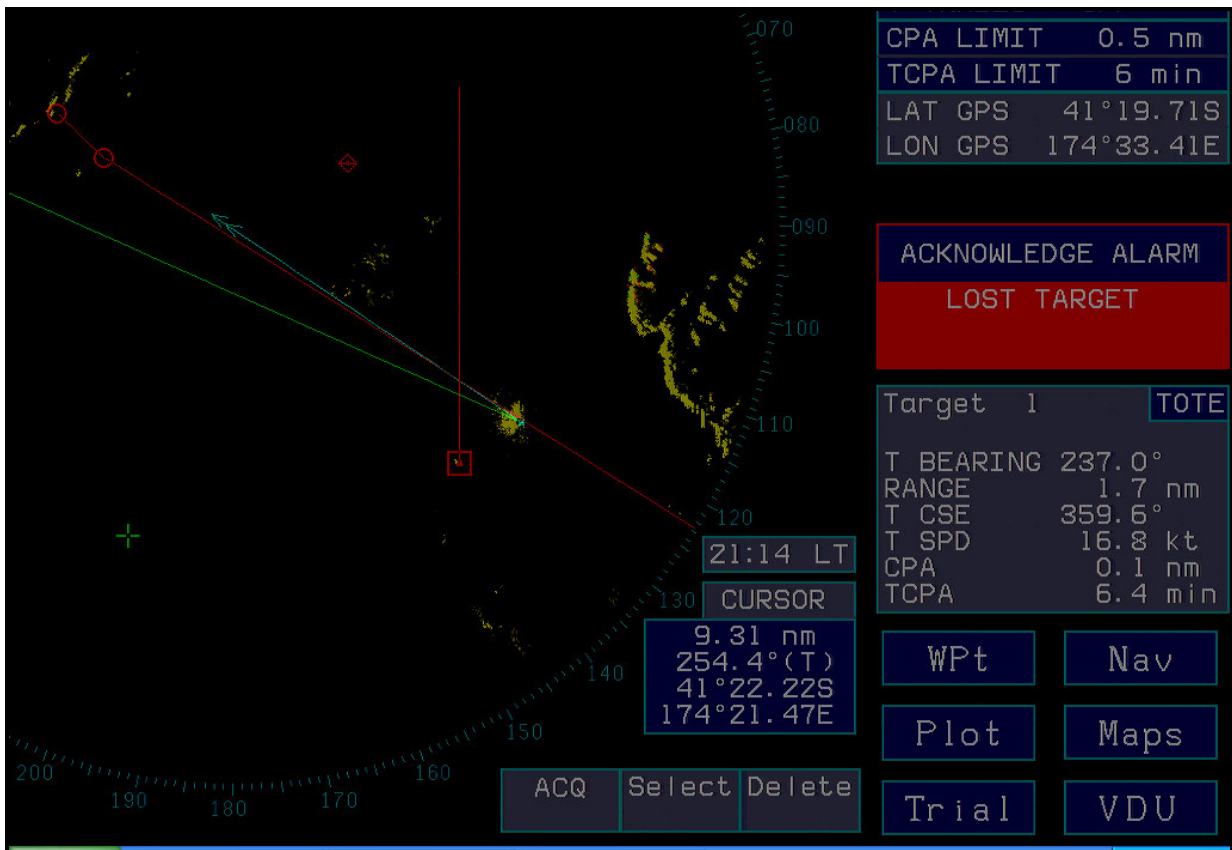
Figure 6
Part of Radar Image at 2114

2114 **Morning Haruka** had not altered course and the ARPA was showing a CPA of 0.1 miles and TCPA of 6.4 minutes at 2120. (See Figure 6 - Part of Radar Image at 2114). The distance between the two vessels at this time was 1.7 miles.

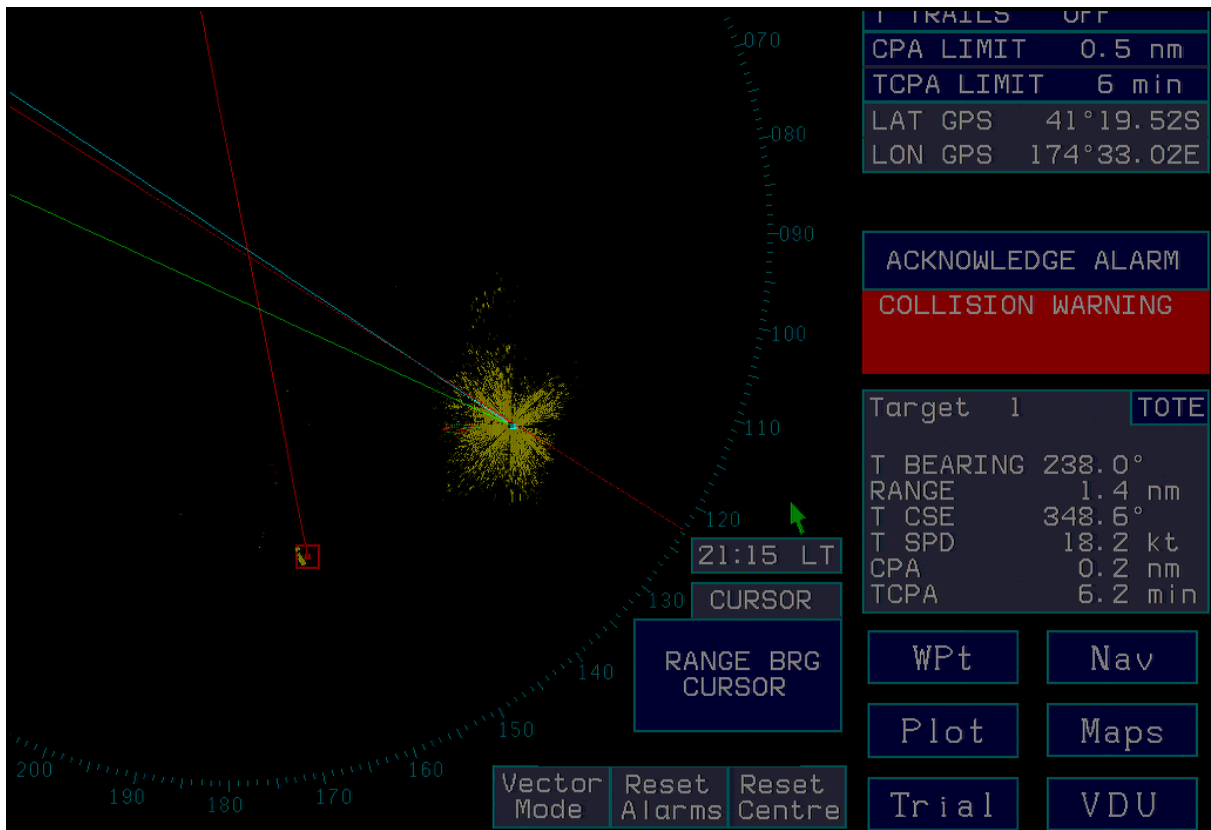
Figure 7
Part of Radar Image at 2115

- 2115 The ARPA showed *Morning Haruka* was altering course to port and was making good a course of 348.6°(T) at a speed of 18.2 knots over the ground. *Purbeck's* log information indicated a set and drift of 024° at 2.6 knots at that time. The CPA was still 0.2 miles but the TCPA had changed to 6.2 minutes at 2121.

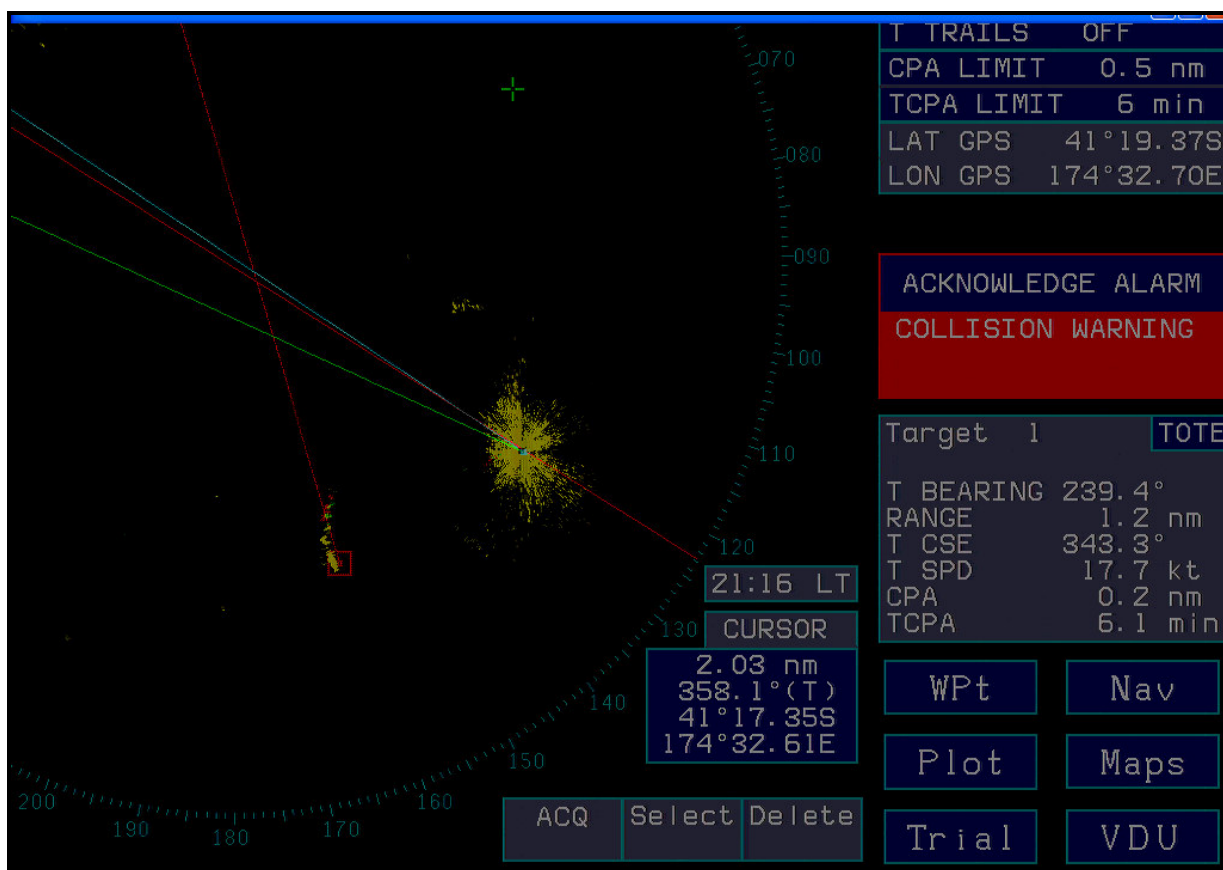
Figure 8
Part of Radar Image at 2116

2116 The ARPA indicated that **Morning Haruka** had altered course approximately 17° to port but the CPA was still 0.2 miles with TCPA of 6.1 minutes at 2122. The distance between the two vessels at this time was 1.2 miles. The following radio communications took place:

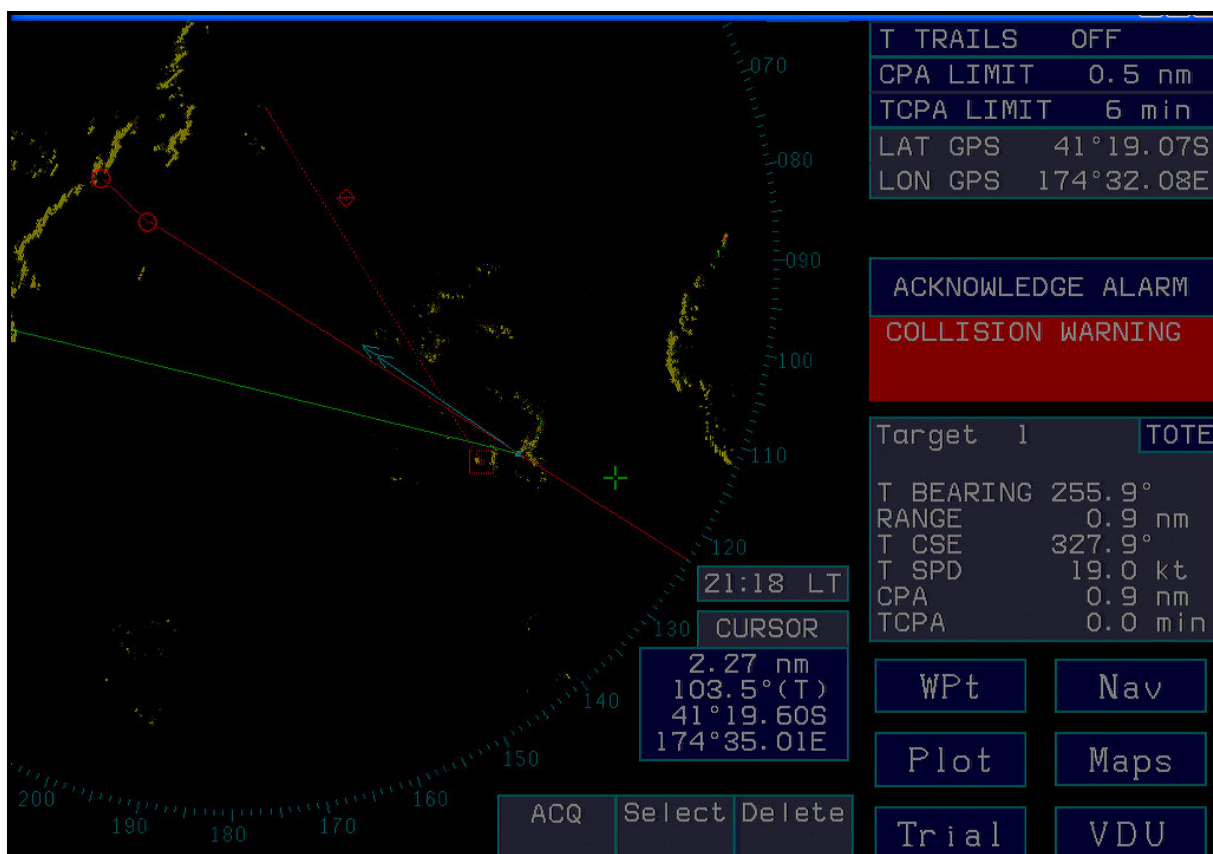
Figure 9
Part of Radar Image at 2118

2118 **Purbeck** had reduced speed to 8.2 knots through the water and had reached her closest approach to **Morning Haruka** of 0.9 miles. (See Figure 9 - Part of Radar Image at 2118).
