Accident Report
Queenstown Princess
Grounding on Lake Wakatipu
on 13 February 2004

REPORT NO.: 04 3381

VESSEL NAME: *QUEENSTOWN PRINCESS*

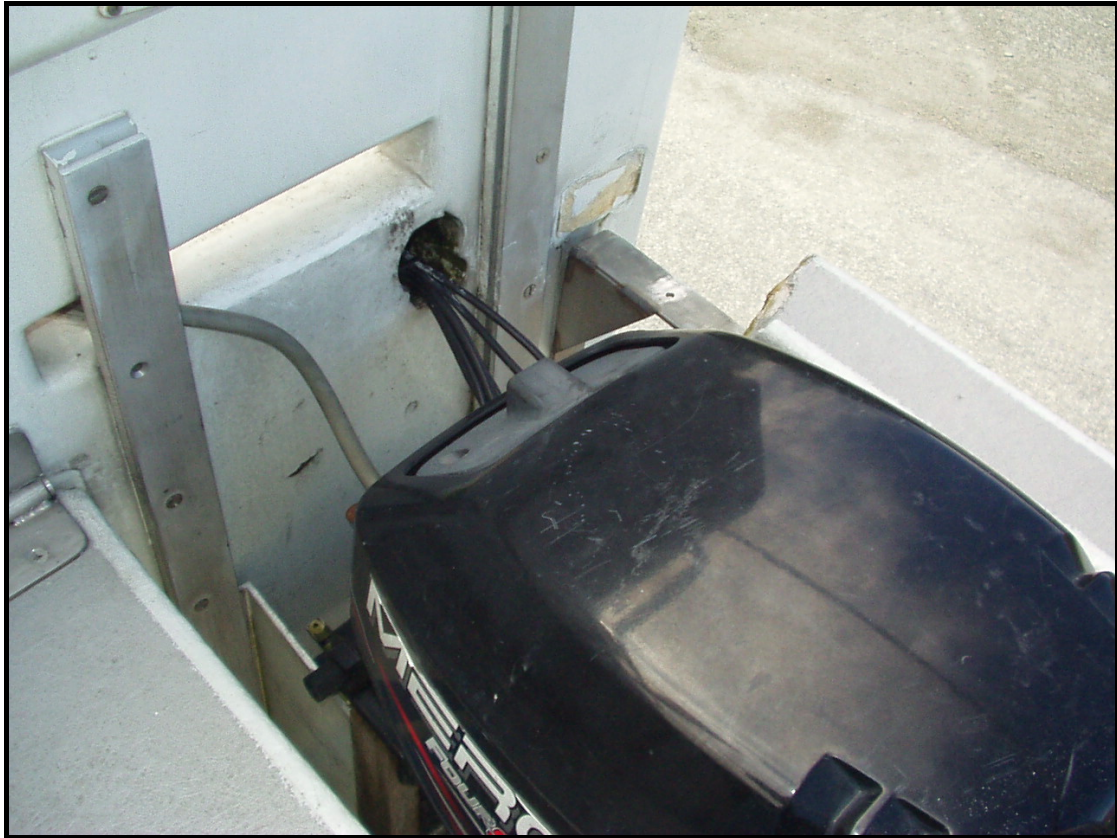
- 1.1.7 Due to the relative grounding angle of the vessel to the shore and lake bed, the after quarter of the starboard hull was submerged. This, in turn, caused water to flood into the starboard hull and engine room through an aperture that had been cut in way of the transom stern; a similar aperture had been cut in way of the stern of the port hull. The aperture or hole in each hull had been cut by the owners of the vessel to allow passage for the controls to the two outboard motors (See Appendix 2 - Photograph).

- 3.1.8 The presence of holes that had been cut in way of starboard transom stern, allowed the starboard hull to start down flooding. This was a very serious non – compliance, that significantly affected the vessel's fitness for purpose and the concomitant safety of the passengers and crew. Such a major modification/alteration in the ship's twin hulls was likely to significantly affect the structural integrity, freeboard, watertight subdivision and stability of the vessel. In such circumstances, the owners were required by **Maritime Rule Part 21.13 (19) – Safe Ship Management Systems**, to obtain:-

3.1.9 Since the accident, the two holes in the hull have been plugged with a proper sealant to ensure the watertight integrity of the vessel; the vessel surveyed by the SSM company and a new Fitness for Purpose Certificate and a SSM Certificate issued in accordance with **Maritime Rule Part 21**.

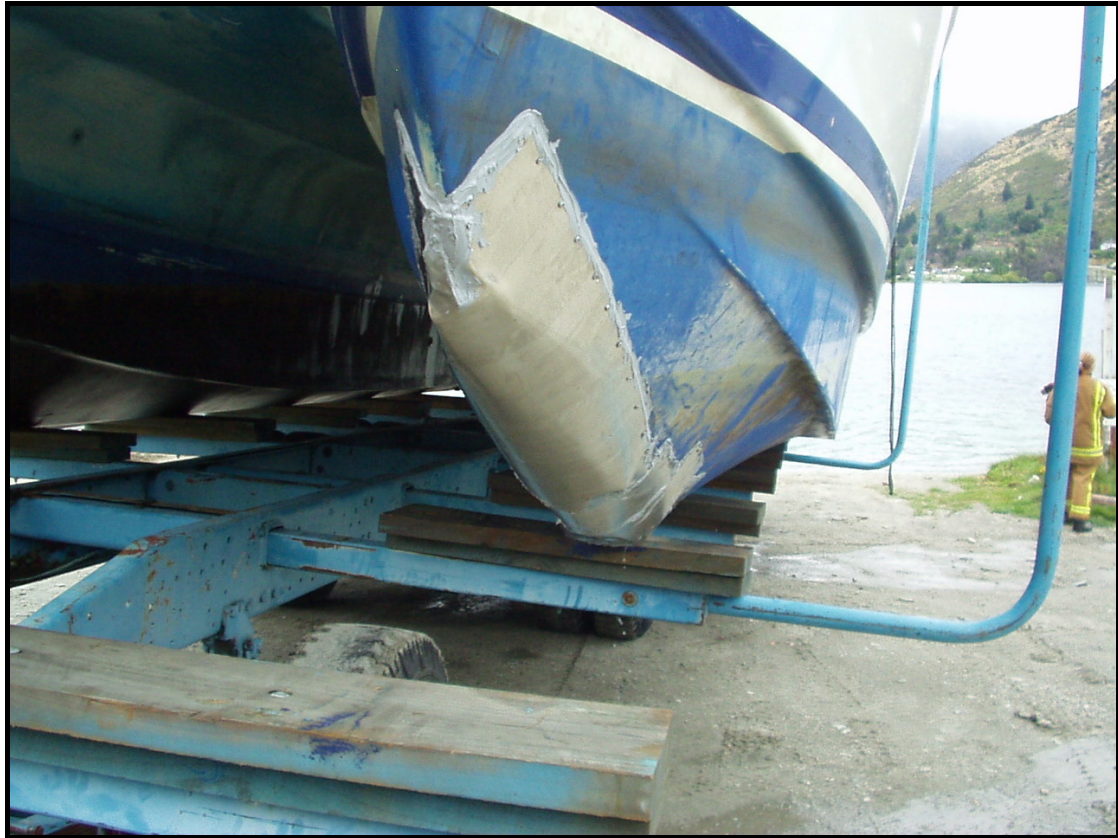
Appendix 3

- 1.1.6 At 2210 hours, a loud bang was heard and the vessel jolted. The port bow of the vessel then grounded on the shore to the north of Collins Bay (See Appendix 1 – Map of Lake Wakatipu). The hull of the vessel, in way of the port bow, was breached severely by a rock on grounding (See Appendices 3 & 6 – Photographs of the vessel's port bow). The Skipper stopped both main engines immediately after the vessel grounded. The terrain, in way of the position where the vessel grounded, was steep to, with cliffs rising from the water's edge, at an angle of 50-60 degrees to the horizontal. Sunset was at 2051 hours on 13 February and, at the time of grounding, there was little or no natural light remaining. The Skipper did not see the shore before the grounding occurred.

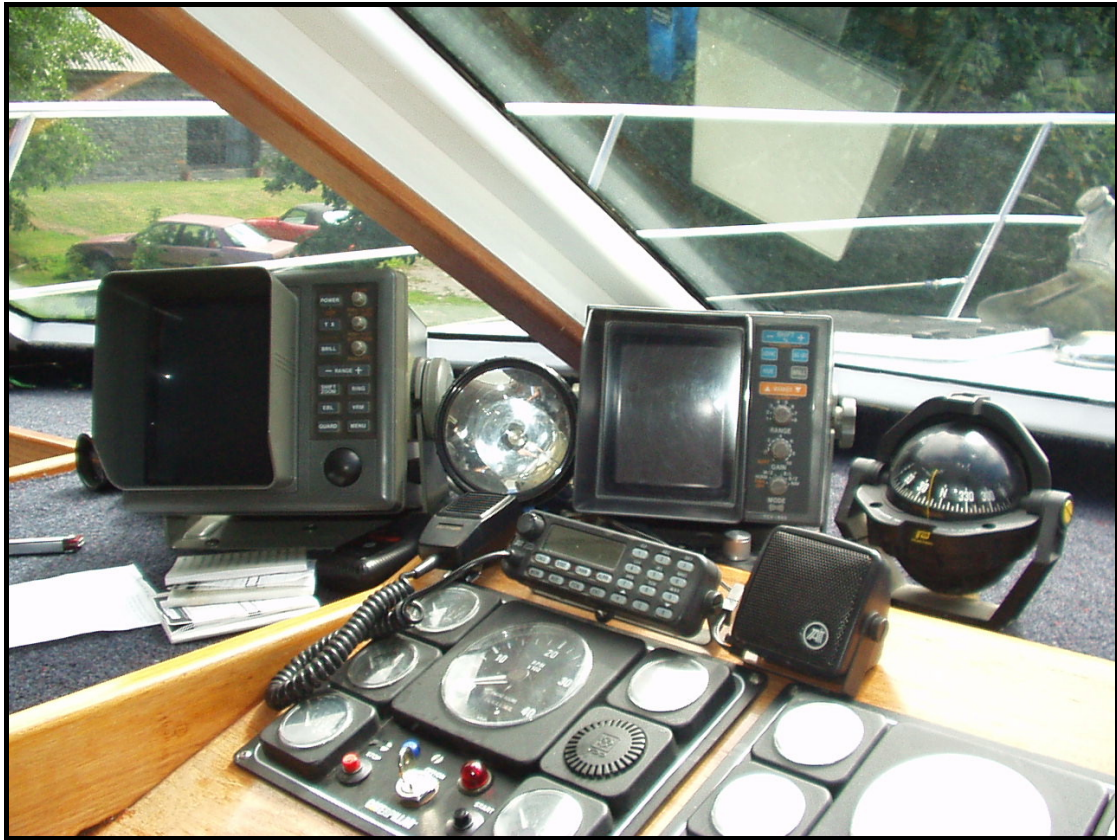
2.2 Navigation and Safety Equipment *(See Appendix 5 – Photographs)*

2.2.1 *Queenstown Princess* was equipped with the following navigational aids:

- 1 x magnetic compass (mounted at steering station)
- 1 x daylight viewing echo sounder: model Furuno FCV – 665
- 1 x day light viewing radar: model Furuno, maximum range 16 miles
- 1x VHF radio: model Tait 2000
- 46 x Lifejackets
- 2 x Lifebuoys
- 4 x distress signals
- Bilge pumping arrangements
- Mechanical pump driven off starboard engine
- Electric bilge pumps x 2 in each sponson positioned in engine room and amidships
