Accident Report  
COLLISION  
*Quickcat & Doctor Hook*  
04 January 2005  
Class A

**VESSEL NAME:                    *QUICKCAT***

**VESSEL NAME:                    *DOCTOR HOOK***

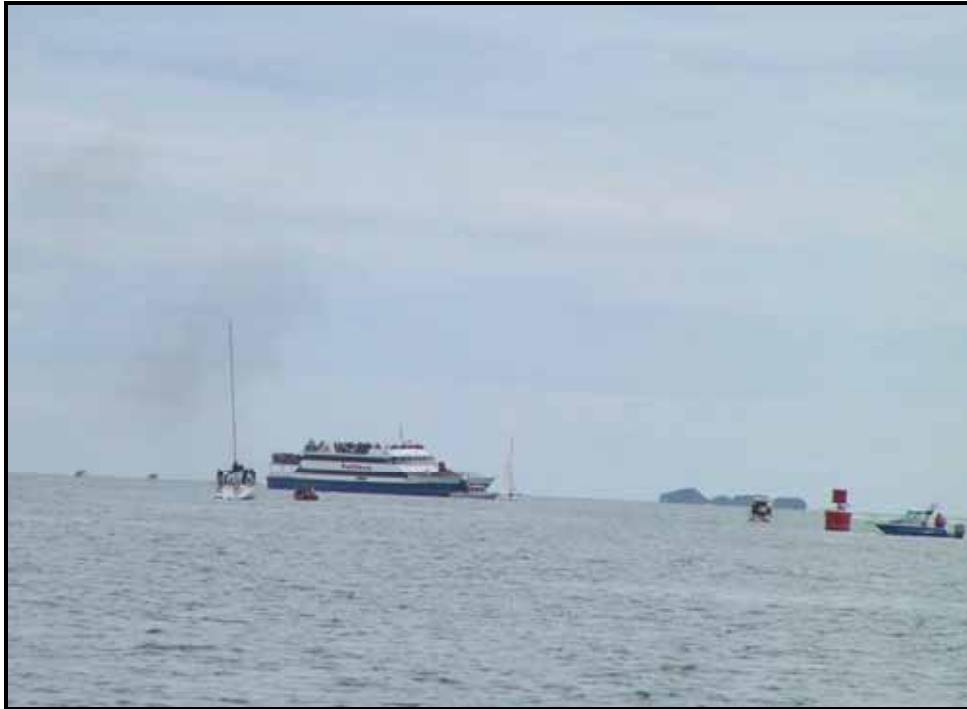
PHOTOGRAPH 4 (COURTESY KEITH INGRAM)

The Skipper observed **Quickcat** was going hard astern at a distance of approximately 50 metres from **Doctor Hook**. After **Doctor Hook** was secured to **Quickcat's** port quarter, the Coastguard and Police arrived and the Skipper and his passengers were taken to hospital (See Photograph 4 – **Quickcat** & **Doctor Hook** after collision).

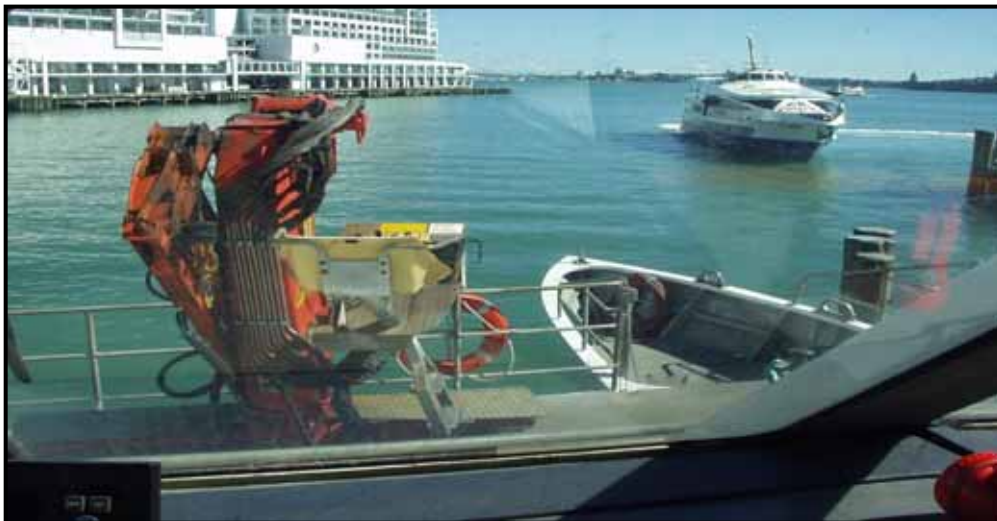
PHOTOGRAPH 5

A helmsman who stands on the bridge of *Quickcat* is offered reasonable vision (See *Photograph 5 – vision from standing position to starboard bow* & *Photograph 6 – vision from seated position*). In the centre of the bridge are two pneumatic chairs, one of which allows the helmsman to steer the vessel whilst seated (See *Photographs 7 & 8 – chairs & bridge*). Vision from the helm chair is compromised by a combination of the crane on the starboard foredeck, the window mullions and the top of the radar screen. There is an approximate 15° sector, when the crane and window mullions are combined, that compromises vision from the helm seat. In addition, any small vessel that is close under *Quickcat's* starboard bow can be hidden behind the radar screen.

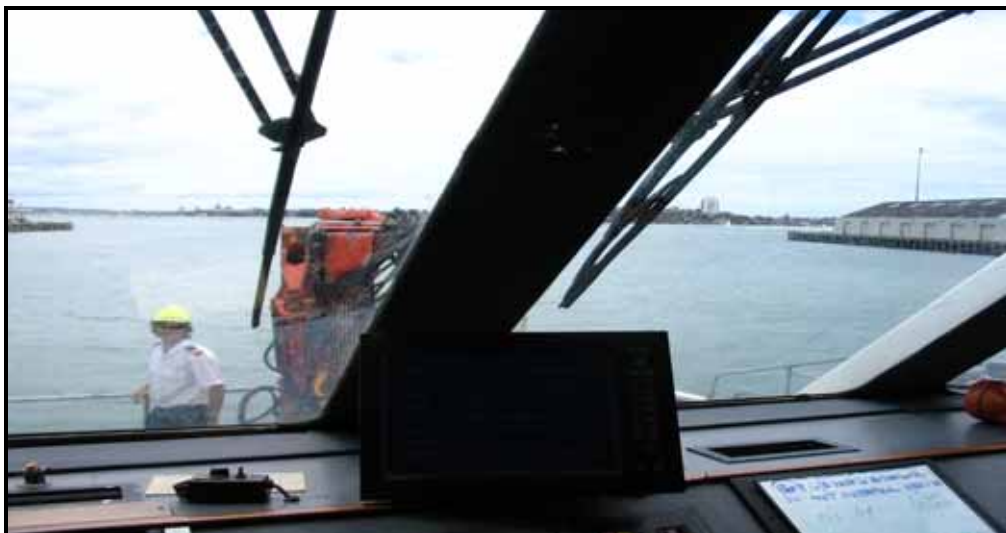
PHOTOGRAPH 6

Initial findings determined that the location of the cargo crane on the starboard bow was a contributing factor in this accident. As a result, MSA served a notice of Imposition of Conditions on the operation of **Quickcat** on 7 January 2005, requiring that two watchkeepers be on duty at all times whilst the vessel is operational, until the crane is removed from the deck. This procedure was initiated by the Company immediately after the accident. During the investigation, company management stated that a collapsible crane for the foredeck had been ordered prior to the accident as the current crane was in need of replacement due to its mechanical condition.

The positioning of any object either within the bridge or on the foredeck that obstructs vision from the helm position should, if practicable, be avoided. This is especially so if the obstruction compromises the helm vision to starboard. There were three objects, all within close proximity of one another that were capable of compromising the helmsman's vision to starboard. The crane was the primary obstruction followed by the window frame and the top of the radar screen.

3. It is recommended that Fullers Group Ltd be severely censured for failing to take proper steps to eliminate, isolate or minimise the hazard presented by the crane and other visual impairments obstructing vision from the helm position.

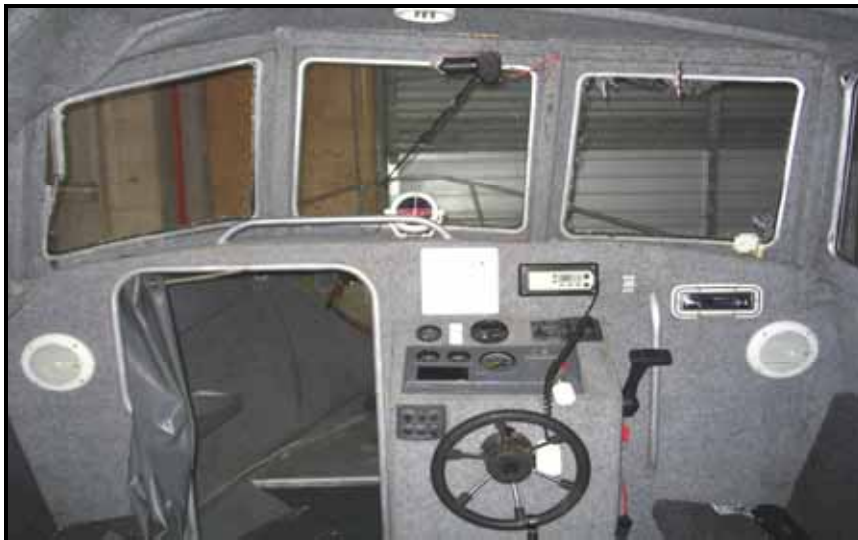
PHOTOGRAPH 9

Vision from the helm of **Doctor Hook** was good. Large windows afforded reasonable visibility fore and aft. The Skipper stated there were small blind spots when looking aft caused by the coach house supports. He believed that when he initially turned after being warned that **Quickcat** was approaching, he failed to see the vessel as one of the passengers was standing in front of the port aft deck coach house window, blocking his vision (See *Photograph 9 – damaged interior of house & Photograph 10 – coach house viewed from aft*).

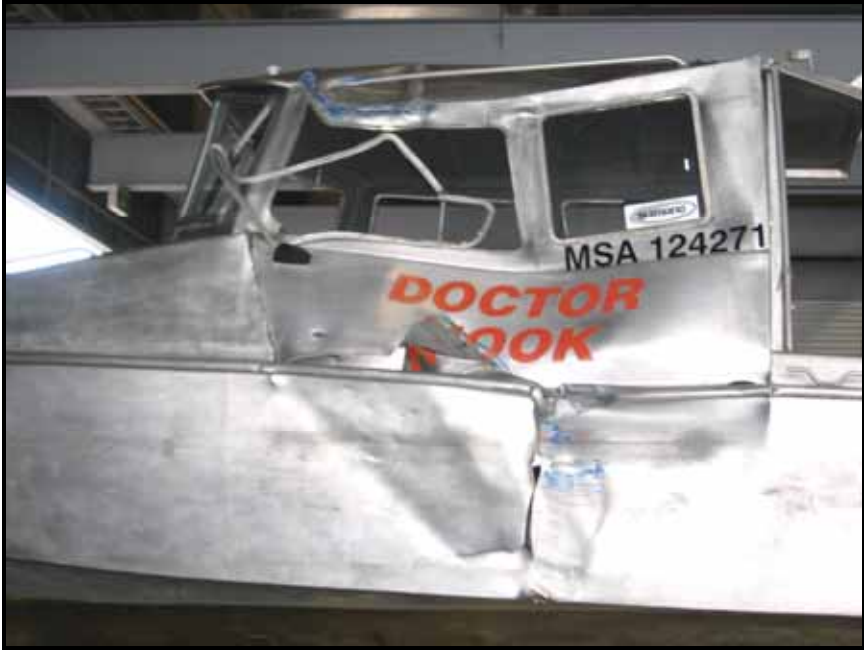
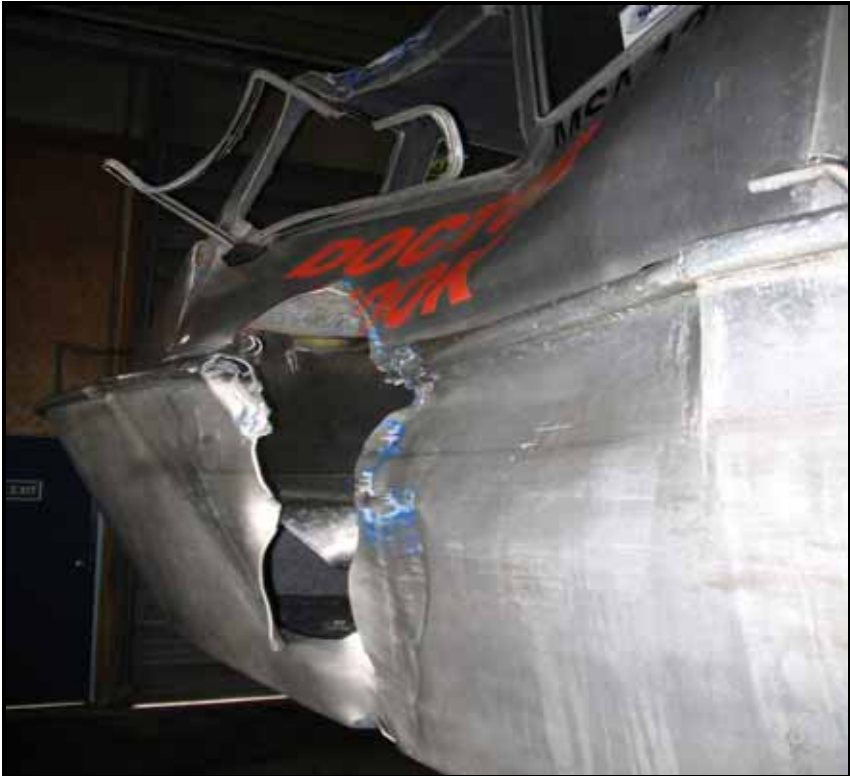
**Doctor Hook** was extensively damaged. The hull was breached on the port side, just forward of amidships. A 0.9 metre gash extended from just above the waterline to below the forward section of the cabin. The force of impact shunted the house approximately 14cm to starboard and most of the windows were shattered (See Photographs 11 & 12 – damage to **Doctor Hook**).

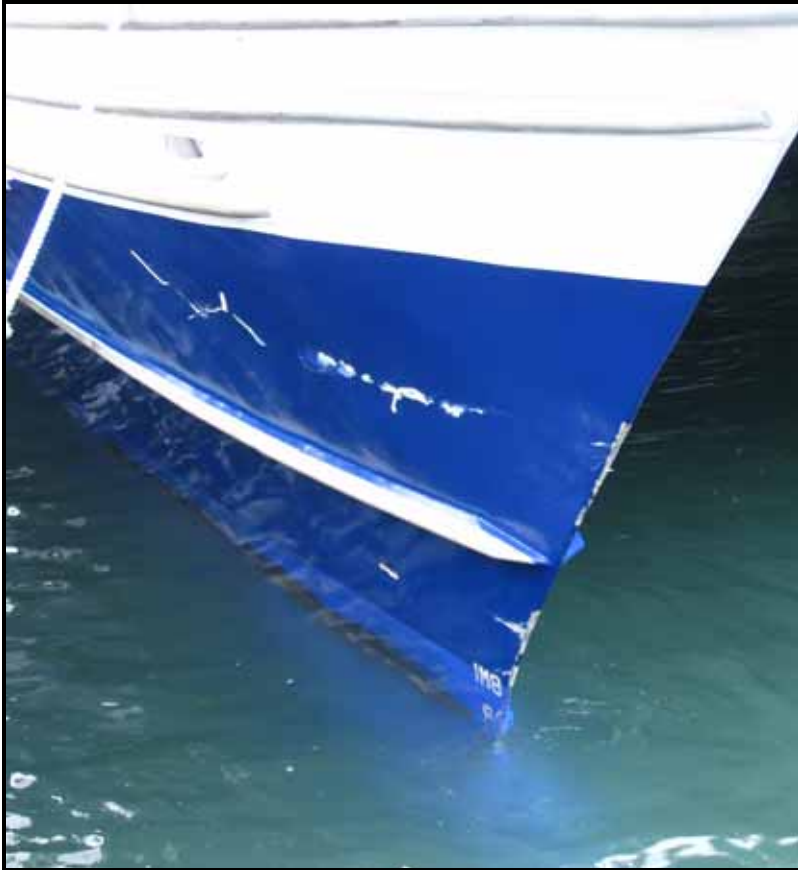
PHOTOGRAPH 13

*Quickcat* sustained paint damage to the starboard hull (See *Photograph 13 – Damage to Quickcat*).
