Accident Report

Fatality

Raft – Incept 22

14 October 2005

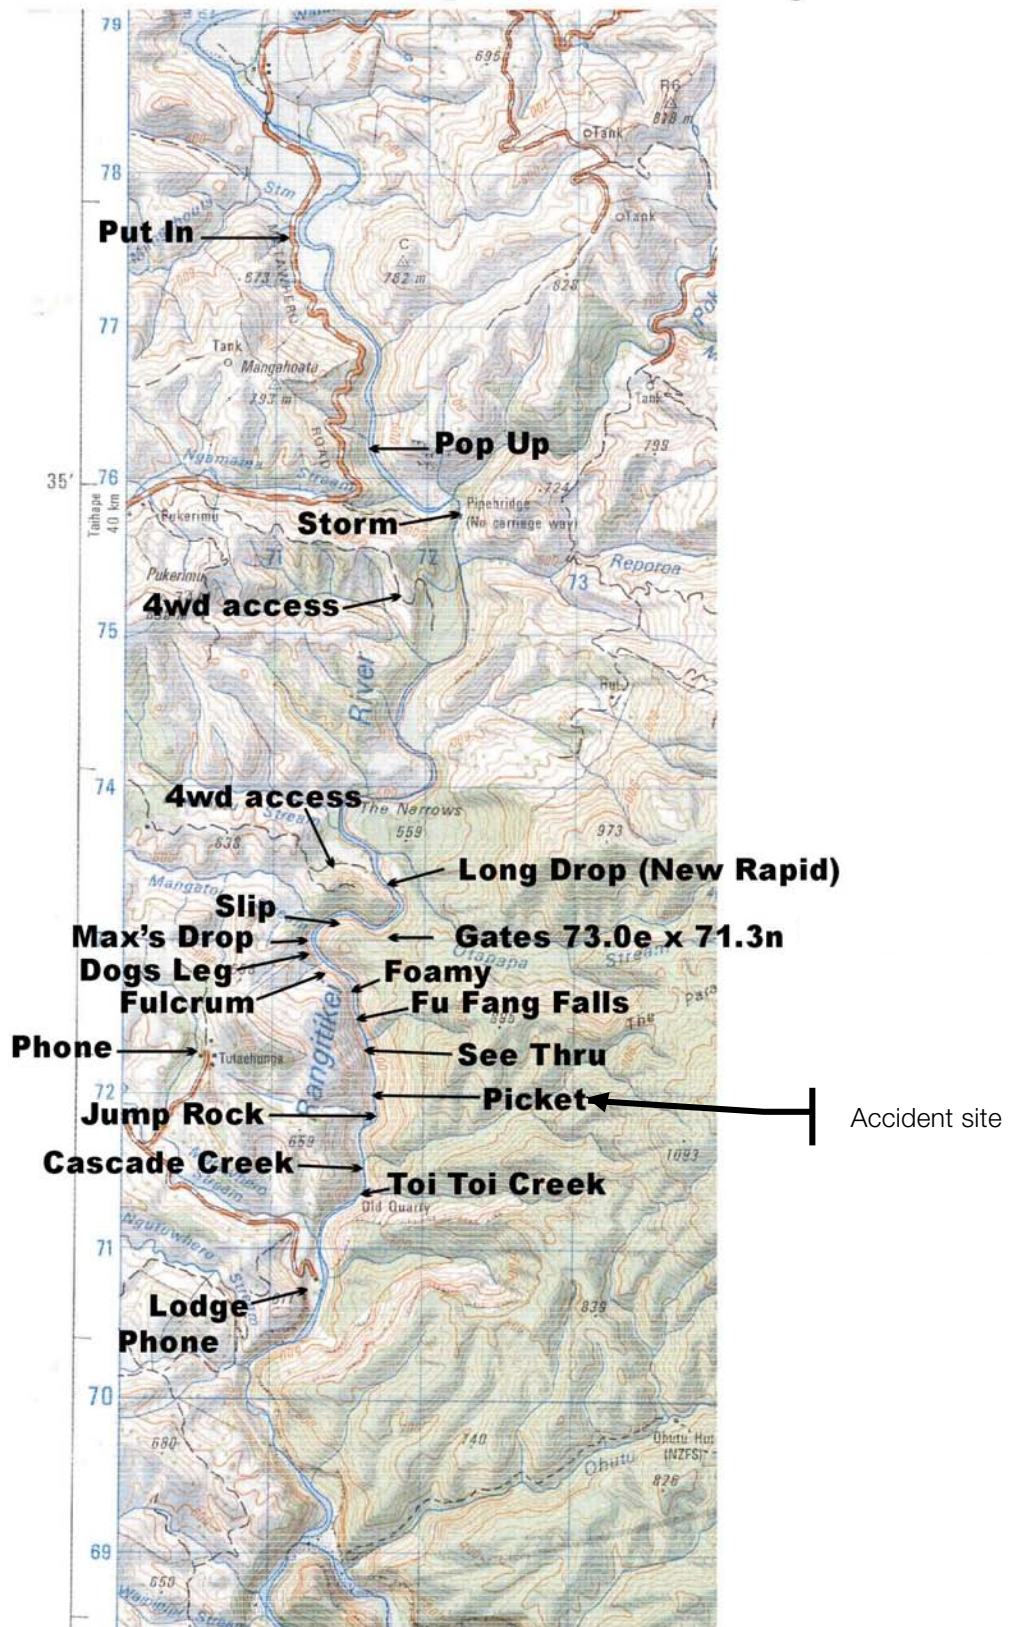
Figure 1
White Water Section Map – River Valley Ventures

Two of the four rafts approached a rapid known as 'Picket' (*See Figure 1*). This is one of the last major rapids, where they slowed and one of the rafts started to make its run towards the chute accessing the rapid. As this raft approached the chute it wrapped (*See Glossary*) on a rock just upstream of the main rapid. The raft rode up on the rock and five of the six passengers were thrown into the water. The Guide and one passenger stayed in the raft which then exited the wrap (*See Glossary*) and continued down the rapid where the guide beached the raft.

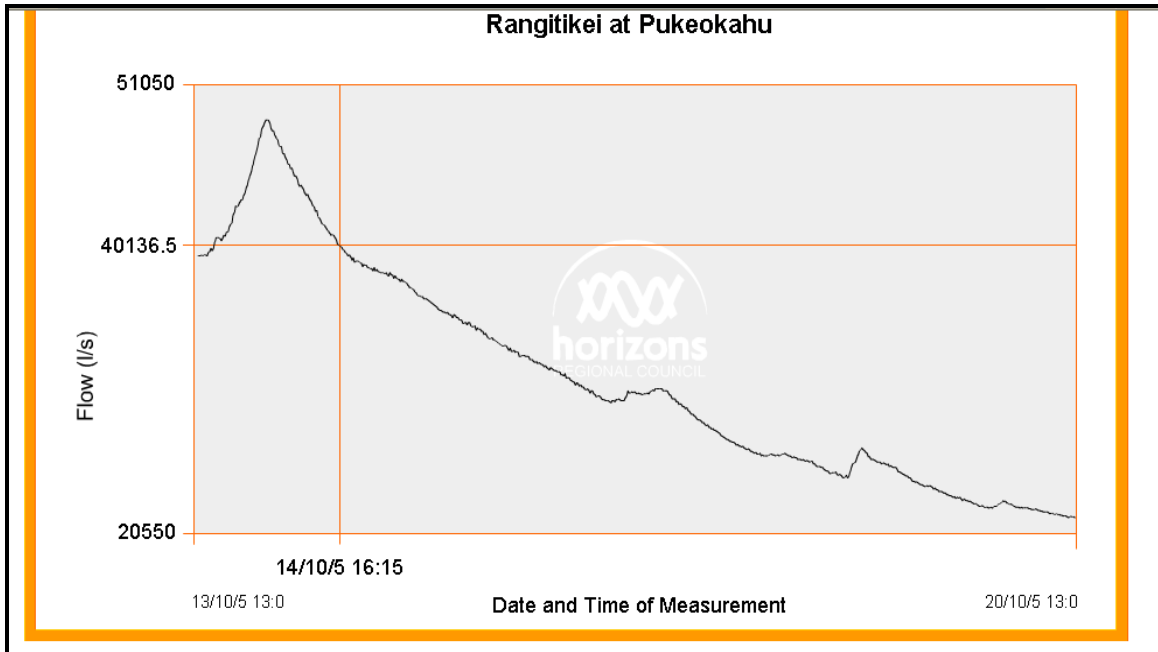
Figure 3

Real time river flow as displayed on the Horizon Regional Council website. The flow at the time of the accident was 40 136.5 litres per second or 40.136.5 cumecs, which is slightly in excess of the figures recorded in *Figure 2* at the time of the accident. The Regional Council show the information in litres per second because by this means they are able to record really low flows in the summer.

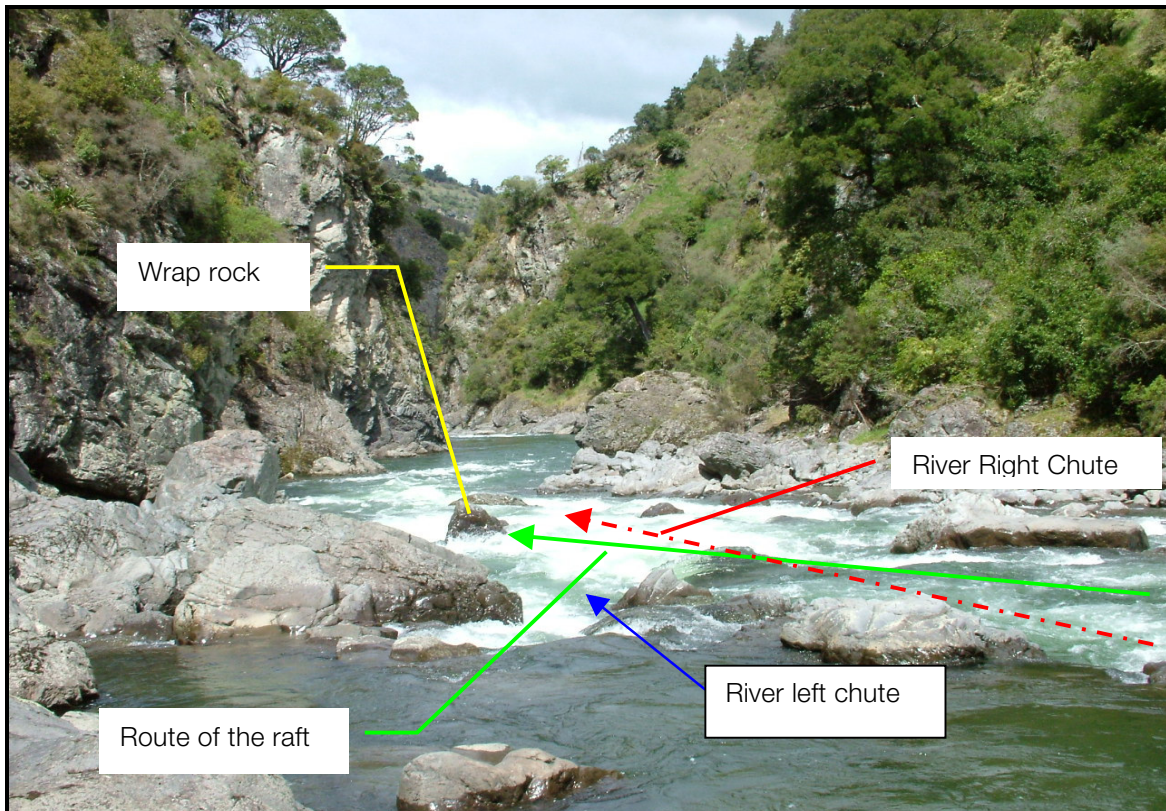
Photograph 2
Picket Rapid

Due to the lack of speed the guide was unable to get the raft to run down the river right chute which gives a clearer line into the rapid. However, there is no 'right' or 'wrong' entry into the rapid and the river left chute had been used on many occasions without incident (See *Photograph 2*). Usually, this is not a major problem as the raft can run down either side of the wrap rock safely. In this case the crew were unable to get to the left of the raft quickly enough to stop the raft from wrapping. If the crew could have got to the top of the tube then they may have been able to prevent a full wrap.

“When the rock in the entry channel of Picket is covered, forming a hole, then rafts MUST enter the rapid from below the guard rocks on river left, with a ferry angle to fully clear the wrap rock and sieves on river left. Rafts should be running either through the hole or to the right of it.”
