Accident Report  
*Recovery II*  
Grounding, approximately 5  
miles south of Karamea  
on 17 May 2004

REPORT NO.: 04 3465

VESSEL NAME: *RECOVERY II*

Casualty Type: Grounding

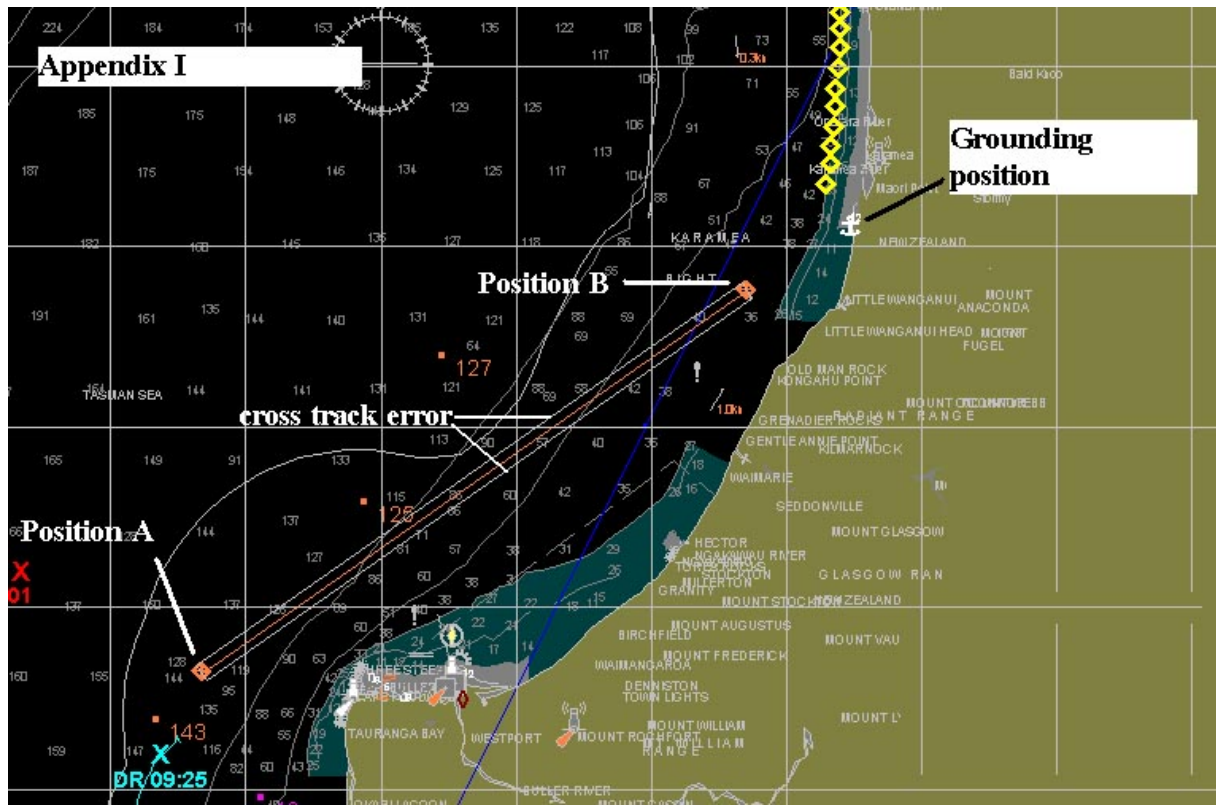
# Appendix I

- 1.5 Deckhand 1 and Deckhand 2 came into the wheelhouse at 0145 hours on 17 May, when the vessel was approximately 5 nautical miles (nm) west of Cape Foulwind. The Skipper told them that he wanted them to follow the course line on the GPS plotter and, if they got to the waypoint earlier than 0600 hours, then they were to stop the vessel (*See Appendix I - Vessel Seaplot chart: Position A start and position B stop*).

- 1.8 Shortly after sitting down again he fell asleep.
- 1.9 The vessel grounded at about 0530 hours. Deckhand 1 and the Skipper woke shortly after the grounding (*See Appendix I - Position C: Grounding*) The Skipper came to the wheelhouse and realised that they were aground. All crew had assembled by now in the wheelhouse, so the Skipper sent them to check the vessel for damage and ingress of water.

- 2.3.2 All the above equipment was working satisfactorily. The Skipper had activated the autopilot and had put a waypoint on the Seaplot screen and its associated route. The Skipper had also set a cross track error alarm each side of the course to steer (*See Appendix I - Cross track error*).
