Summary Report

Grounding

Rere

14 August 2006

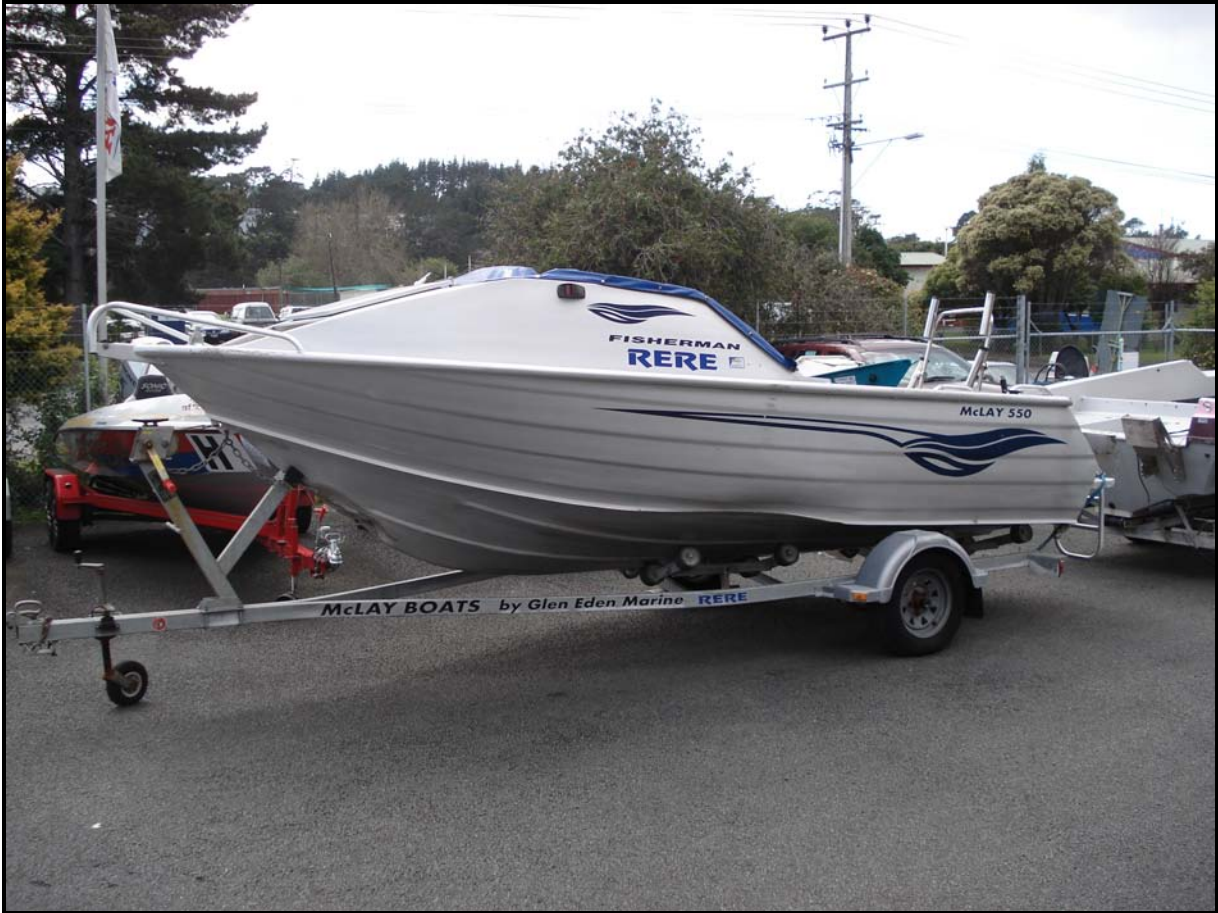
Photograph 1
Rere

- 5.5 m McLay fisherman cabin boat (*See Photograph 1*)
- Power – 67 kW Honda outboard
- Hull 5 mm alloy with 4 mm topsides
- GPS/Depth sounder
- Flare Pack
- VHF
- Six Lifejackets

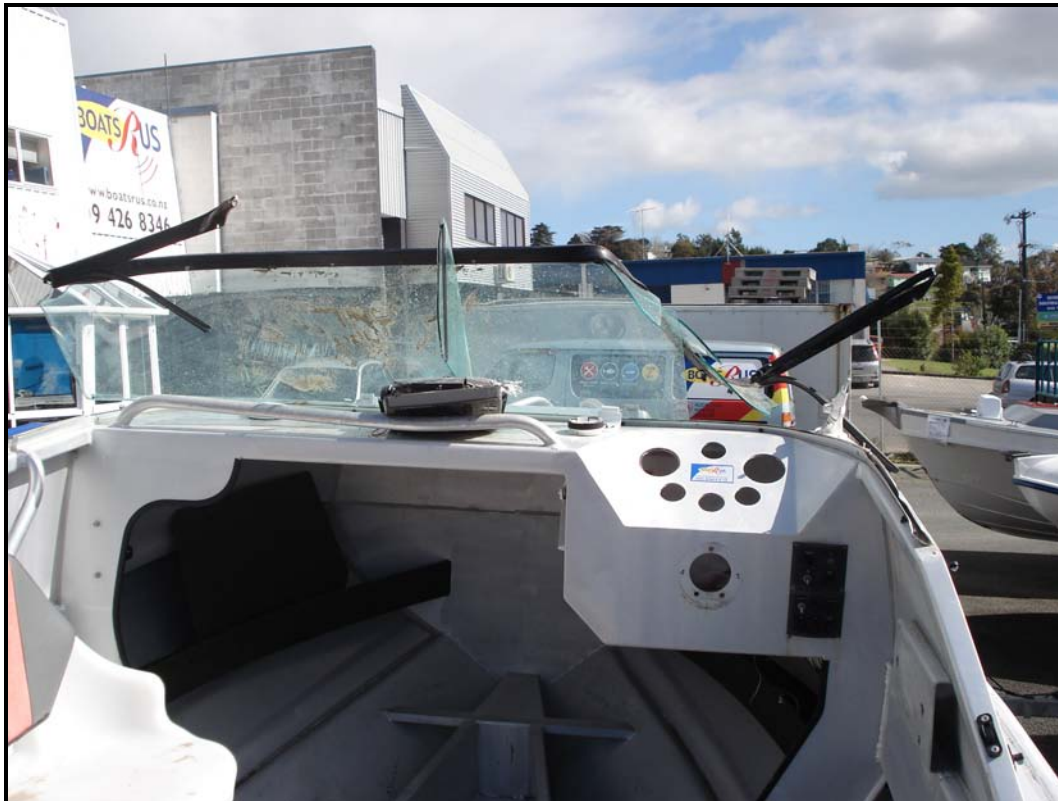
Photograph 2

Rere sustained substantial damage. The Perspex windscreen was smashed by impact with the vessel's crew, two of whom sustained severe cuts to their faces (*See Photograph 2*). The section directly in front of the steering station appears to have being subject to high impact, probably from the Skipper's body.

The collapsible canopy that was fixed to the top of the windscreen and supported by alloy poles also showed signs of a high force impact with many of the poles being bent.

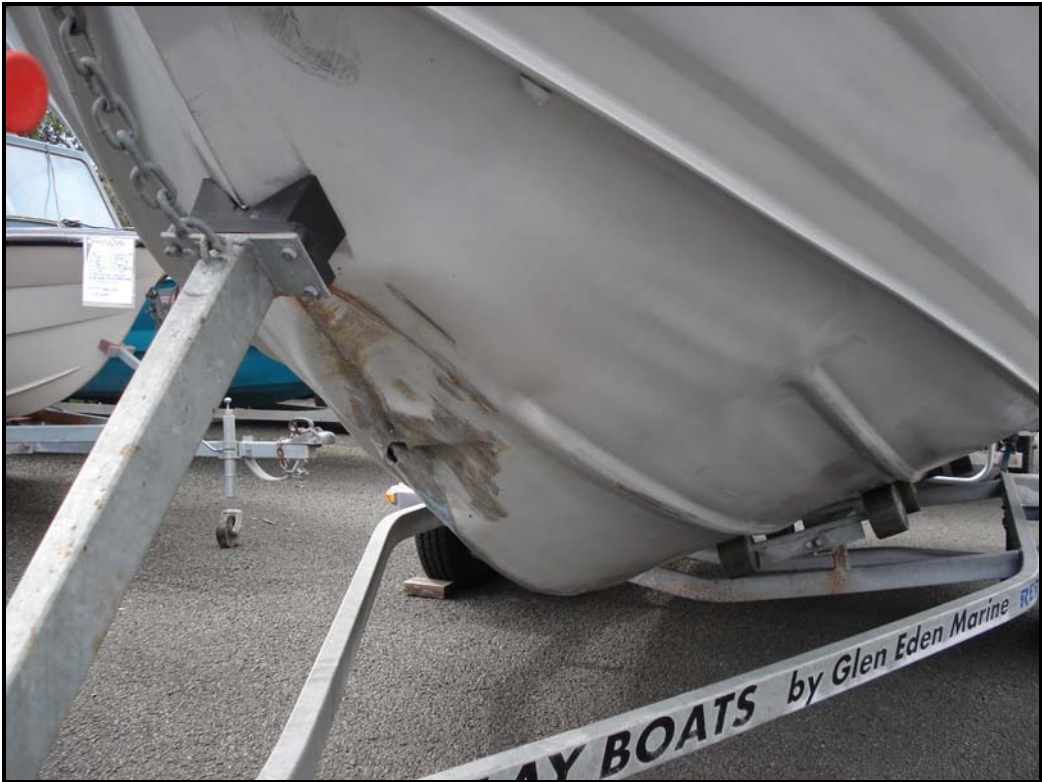
Photograph 3

A 500 mm section of bow was stove in with a 45mm hole (See *Photograph 3*). An indentation of 1.13 metres was observed on the port planning strake. On the starboard side an indentation 350 cm x 200 cm was observed just above the planning strake forward of amidships.

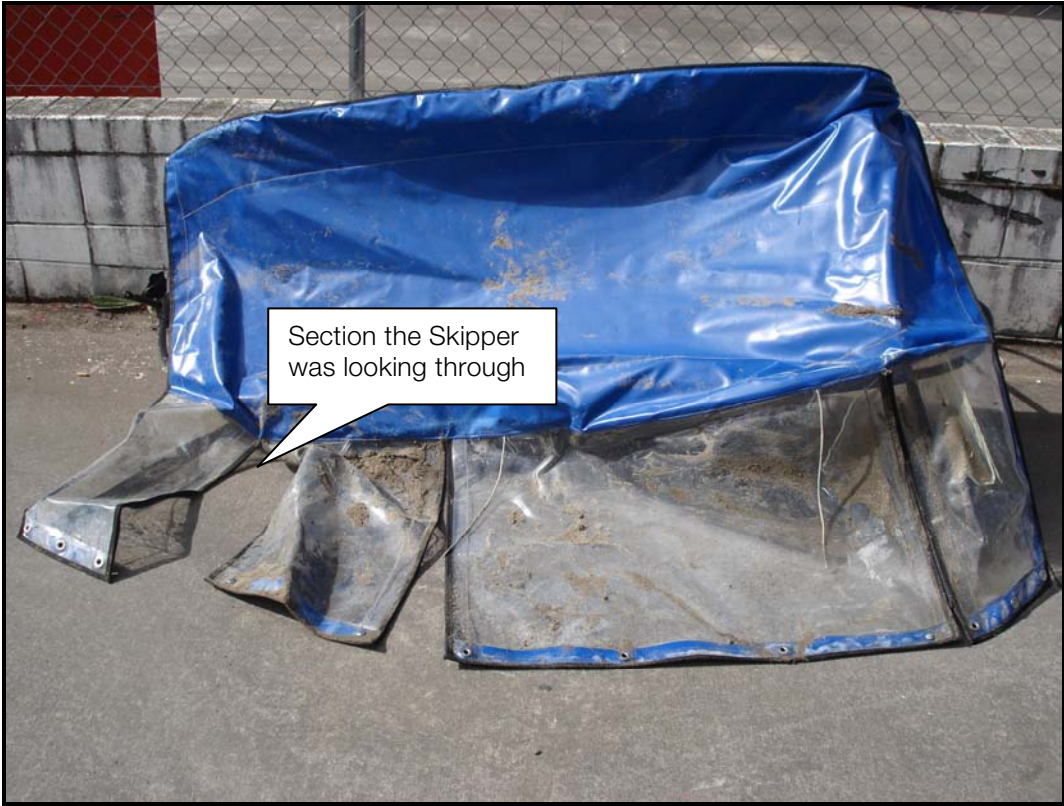
Photograph 4
Canopy

The canopy had a section above the top of the windscreen that could be rolled up to allow the helmsman to poke his head through for the purpose of providing better vision (See *Photograph 4*).

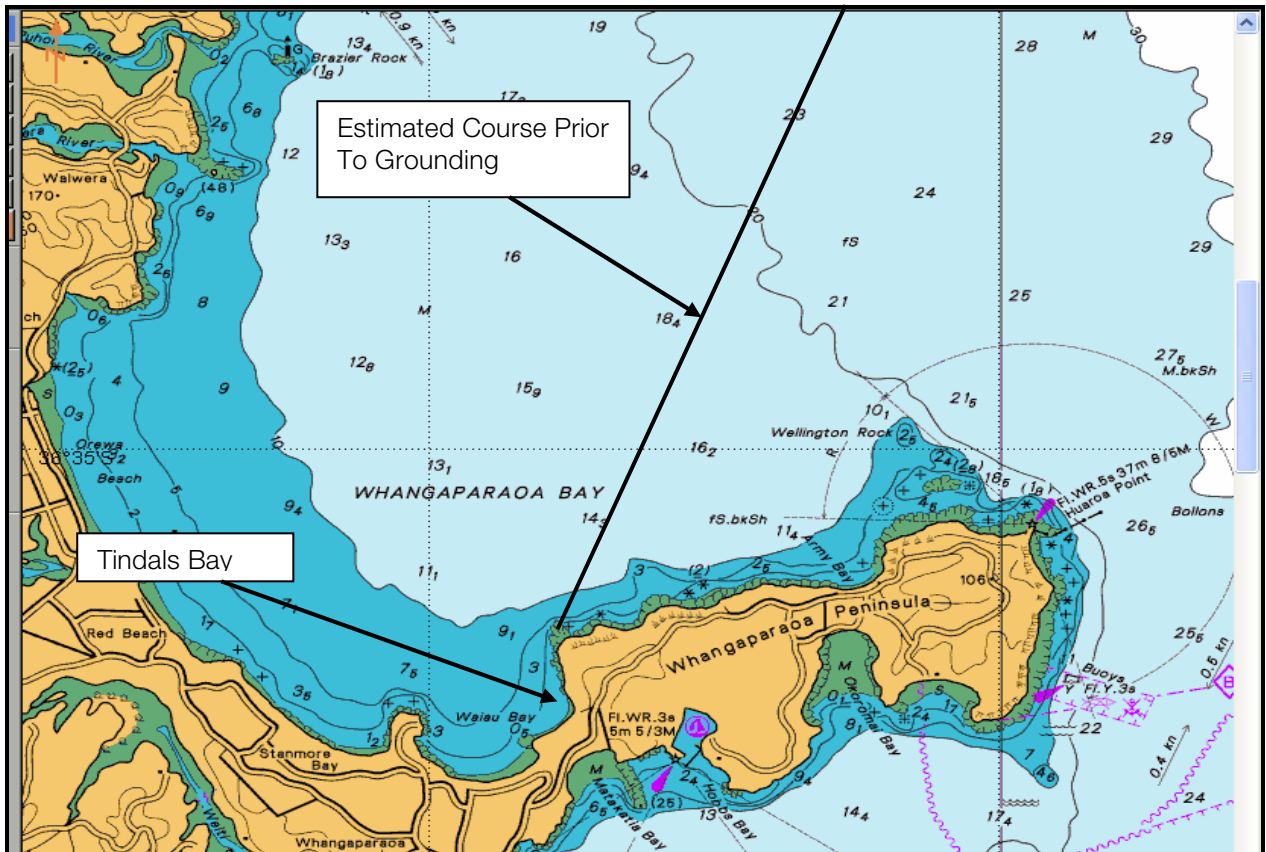
Figure 1

The north coast of the Whangaparaoa Peninsula is a jagged coastline characterised by rocks and reefs extending well out from the shoreline. There are no lights or marks identifying outlying dangers where the accident occurred (See Figure 1).
