Accident Report
Collision
Rescue Alpha v PWC 911
13 June 2009

Maritime New Zealand

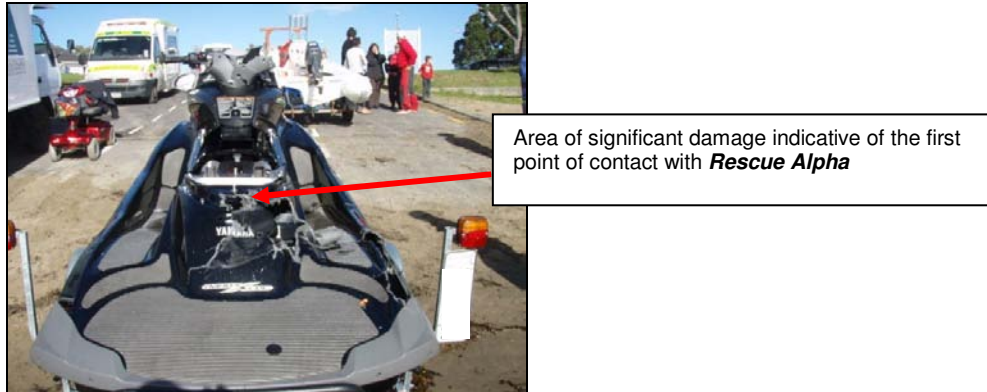
Figure 2 Photograph showing damage sustained by **PWC 911**

23. The photograph above was taken shortly after **PWC 911** was recovered from the water.⁶ The damage is situated predominately on the starboard side, and after quarter of **PWC 911**, which indicates **Rescue Alpha's** impact with **PWC 911**, and is consistent with eyewitness accounts.

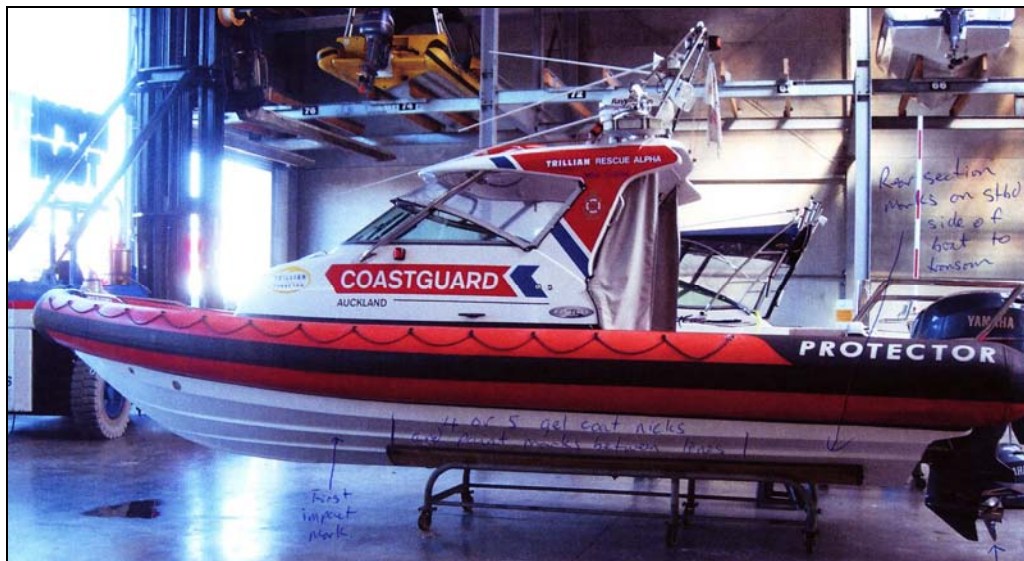
Figure 3 Photograph showing damage sustained by **Rescue Alpha**. Handwritten notes explaining areas of damage.

24. **Rescue Alpha** was taken from the water and repaired before a MNZ investigator could examine the damage. The photograph above was taken shortly after the accident and contains hand-written notes describing the damage, which were made by the repairer. There was damage to the port side and the starboard skeep of **Rescue Alpha**. The damage is consistent with witness accounts of **Rescue Alpha** riding up and over **PWC 911**. The damage to the port side of **Rescue Alpha** corresponds to the area of significant damage on the starboard after quarter of **PWC 911**.

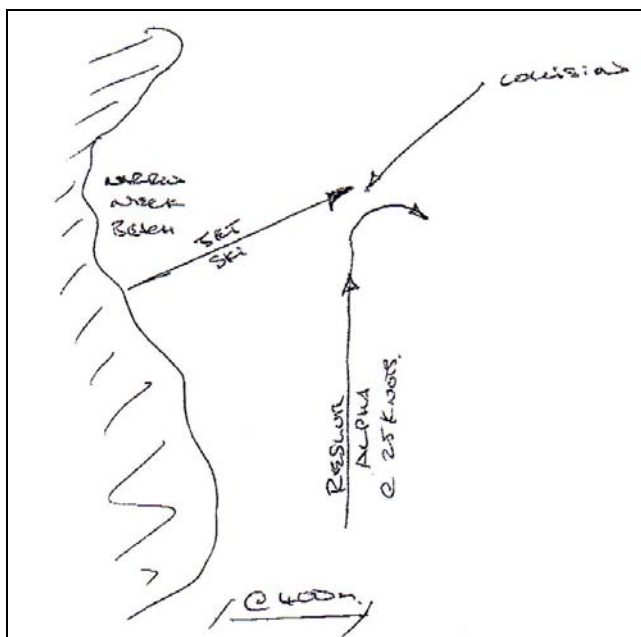
Figure 4 Sketch diagram provided by skipper of **Rescue Alpha**

38. When reporting the matter, the master of **Rescue Alpha** provided the following sketch showing the course of each vessel to the point of collision. From this sketch it is possible that **Rescue Alpha** may have been within the **PWC 911** rider's field of view when the crew of **Rescue Alpha** first sighted **PWC 911**. However, given the courses indicated it is possible that **Rescue Alpha** was outside the rider's restricted field of vision as the vessels converged.

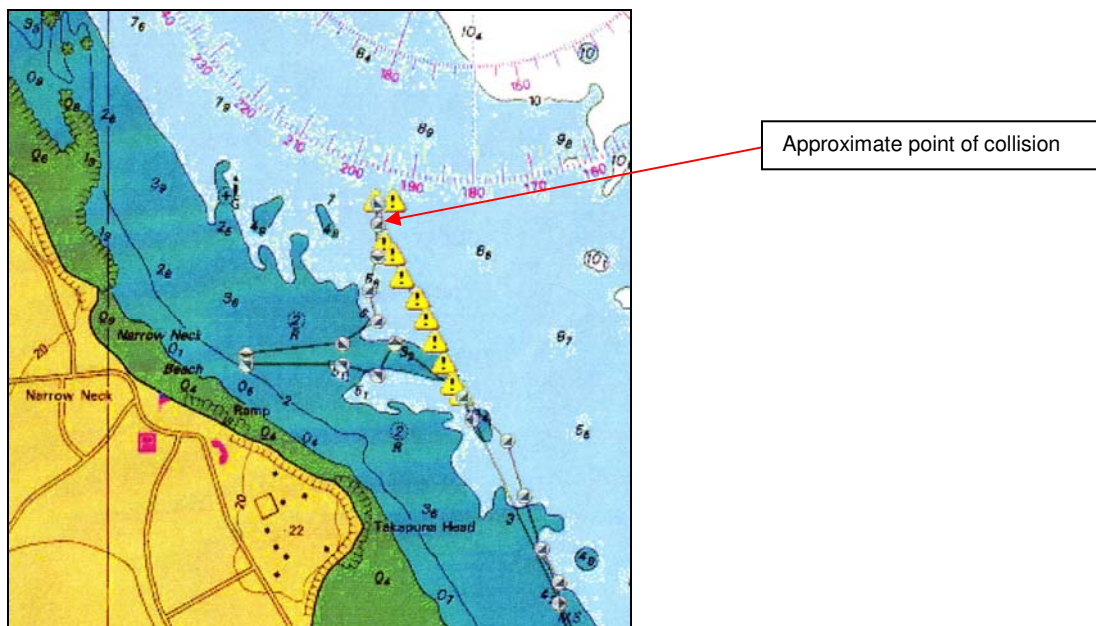
Figure 5 Course taken by *Rescue Alpha*⁸

39. This sketch is corroborated by the screen-shot below, taken from the Coastguard Northern Region's Global Positioning System (GPS) plotter that monitors Coastguard vessels. The GPS screen-shot provided an accurate account of *Rescue Alpha's* course. The path of the collision course is highlighted by the exclamation marks shown in yellow.
