Summary Report
Grounding
Rex
4 June 2006

REPORT NO.: 06 4100

VESSEL NAME: *REX*

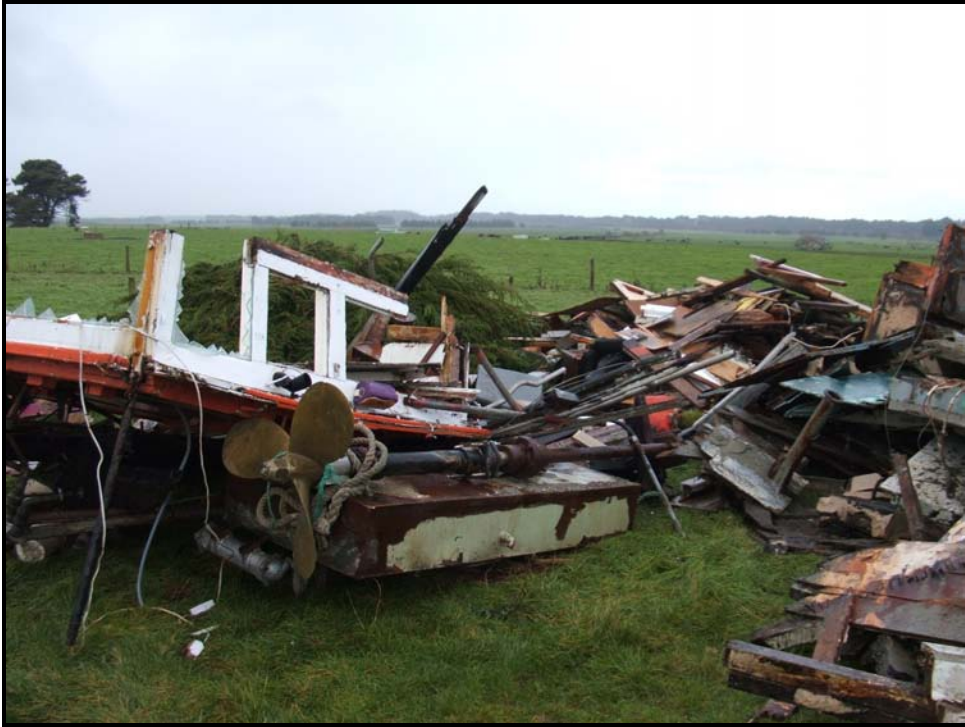
Attempts to tow the vessel off the beach were unsuccessful and **Rex** remained hard aground. The Skipper and his friend left the vessel at about 0430 hours after all hope was lost. The vessel started breaking up in the 1 to 2 metre swell shortly afterwards. Over the next 24 hours the vessel was reduced to 'matchwood' and was a constructive total loss.

Photograph 2
Rex after the accident.
